## Laboratory Investigation Of Coating Failure From Stucco Façades Of An 18<sup>th</sup> Century Courthouse In Charleston, South Carolina

Charleston County Courthouse Exterior Façade  
Charleston, South Carolina

September 29, 2020  
CMC 0820145

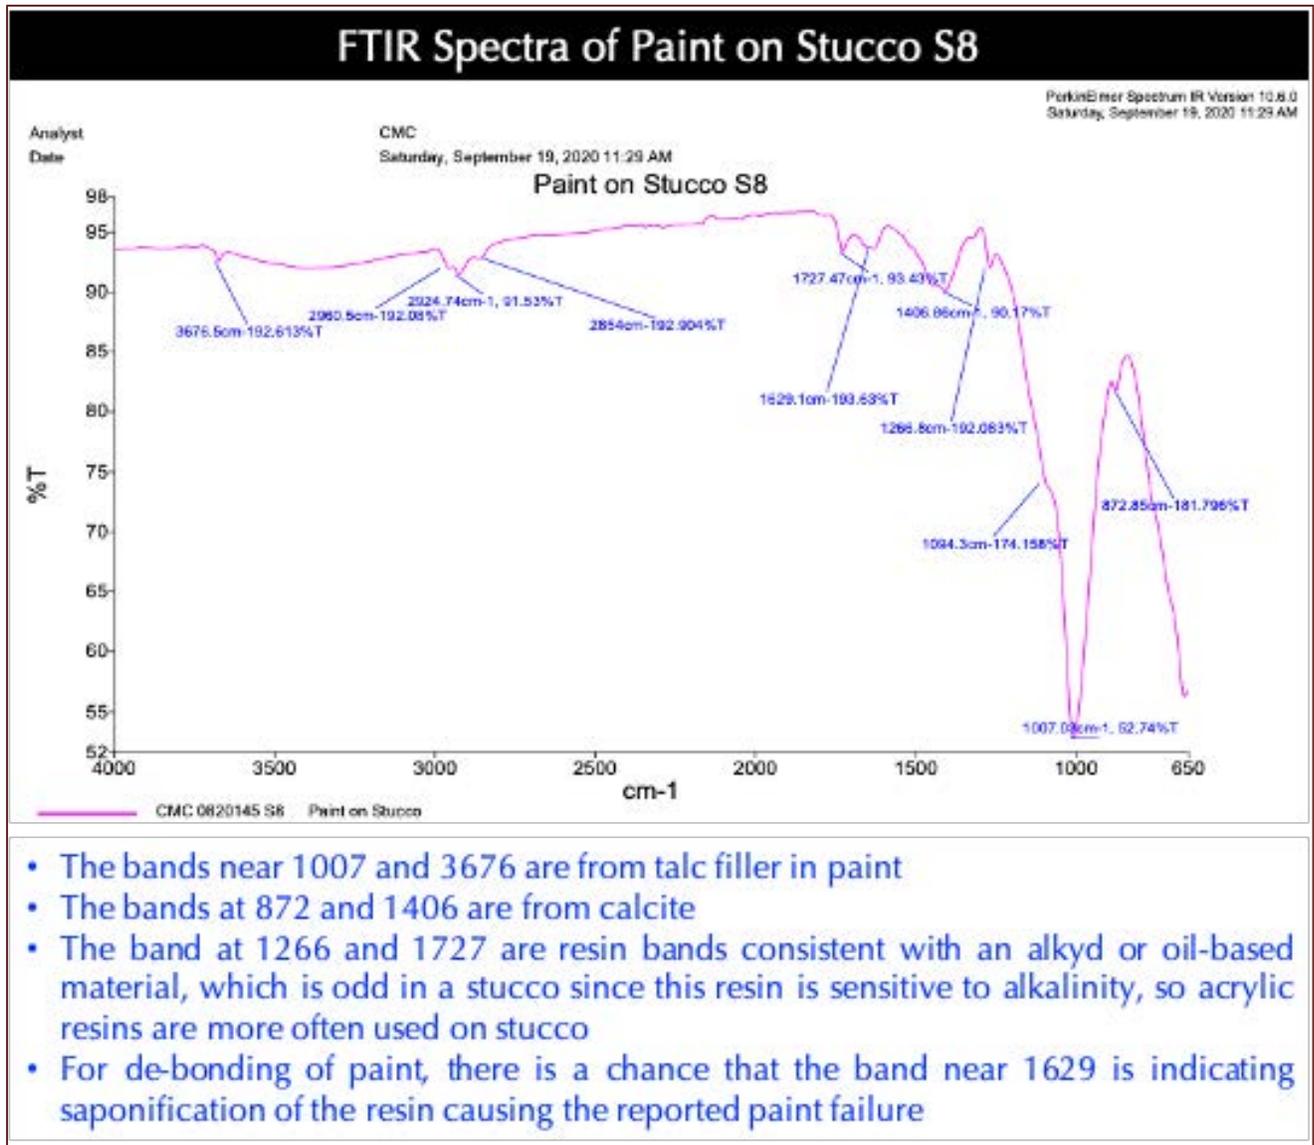
There is no evidence of any other filler found in the optical microscopy, or SEM-EDS, or FTIR scans in Figures 72 through 76. For example, there is no nepheline syenite, diatom, dolomite, or silicon dioxide fillers found either in optical or electron microscopy, or in FTIR studies. Amorphous silica in diatom gives a large band near  $1100\text{ cm}^{-1}$  with bands at  $800\text{ cm}^{-1}$  and  $500\text{ cm}^{-1}$ , which are not present. Crystalline silica has a characteristic doublet near  $800/780\text{ cm}^{-1}$ , which is not present. Dolomite has large doublet at  $1480/1410\text{ cm}^{-1}$  which are not present. Bands found at  $1267\text{ cm}^{-1}$  and  $1732\text{ cm}^{-1}$  correspond to an alkyd resin or oil-based binder, which is not resistant to the alkaline medium of stucco especially at the newly installed stage before the stucco surface that was painted has had a pH around 9 or lower from atmospheric carbonation to prevent alkali-induced deterioration of alkyd-based paint. For the reported peeling of paint, there is a possibility that the band near  $1628\text{ cm}^{-1}$  is indicating saponification of

the resin to cause the paint failure from alkaline degradation of alkyd-based paint. An acrylic paint would have produced a band near  $1170\text{ cm}^{-1}$  sometimes with a smaller band near  $1240\text{ cm}^{-1}$ , which are not found. Siloxane would usually have a broader band between  $1100$  and  $1000\text{ cm}^{-1}$ , which is not found.

Figure 76: FTIR spectra of paint coat scrapped from the exterior face of Sample S8 showing: (a) bands near  $1007\text{ cm}^{-1}$  and  $3676\text{ cm}^{-1}$  corresponding to talc filler in paint; (b) bands at  $872\text{ cm}^{-1}$  and  $1406\text{ cm}^{-1}$  corresponding to calcite partly from calcite filler in the bonding agent of paint and partly from contaminant carbonated lime binder of stucco; and (c) bands at  $1266\text{ cm}^{-1}$  and  $1727\text{ cm}^{-1}$  corresponding to an alkyd resin or oil-based binder, which is not resistant to the alkaline medium of stucco especially at the newly installed stage before the stucco surface that was painted has had a pH around 9 or lower from atmospheric carbonation to prevent alkali-induced deterioration of alkyd based paint. For the reported peeling of paint, there is a possibility that the band near  $1629\text{ cm}^{-1}$  is indicating saponification of the resin to cause the paint failure from alkaline degradation of alkyd-based paint. An acrylic paint would have produced a band near  $1170\text{ cm}^{-1}$  sometimes with a smaller band near  $1240\text{ cm}^{-1}$ .

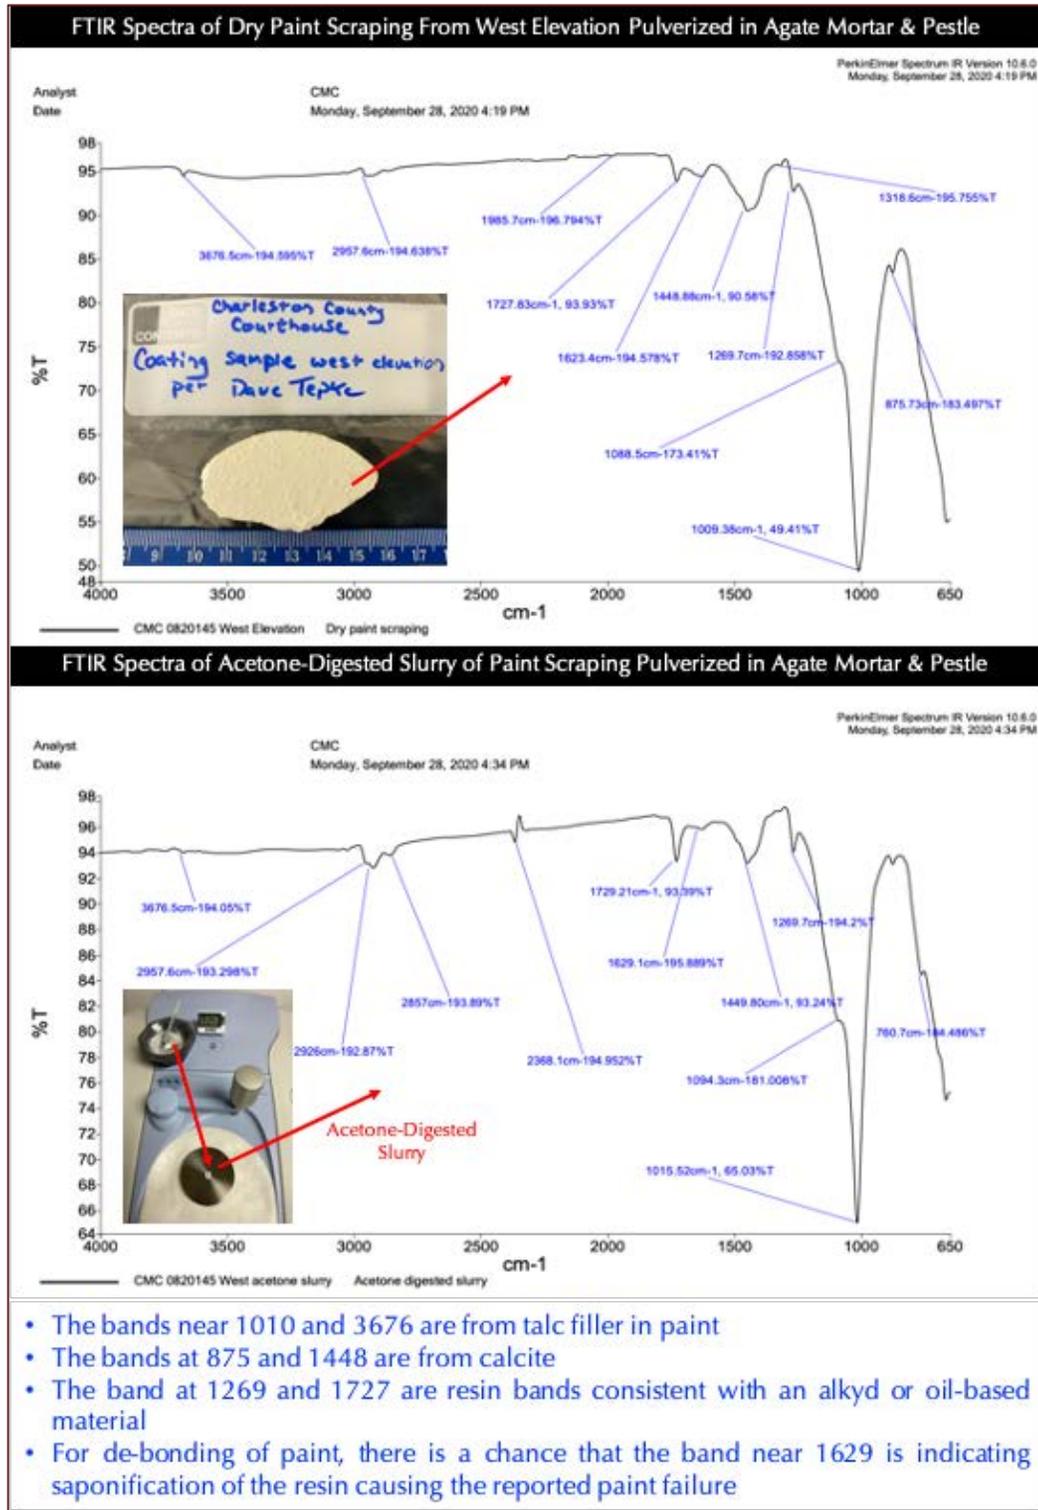
Figure 77: FTIR spectra of paint coat scrapped from the west elevation showing similar spectra as seen in other samples, e.g.: (a) bands near 1010  $\text{cm}^{-1}$  and 3676  $\text{cm}^{-1}$  corresponding to talc filler in paint; (b) bands at 875  $\text{cm}^{-1}$  and 1448  $\text{cm}^{-1}$  corresponding to calcite partly from calcite filler in the bonding agent of paint and partly from contaminant carbonated lime binder of stucco; and (c) bands at 1269  $\text{cm}^{-1}$  and 1727  $\text{cm}^{-1}$  corresponding to an alkyd resin or oil-based binder. For the reported peeling of paint, there is a possibility that the band near 1629  $\text{cm}^{-1}$  is indicating saponification of the resin to cause the paint failure from alkaline degradation of alkyd-based paint. An acrylic paint would have produced a band near 1170  $\text{cm}^{-1}$  sometimes with a smaller band near 1240  $\text{cm}^{-1}$ .
