INVESTIGATION OF SUSPENDED WALKWAY DISTRESS BY LABORATORY STUDIES OF FOUR CONCRETE CORES AND A POST-POCKET GROUT SAMPLE

EXECUTIVE SUMMARY

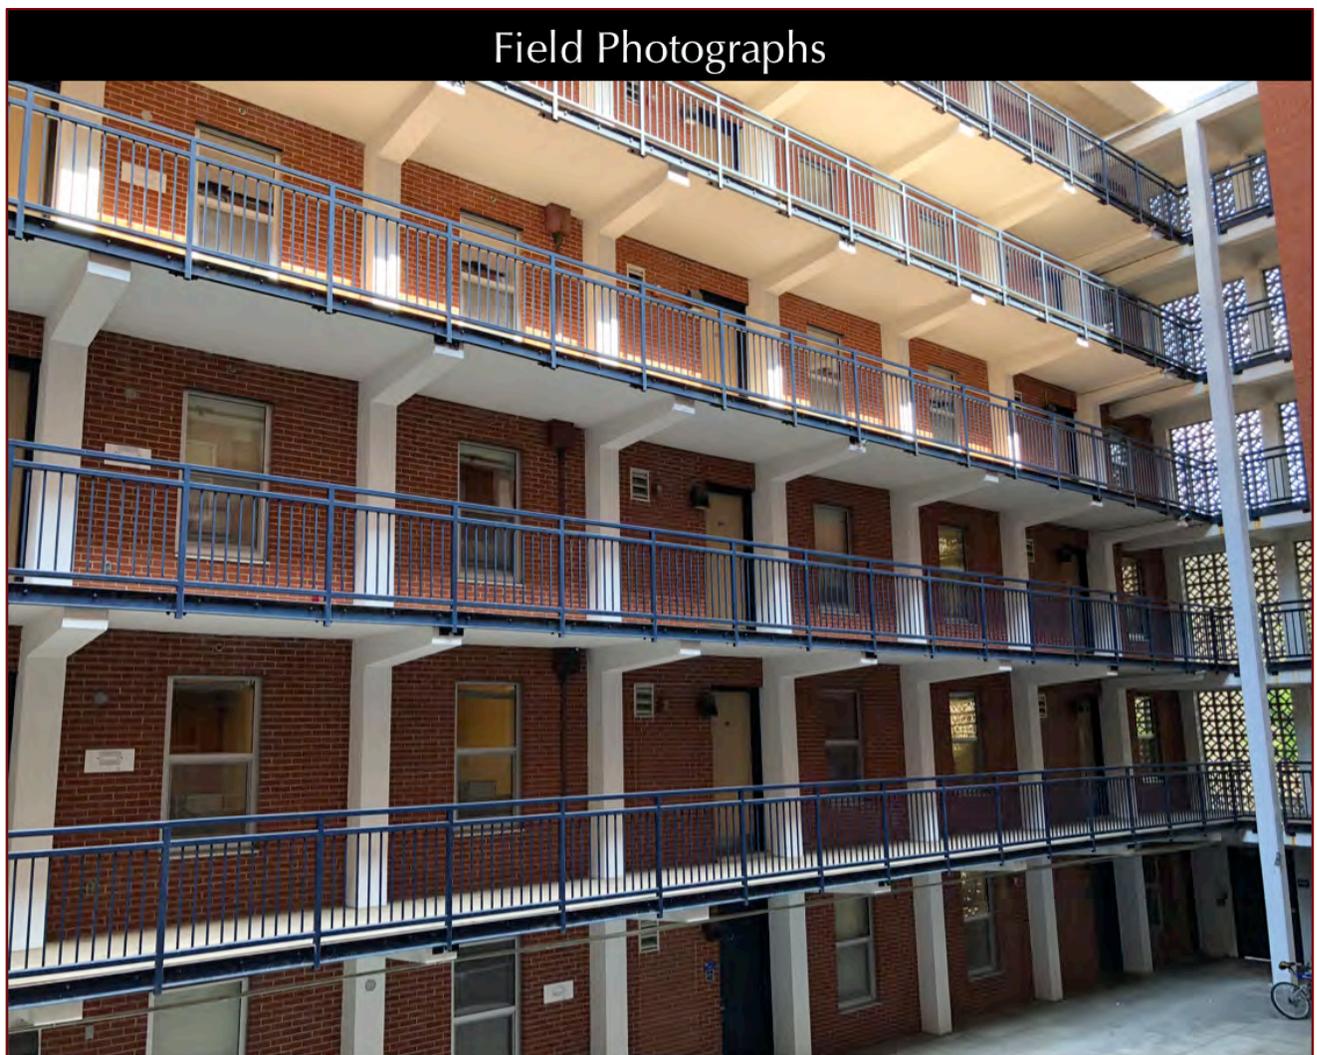
Figure 1: Field photograph showing an overview of the elevated concrete walkway slabs.

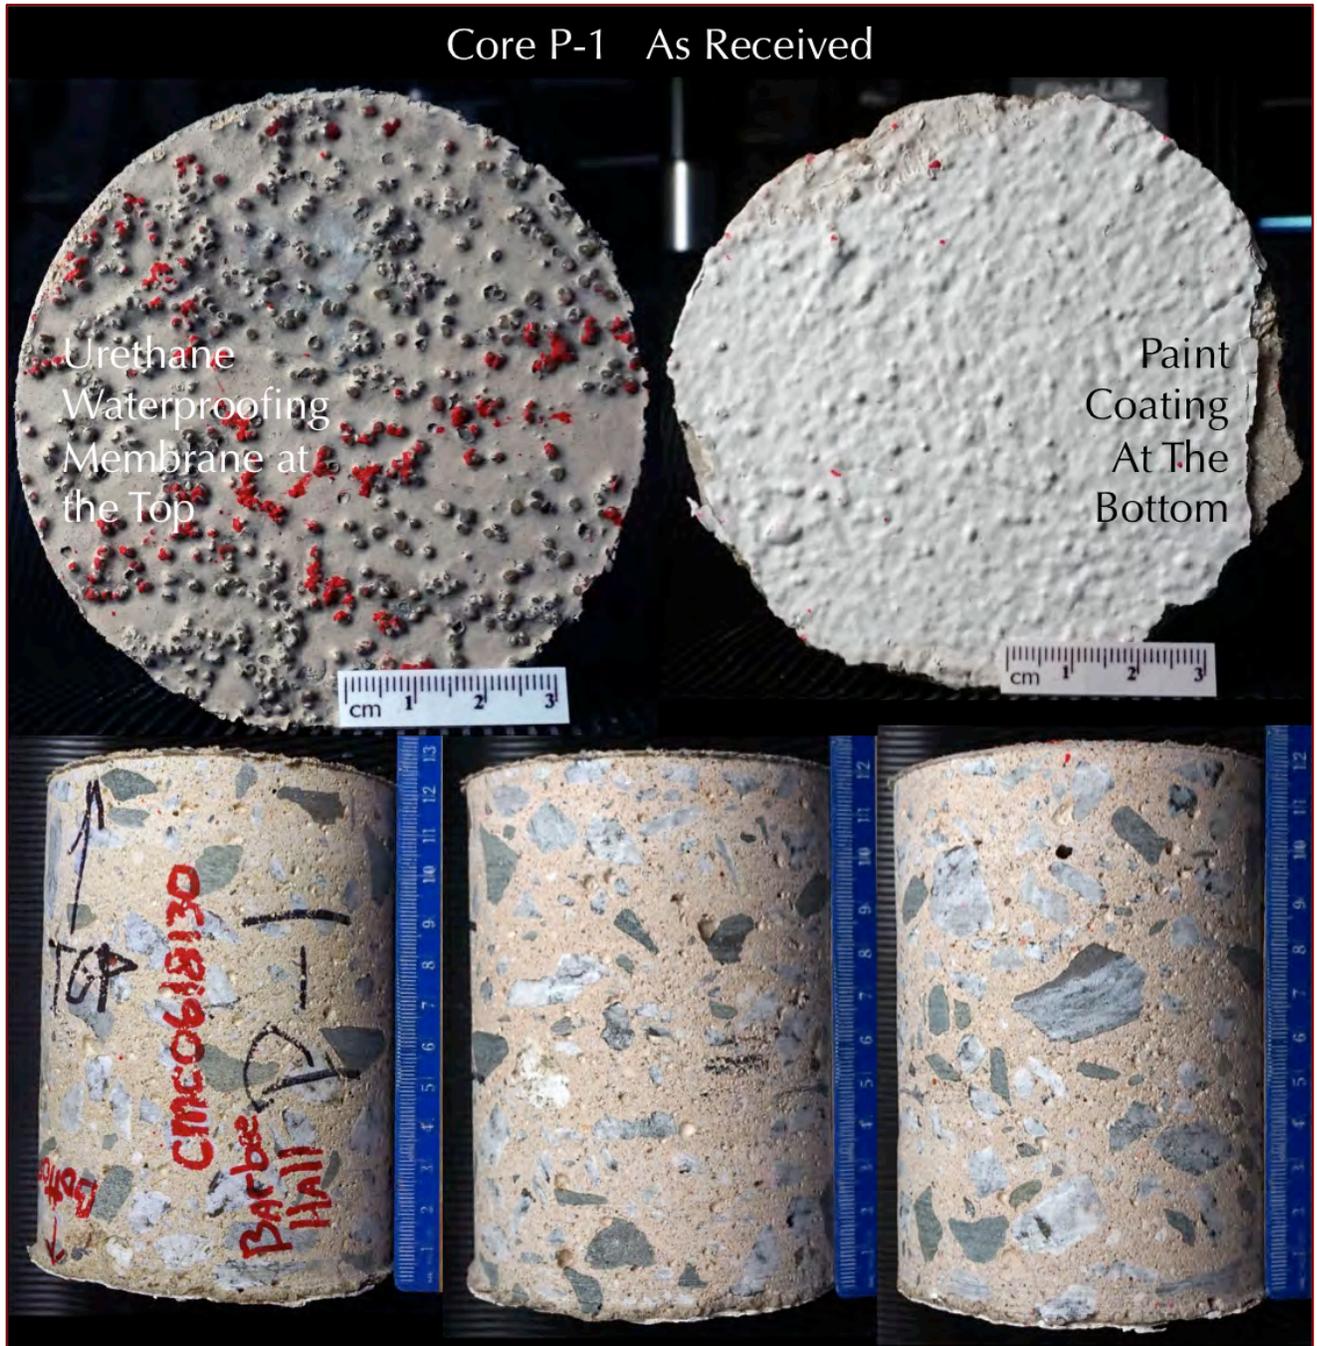
Figure 4: Shown are: (a) the top surface with tan urethane-type waterproofing membrane (top left); (b) the bottom surface with white coating (top right); and (c) cylindrical side views of Core P-1 (bottom photos), as received. Notice the overall beige color of concrete in the cylindrical surfaces.

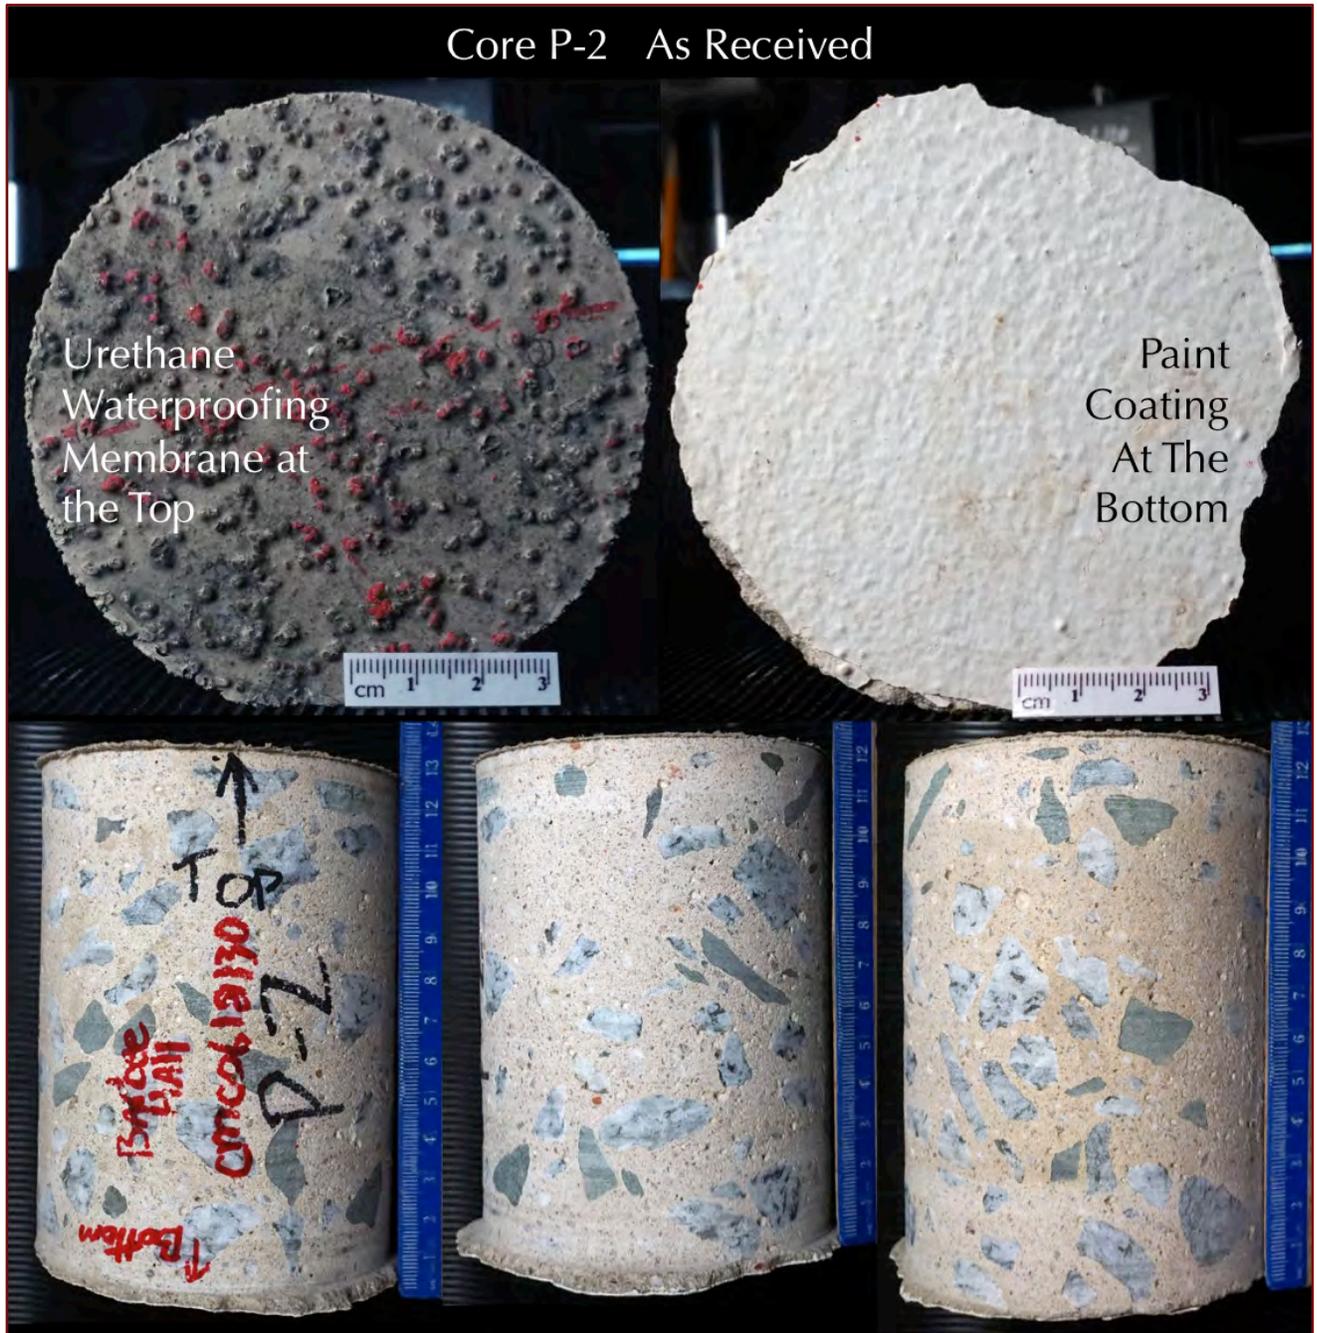
Figure 5: Shown are: (a) the top surface with tan urethane-type waterproofing membrane (top left); (b) the bottom surface with white coating (top right); and (c) cylindrical side views of Core P-2 (bottom photos), as received.

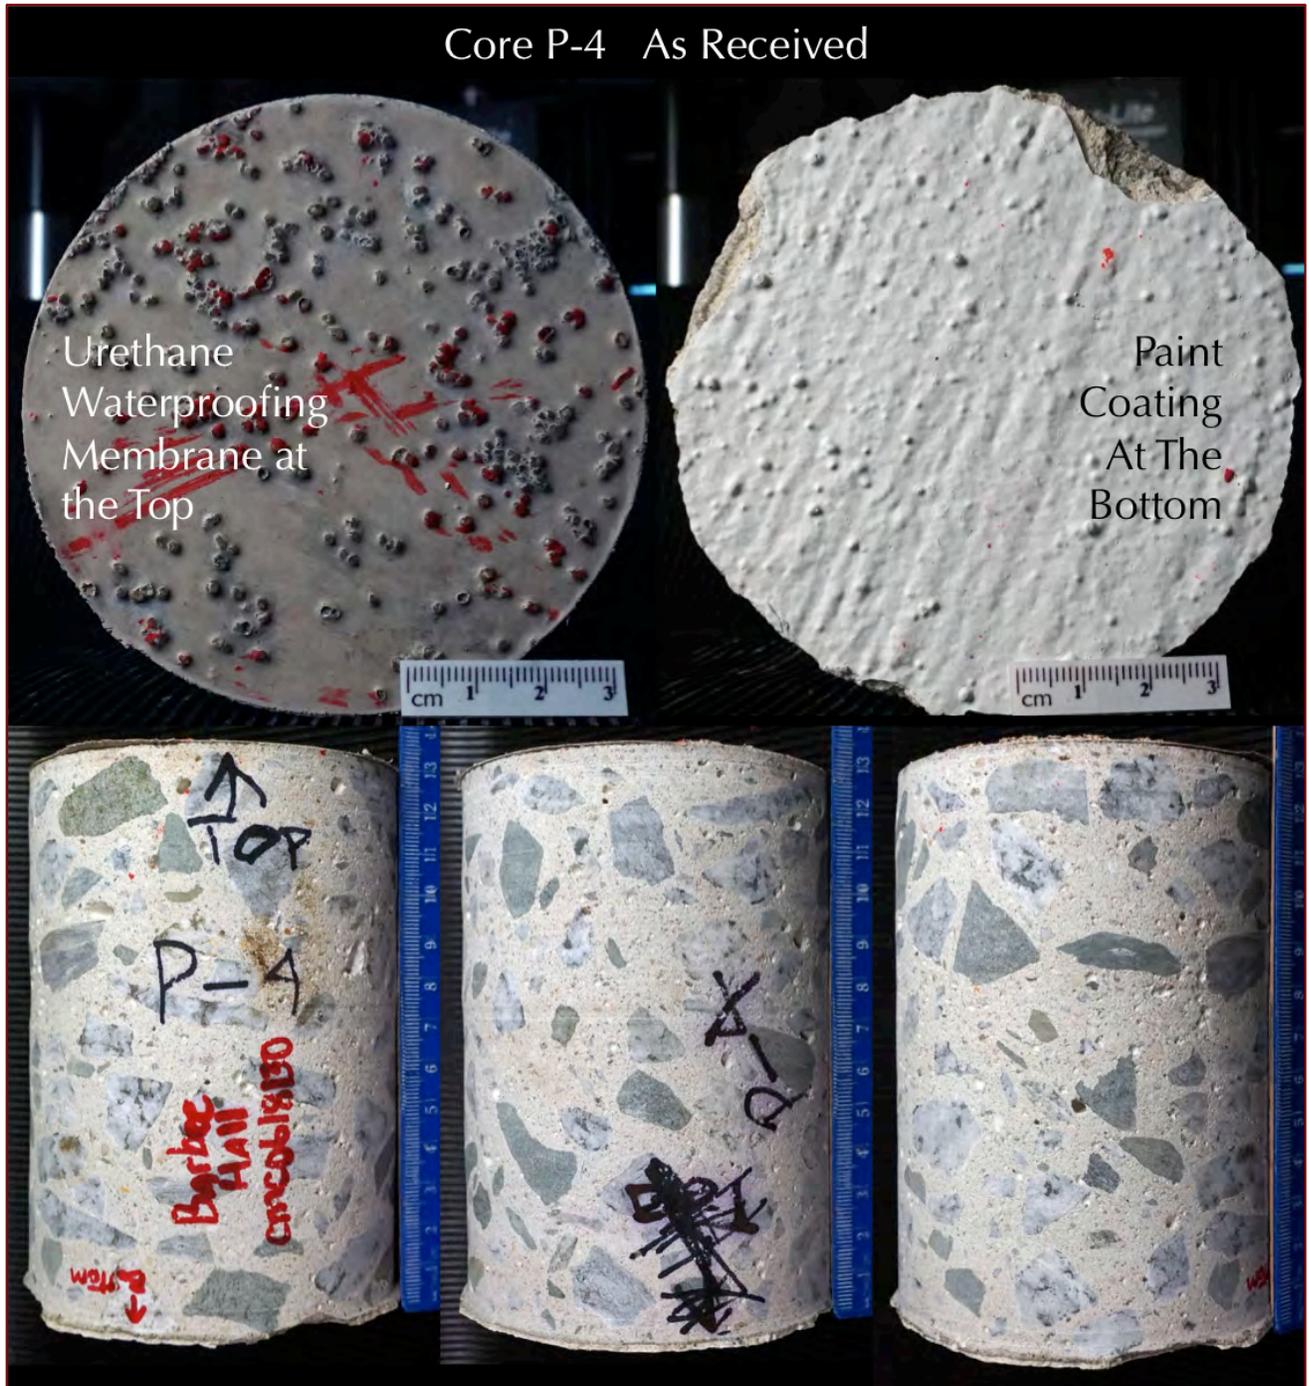
Figure 7: Shown are: (a) the top surface with tan urethane-type waterproofing membrane (top left); (b) the bottom surface with white paint coating (top right); and (c) cylindrical side views of Core P-4 (bottom photos), as received.

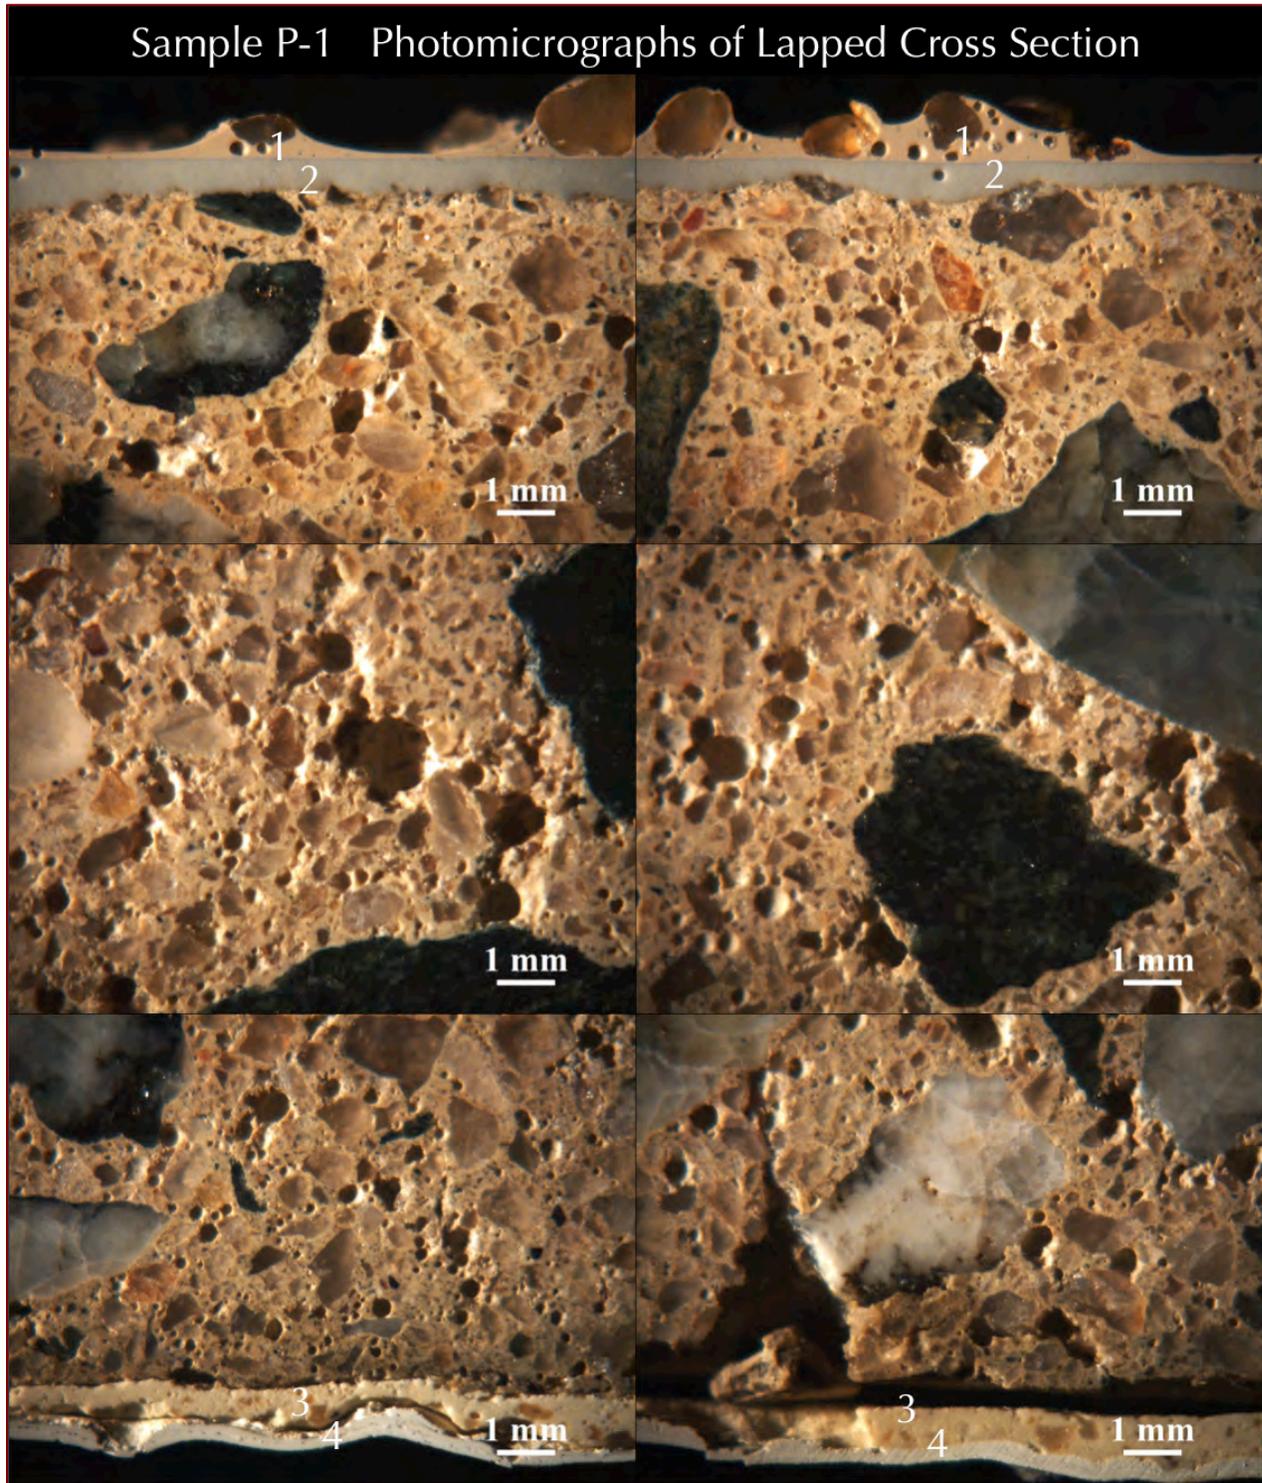
Figure 16: Photomicrographs of lapped cross section of Core P-1 showing: (a) two protective coatings #1 and 2 at the top, and another two coatings #3 and 4 at the bottom end; and (b) air-entrained (AE) nature of the concrete with many spherical voids less than one mm in size but non-uniform distribution of air (all photos). Air is higher in the interior than at both ends. Air varied from 5-6% (AE) at top $\frac{3}{4}$ in., to 9-10% (AE) from $\frac{3}{4}$ to to $3\frac{3}{4}$ in. depth, then 7-8% (AE) from $3\frac{3}{4}$ to $4\frac{3}{4}$ in. depth from top.

Core ID	Top Exposed End	Middle Interior Body	Bottom End
P-1 (Figure 16)	Top 3/4 in. Air-entrained, Estimated 5-6% air	Interior 3/4 to 3 3/4 in.: Air-entrained Estimated 9-10% air	Bottom 3 3/4 to 4 3/4 in.: Air-entrained Estimated 7-8% air
P-2 (Figure 17)	Top 1 in. Non-Air-entrained, Estimated 1-2% air	Interior 1 to 4 in.: Air-entrained Estimated 5-6% air	Bottom 4 to 5 in.: Marginally Air-entrained Estimated 1 1/2-2 1/2%
P-3 (Figure 18)	Top 1/2 in. Non-Air-entrained, Estimated 0-1%	Interior 1/2 to 4 1/2 in.: Non-Air-entrained Estimated 1 1/2-2 1/2%	Bottom 4 1/2 to 5 1/4 in.: Non-Air-entrained Estimated 0-1%
P-4 (Figure 19)	Top 1 in. Non-Air-entrained, Estimated 0-1%	Interior 1 to 4 in.: Air-entrained Estimated 5-6% air	Bottom 4 to 5 in.: Non-Air-entrained Estimated 1-2%

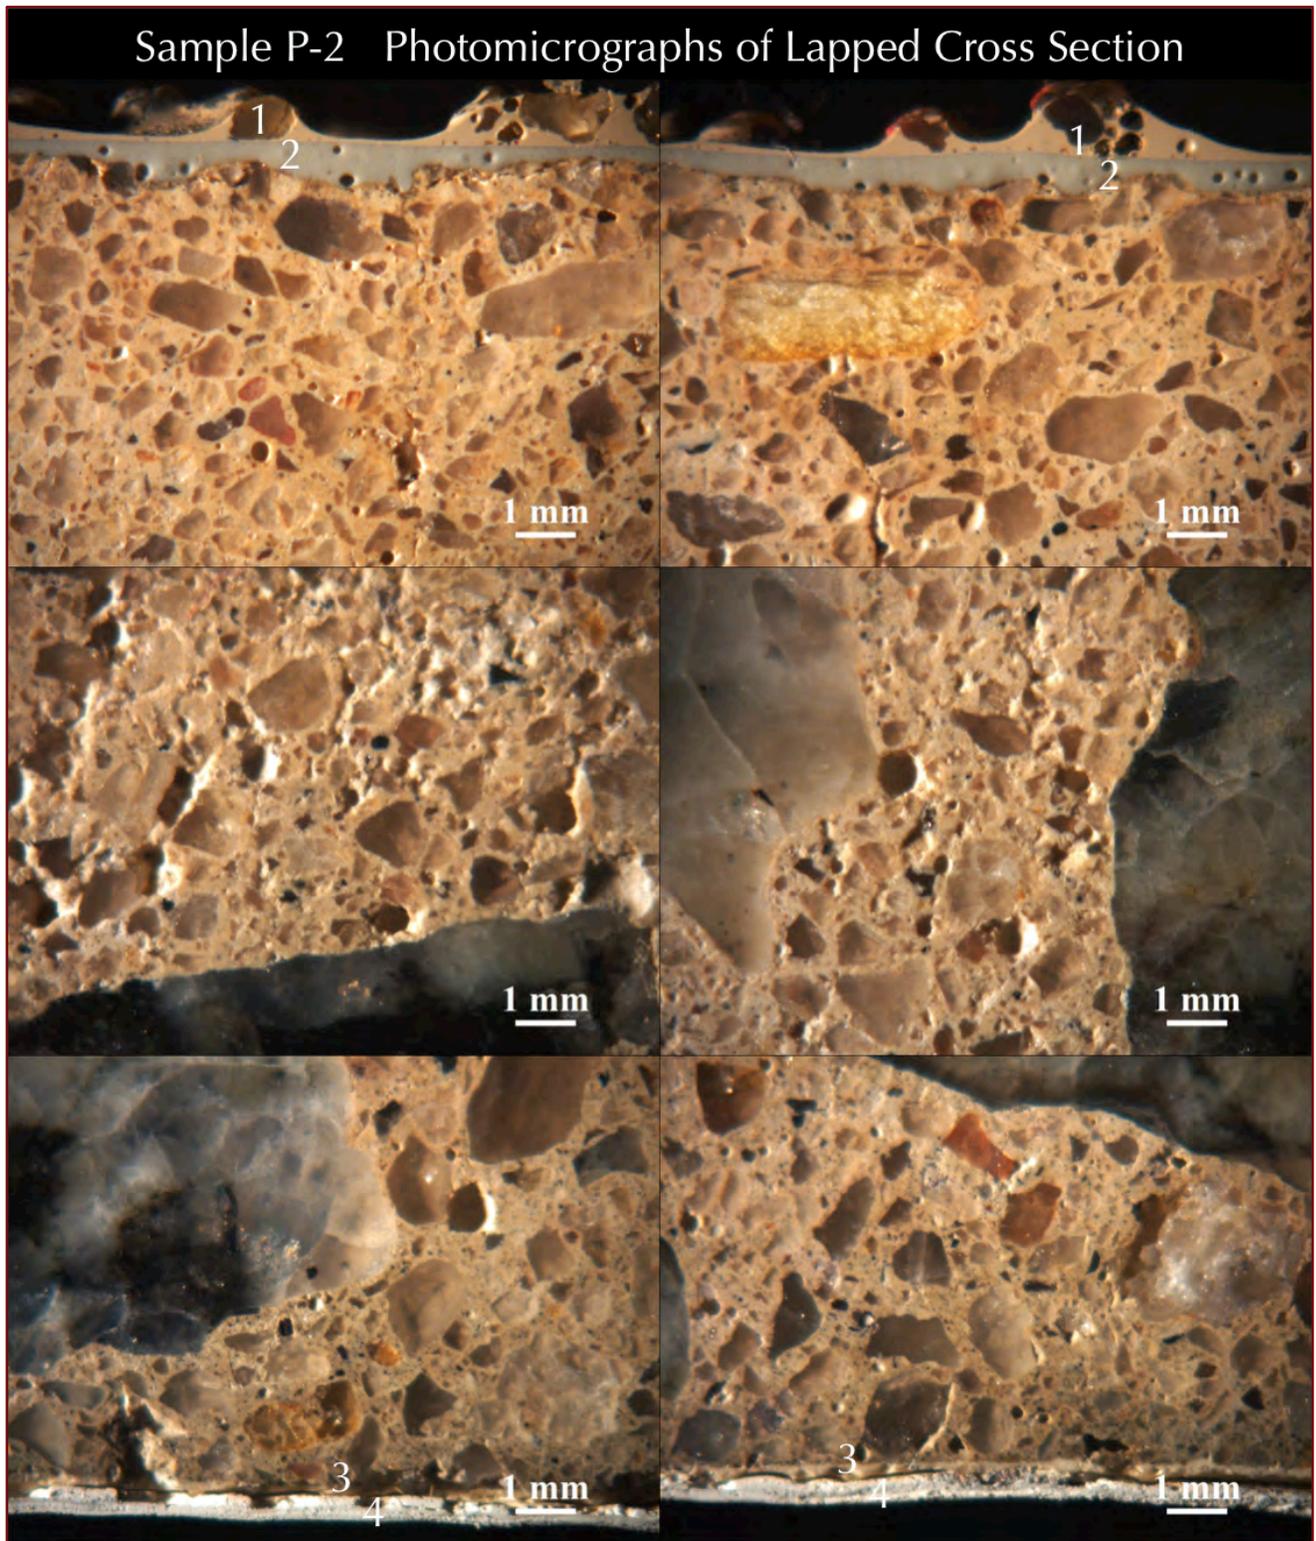
Figure 17: Photomicrographs of lapped cross section of Core P-2 showing: (a) two protective coatings #1 and 2 at the top and another two coatings #3 and 4 at the bottom end; and (b) no air at the ends to air-entrained (AE) nature of the interior concrete with a few spherical voids less than one mm in size but non-uniform distribution of air (all photos). Air is higher in the interior than at both ends. Air varied from 1-2% (non-AE) at top 1 in. depth to 5-6% (AE) from 1 to 4 in. depth, then dropped to 1¹/₂ to 2¹/₂% (non-AE) at 4 to 5 in. depth.

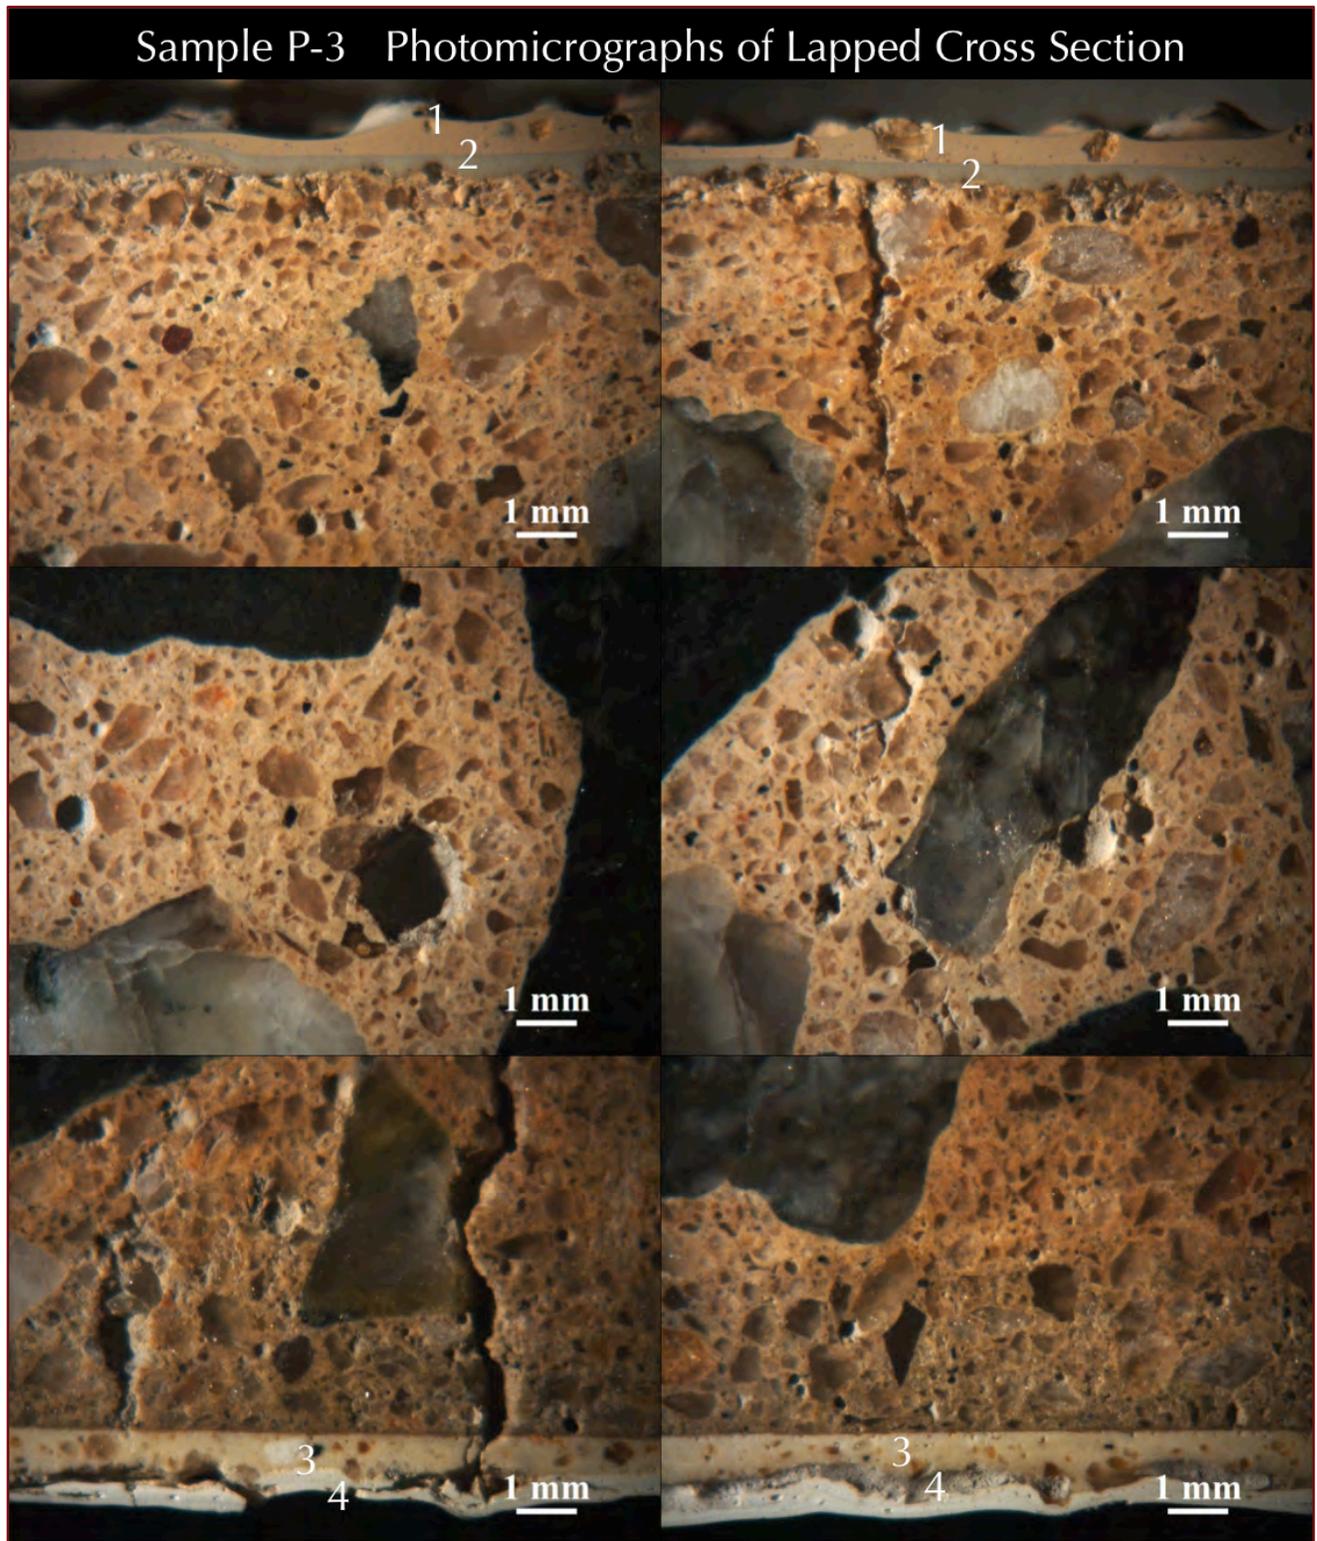
Figure 18: Photomicrographs of lapped cross section of Core P-3 showing: (a) two protective coatings #1 and 2 at the top, and another two coatings #3 and 4 at the bottom end; (b) non-air-entrained nature of the concrete (all photos); and (c) visible cracking in concrete at both ends that are truncated against the protective coatings at the top but transected the coating at the bottom end. Air varied from 0-1% (non-AE) at the top $\frac{1}{2}$ in. depth, to $1\frac{1}{2}$ to $2\frac{1}{2}$ % (non-AE) at $\frac{1}{2}$ to $4\frac{1}{2}$ in. interior, then dropped to 0-1% (non-AE) at $4\frac{1}{2}$ to $5\frac{1}{4}$ in. depth from top.

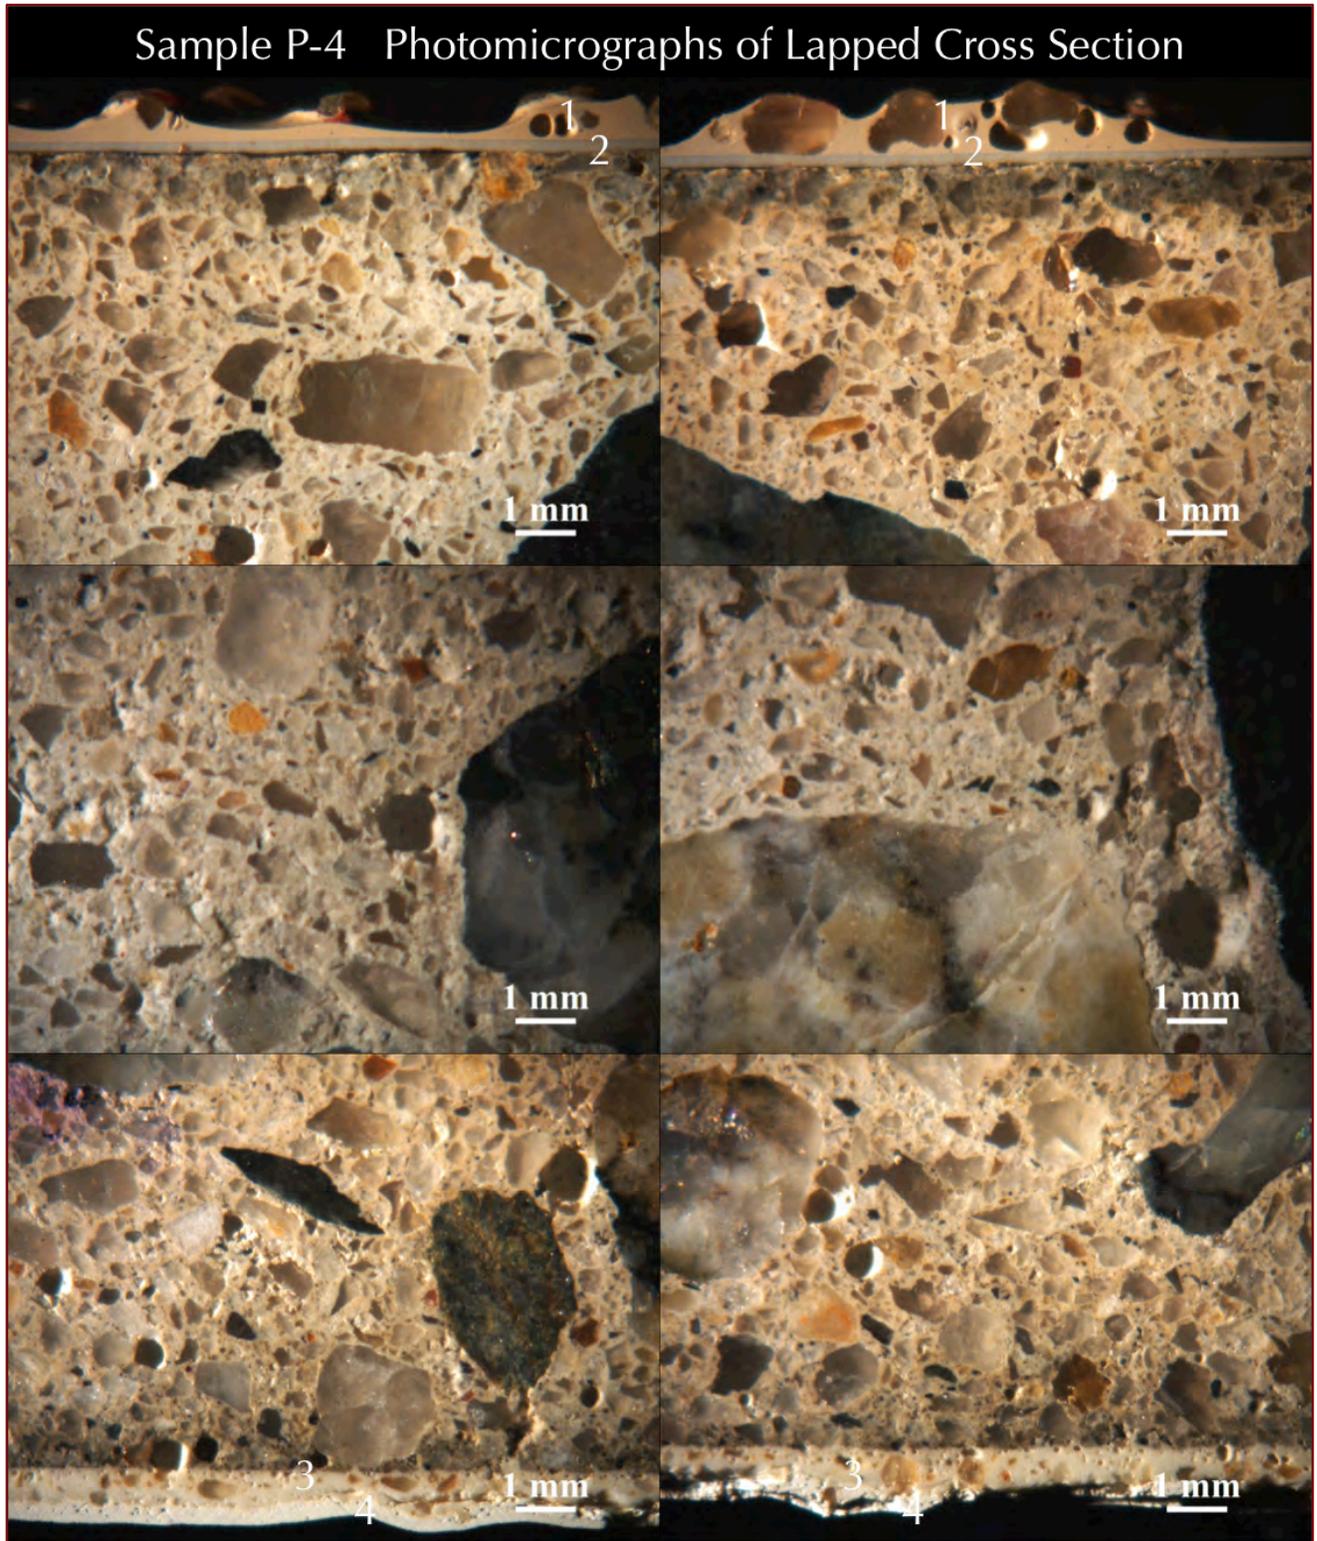
Figure 19: Photomicrographs of lapped cross section of Core P-4 showing: (a) two protective coatings #1 and 2 at the top, and another two coatings #3 and 4 at the bottom end; and (b) non-air-entrained nature of the concrete (all photos). Air varied from 0-1% at the top 1 in. depth (non-AE), to 5-6% from 1 to 4¹/₄ in. interior (AE), then dropped to 1-2% (non-AE) from 4¹/₄ to 5¹/₄ in. depth from top.

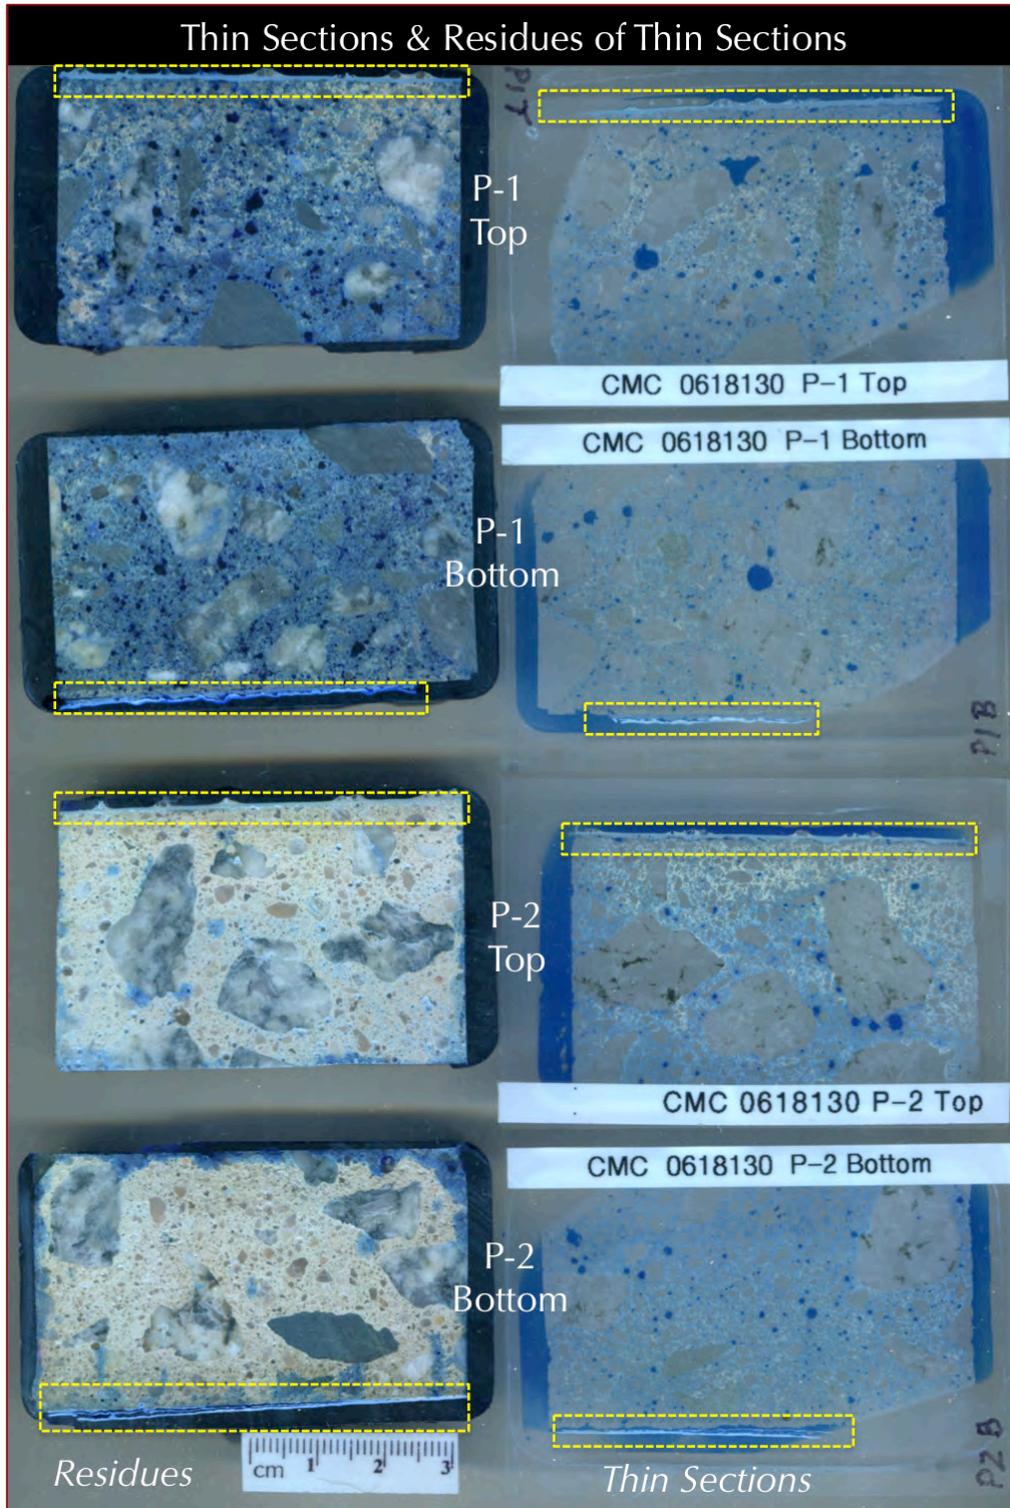
Figure 22: Blue dye-mixed epoxy-impregnated thin sections of the top and bottom portions of Core Nos. P-1 and P-2 in right column and corresponding residues left from thin section preparation in left column showing the surface coatings at both ends that are marked in boxes. Blue dyed epoxy highlights voids, pore spaces in paste and cracks in concrete.

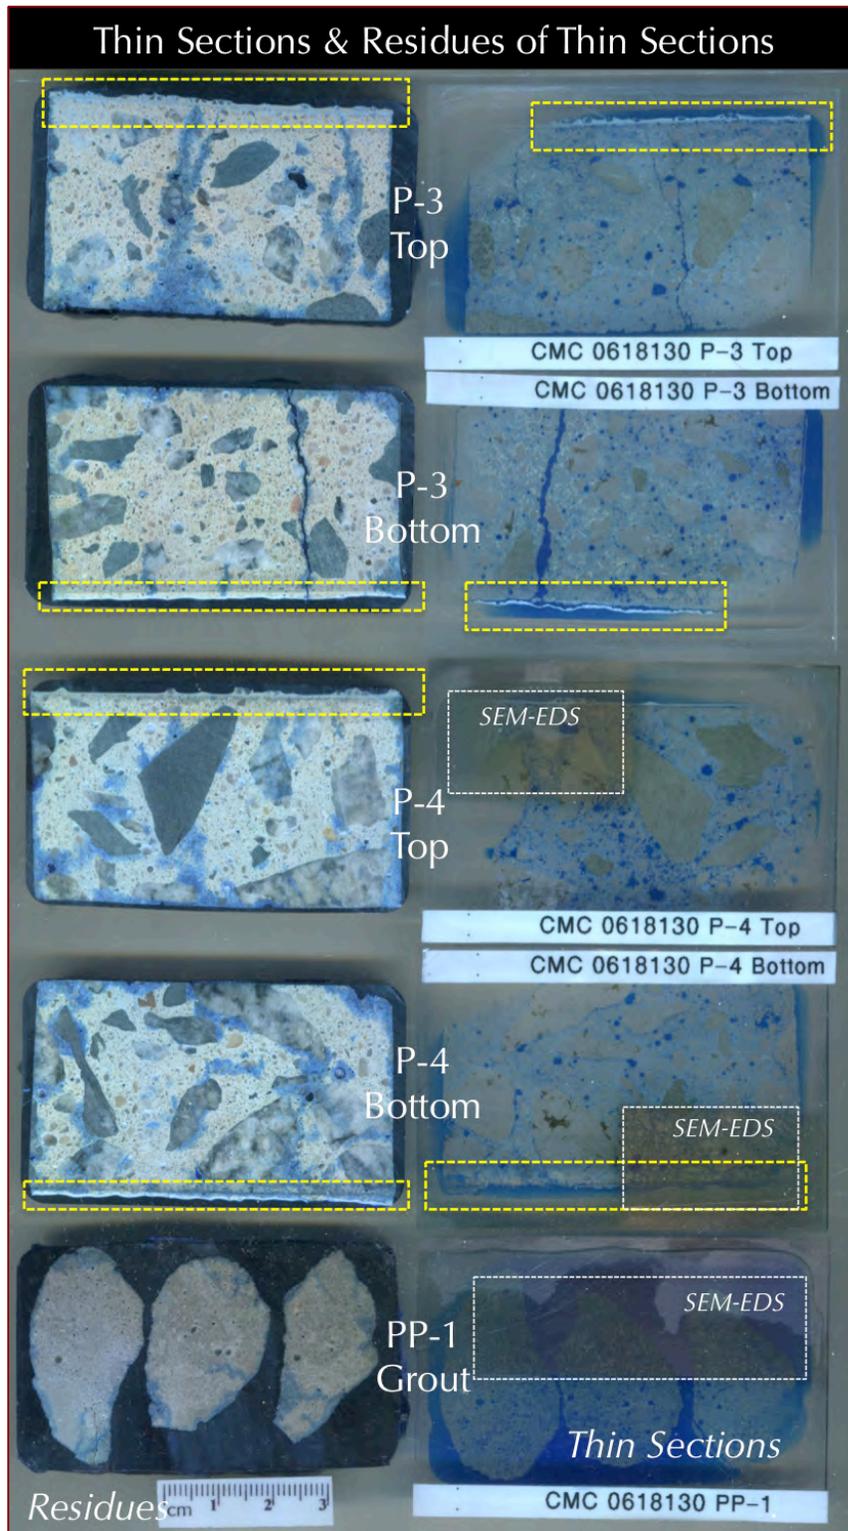
Figure 23: Blue dye-mixed epoxy-impregnated thin sections of the top and bottom portions of Core Nos. P-3, P-4 and the anchoring grout sample in right column and corresponding residues left from thin section preparation in left column showing the surface coatings at both ends that are marked in boxes. Blue dyed epoxy highlights voids, pore spaces in paste and cracks in samples. Portions further studied in SEM-EDS are boxed in dashed white lines.

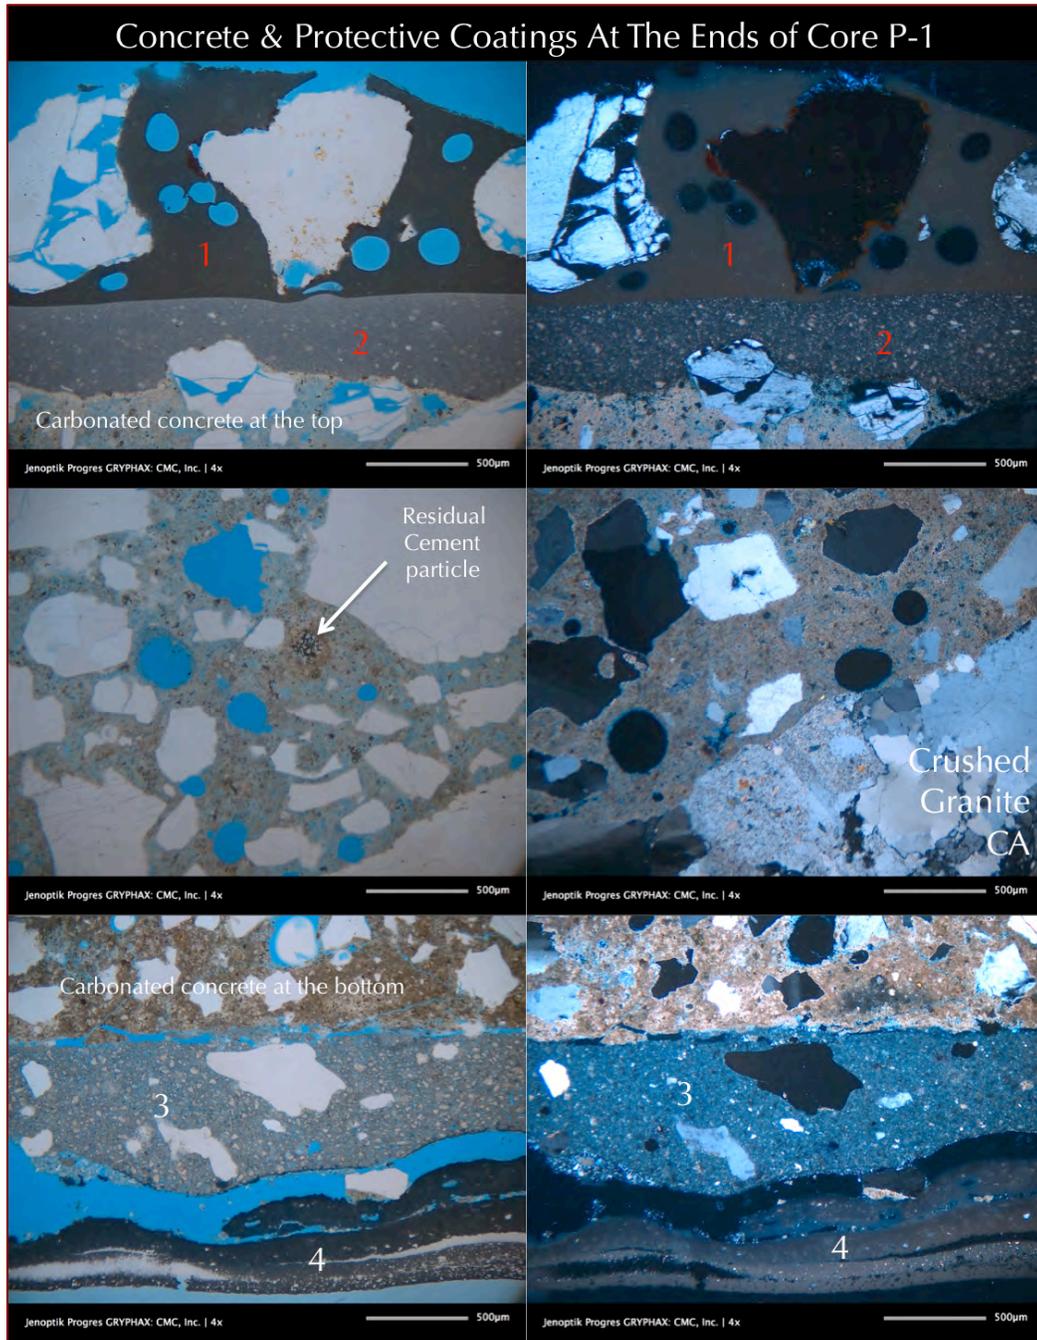
Figure 24: Photomicrographs of blue dye-mixed epoxy-impregnated thin section from the top and bottom ends of Core P-1 showing: (a) two layers of protective coatings at both ends (#1 and 2 at the top, and #3 and 4 at the bottom end); (b) air bubbles and rounded to subangular quartz fillers in Coat #1 in a polymer medium, whereas (c) lack of such fillers in Coat #2, (d) many fine silt-sized fillers in a polymer medium in Coat #2, (e) presence of fine angular quartz and much finer particulate materials in a polymer medium in Coat #3, (f) multi-layered more opaque-like Coat #4, (g) presence of crushed granite and schist (not shown) coarse aggregate and silica (quartz) sand fine aggregate in concrete, (h) Portland cement paste having a few residual cement particles; (i) a few air voids highlighted by blue epoxy, and (j) carbonated concrete especially at ends adjacent to the protective coatings.

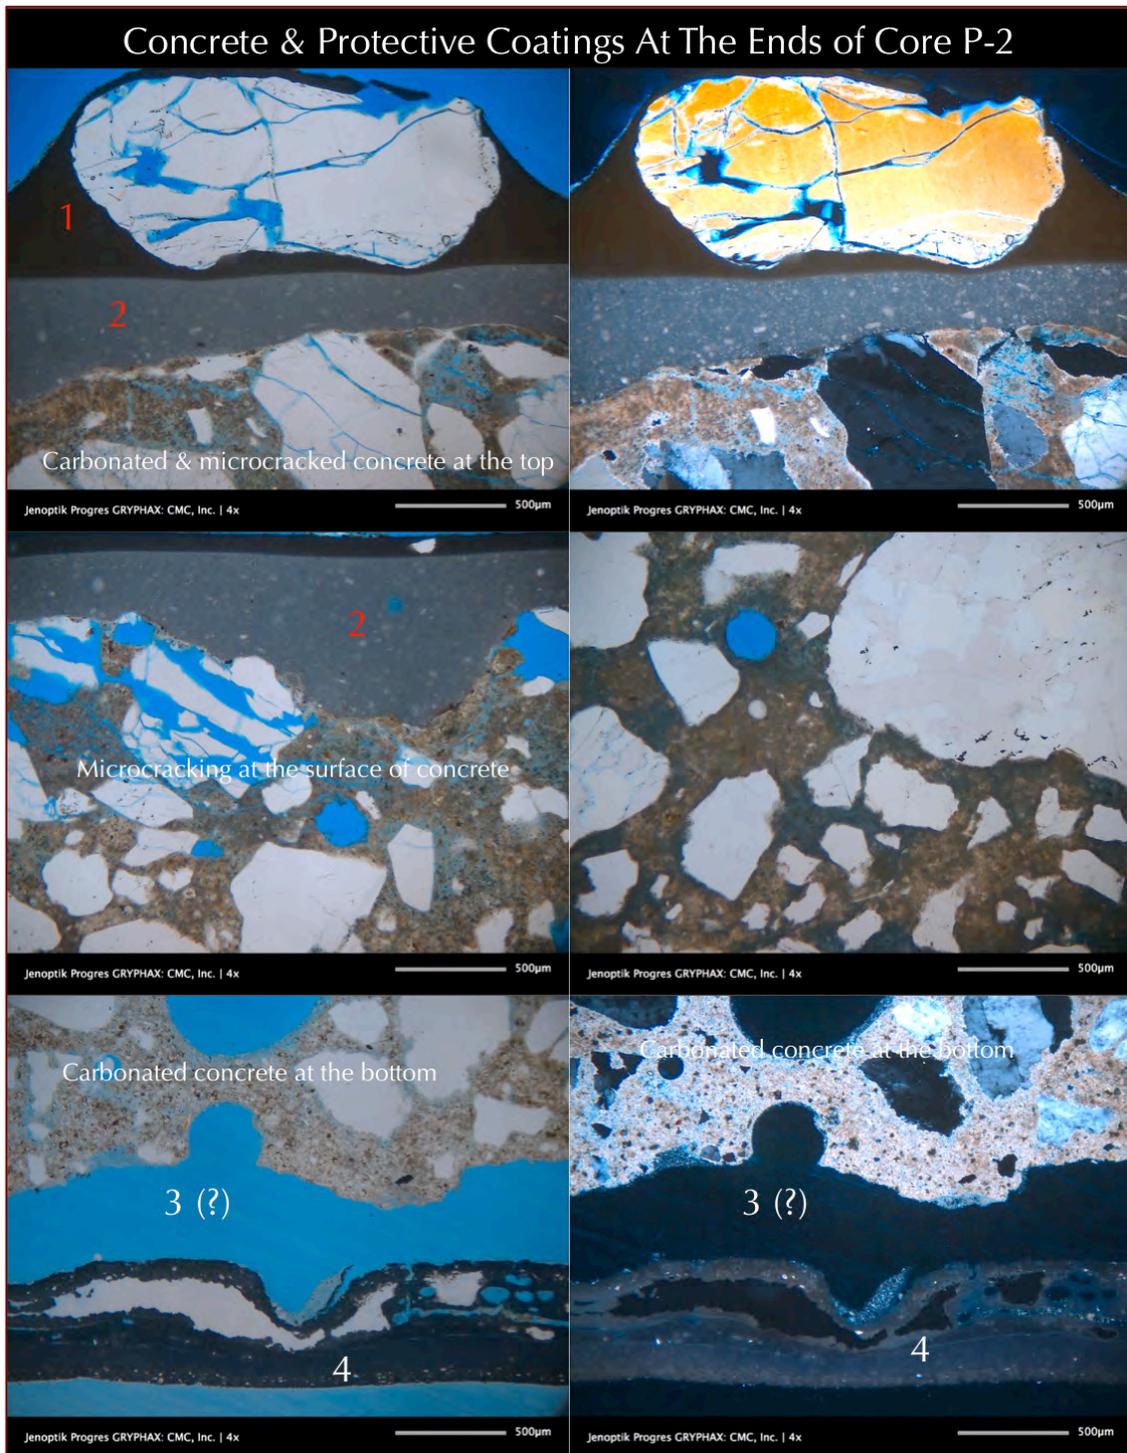
Figure 25: Photomicrographs of blue dye-mixed epoxy-impregnated thin section from the top and bottom ends of Core P-2 showing: (a) two layers of protective coatings at both ends (#1 and 2 at the top, and #3 and 4 at the bottom end); (b) rounded to subangular quartz fillers in Coat #1 in a polymer medium, whereas (c) lack of such fillers in Coat #2, (d) many fine silt-sized fillers in a polymer medium in Coat #2, (e) absence of Coat #3 in this portion of thin section, (f) multi-layered more opaque-like Coat #4, (g) presence of crushed granite and schist (not shown) coarse aggregate and silica (quartz) sand fine aggregate in concrete, (h) Portland cement paste having a few residual cement particles; (i) a few air voids in concrete highlighted by blue epoxy, and (j) carbonated concrete especially at both ends adjacent to the protective coatings.
