INVESTIGATION OF SUSPENDED WALKWAY DISTRESS BY LABORATORY STUDIES OF FOUR CONCRETE CORES AND A POST-POCKET GROUT SAMPLE

EXECUTIVE SUMMARY

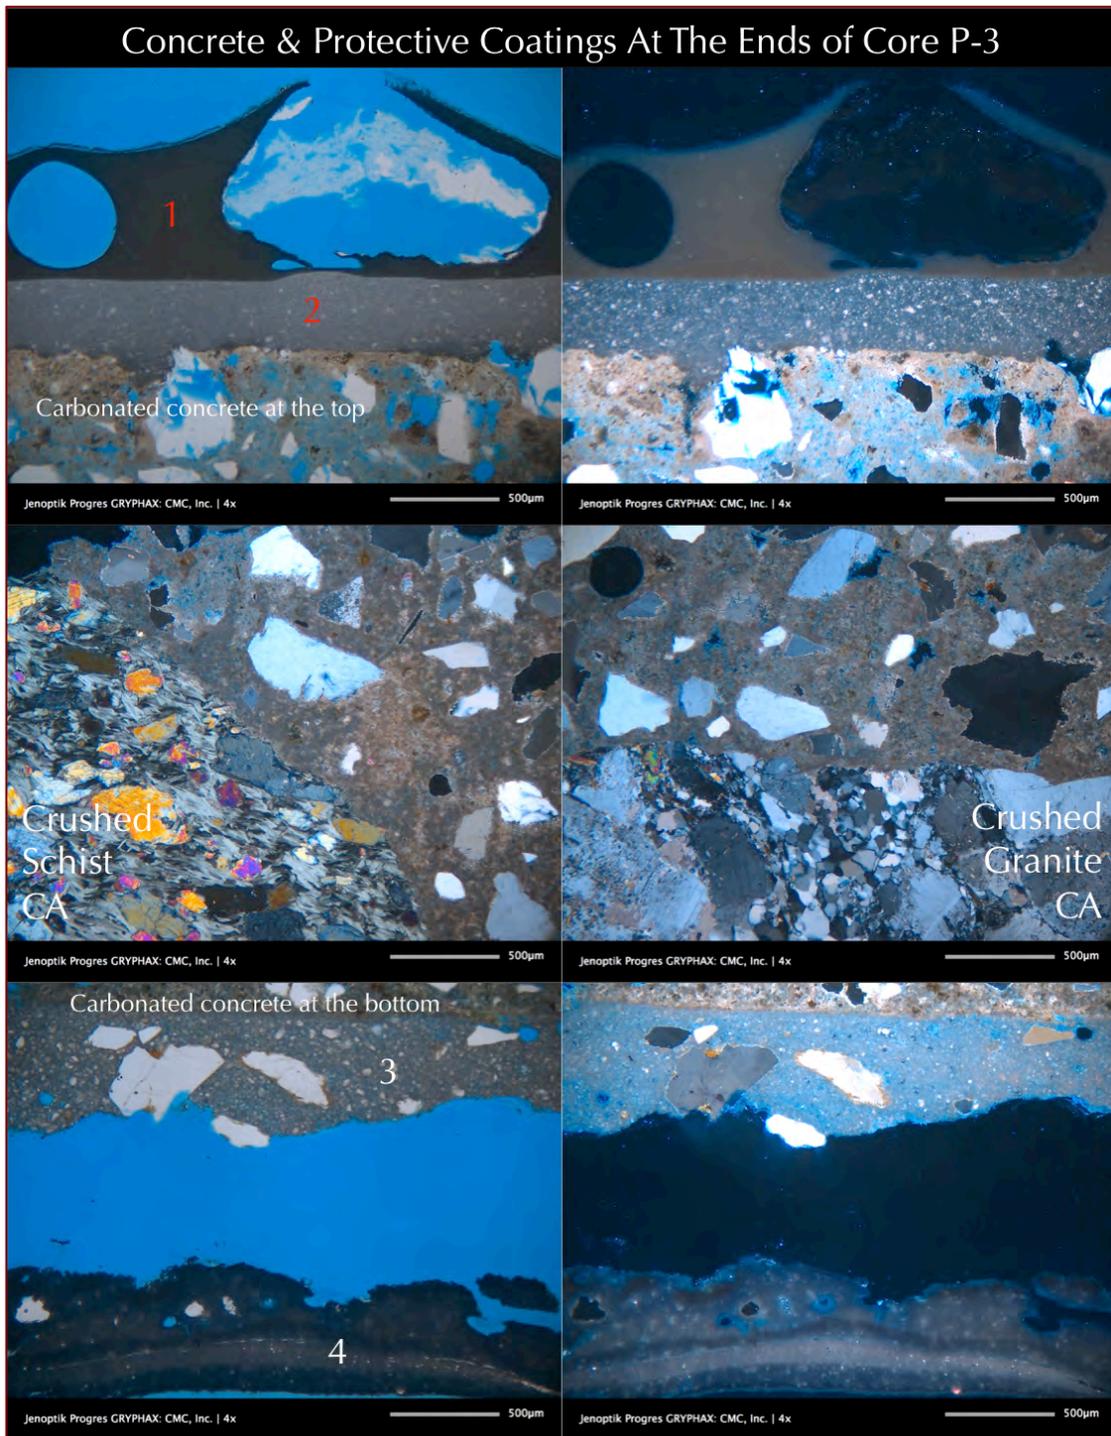
Figure 26: Photomicrographs of blue dye-mixed epoxy-impregnated thin section from the top and bottom ends of Core P-3 showing: (a) two layers of protective coatings at both ends (#1 and 2 at the top, and #3 and 4 at the bottom end); (b) air bubbles and rounded to subangular quartz fillers in Coat #1 in a polymer medium, whereas (c) lack of such fillers in Coat #2, (d) many fine silt-sized fillers in a polymer medium in Coat #2, (e) presence of fine angular quartz and much finer particulate materials in a polymer medium in Coat #3, which is de-bonded from (f) multi-layered more opaque-like Coat #4, (g) presence of crushed granite and schist coarse aggregate and silica (quartz) sand fine aggregate in concrete, (h) Portland cement paste having a few residual cement particles; (i) a few air voids in concrete highlighted by blue epoxy, and (j) carbonated concrete especially at both ends adjacent to the protective coatings.

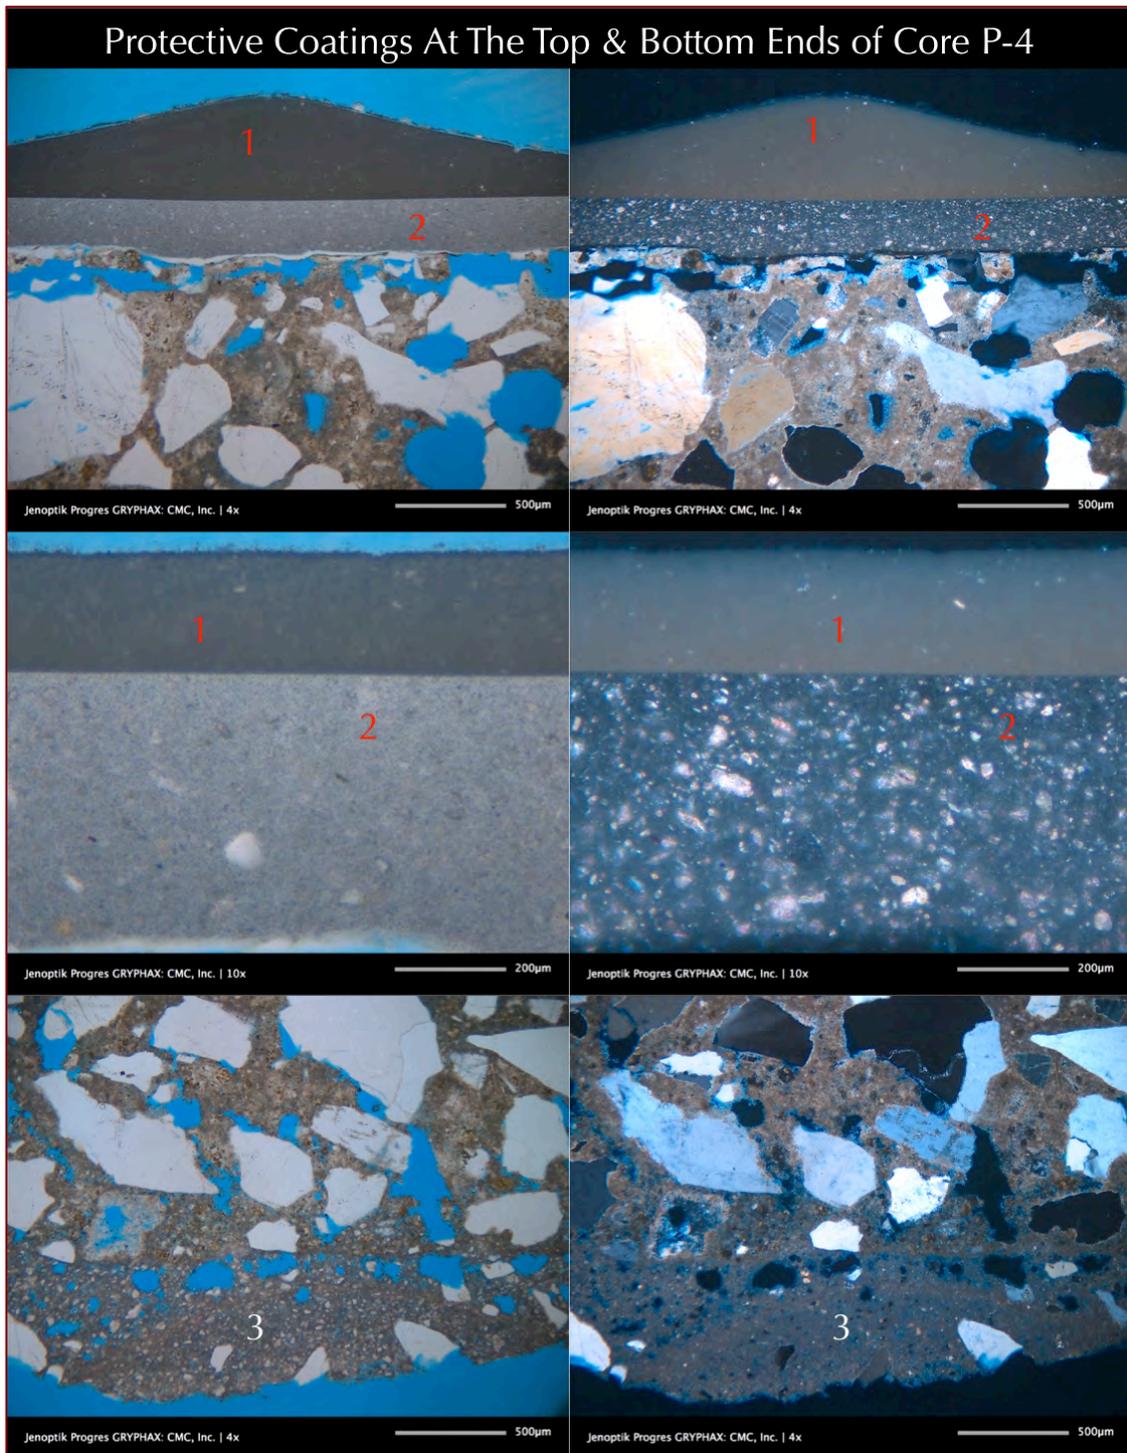
Figure 27: Photomicrographs of blue dye-mixed epoxy-impregnated thin section from the top and bottom ends of Core P-4 showing: (a) two layers of protective coatings at both ends (#1 and 2 at the top, and #3 and 4 (not shown here) at the bottom end); (b) air bubbles and rounded to subangular quartz fillers in Coat #1 in a polymer medium, whereas (c) lack of such fillers in Coat #2, (d) many fine silt-sized fillers in a polymer medium in Coat #2, (e) presence of fine angular quartz and much finer particulate materials in a polymer medium in Coat #3, (f) missing of multi-layered more opaque-like Coat #4 in this section, (g) presence of silica (quartz) sand fine aggregate in concrete, (h) Portland cement paste having a few residual cement particles; (i) a few air voids highlighted by blue epoxy, and (j) carbonated concrete especially at both ends adjacent to the protective coatings.

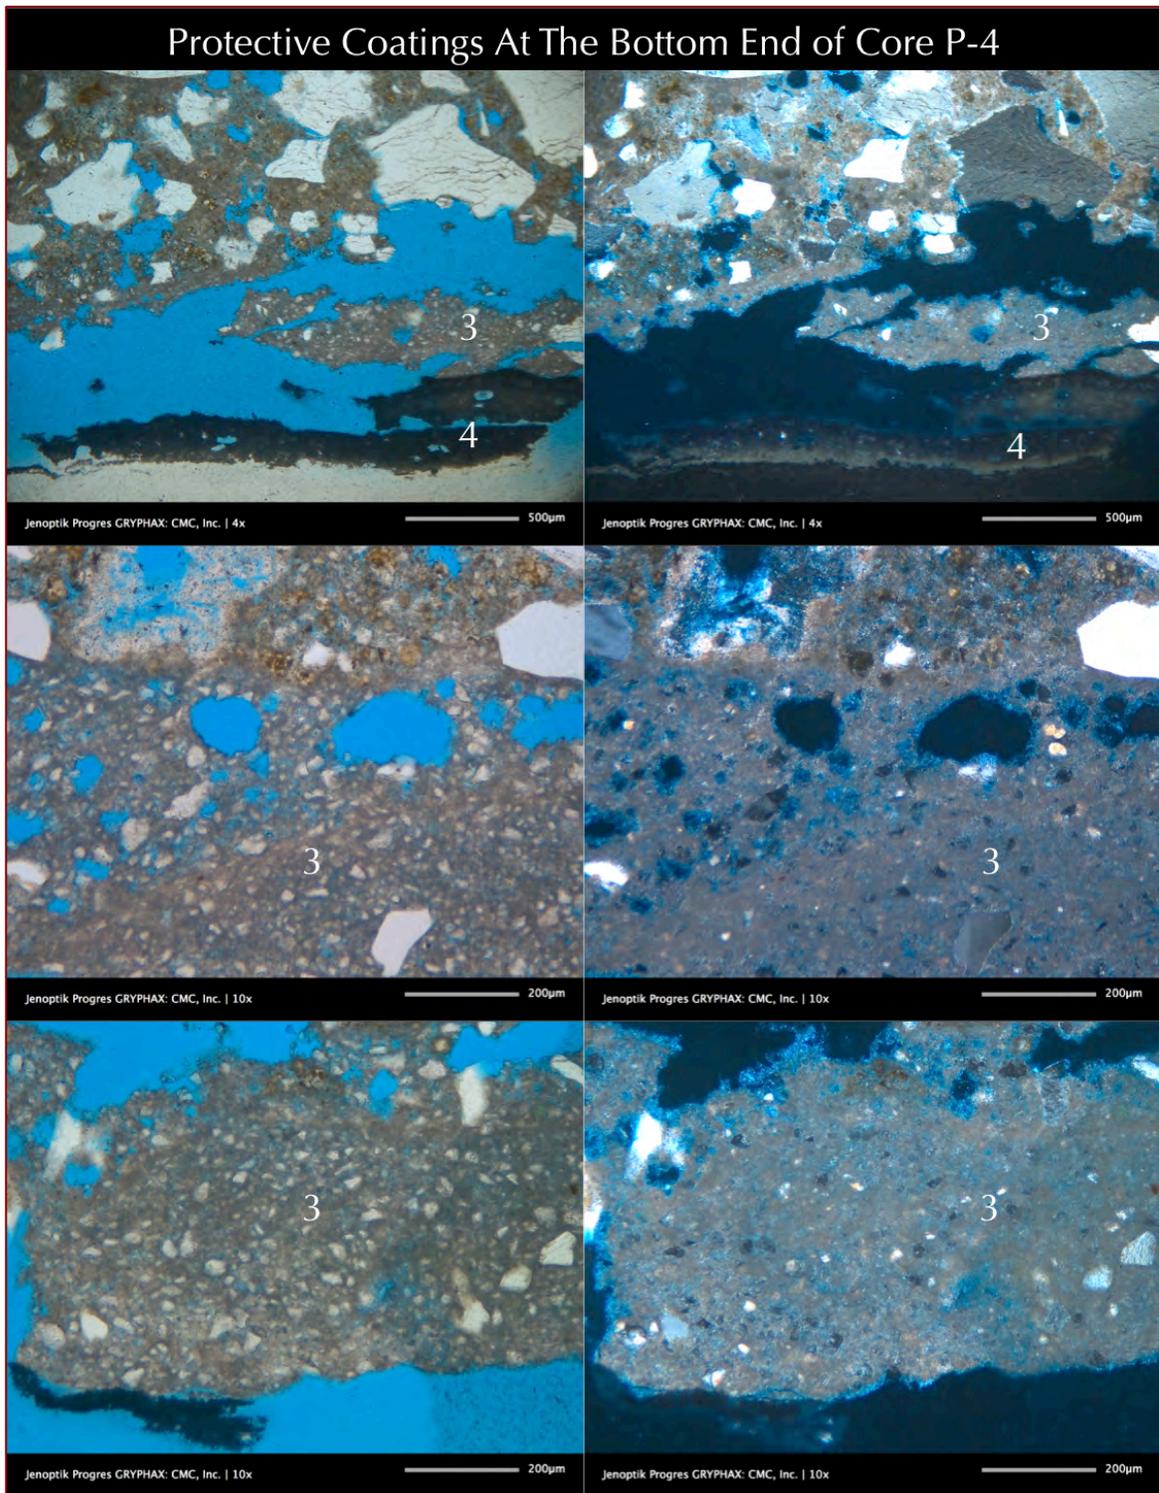
Figure 28: Photomicrographs of blue dye-mixed epoxy-impregnated thin section from the bottom end of Core P-4 showing: (a) two layers of protective coatings #3 and 4 at the bottom end; (b) presence of fine angular quartz and much finer particulate materials in a polymer medium in Coat #3, which is de-bonded from (c) opaque-like Coat #4, (d) presence of silica (quartz) sand fine aggregate in concrete, (e) Portland cement paste having a few residual cement particles; and (f) carbonated concrete especially at both ends adjacent to the protective coatings.

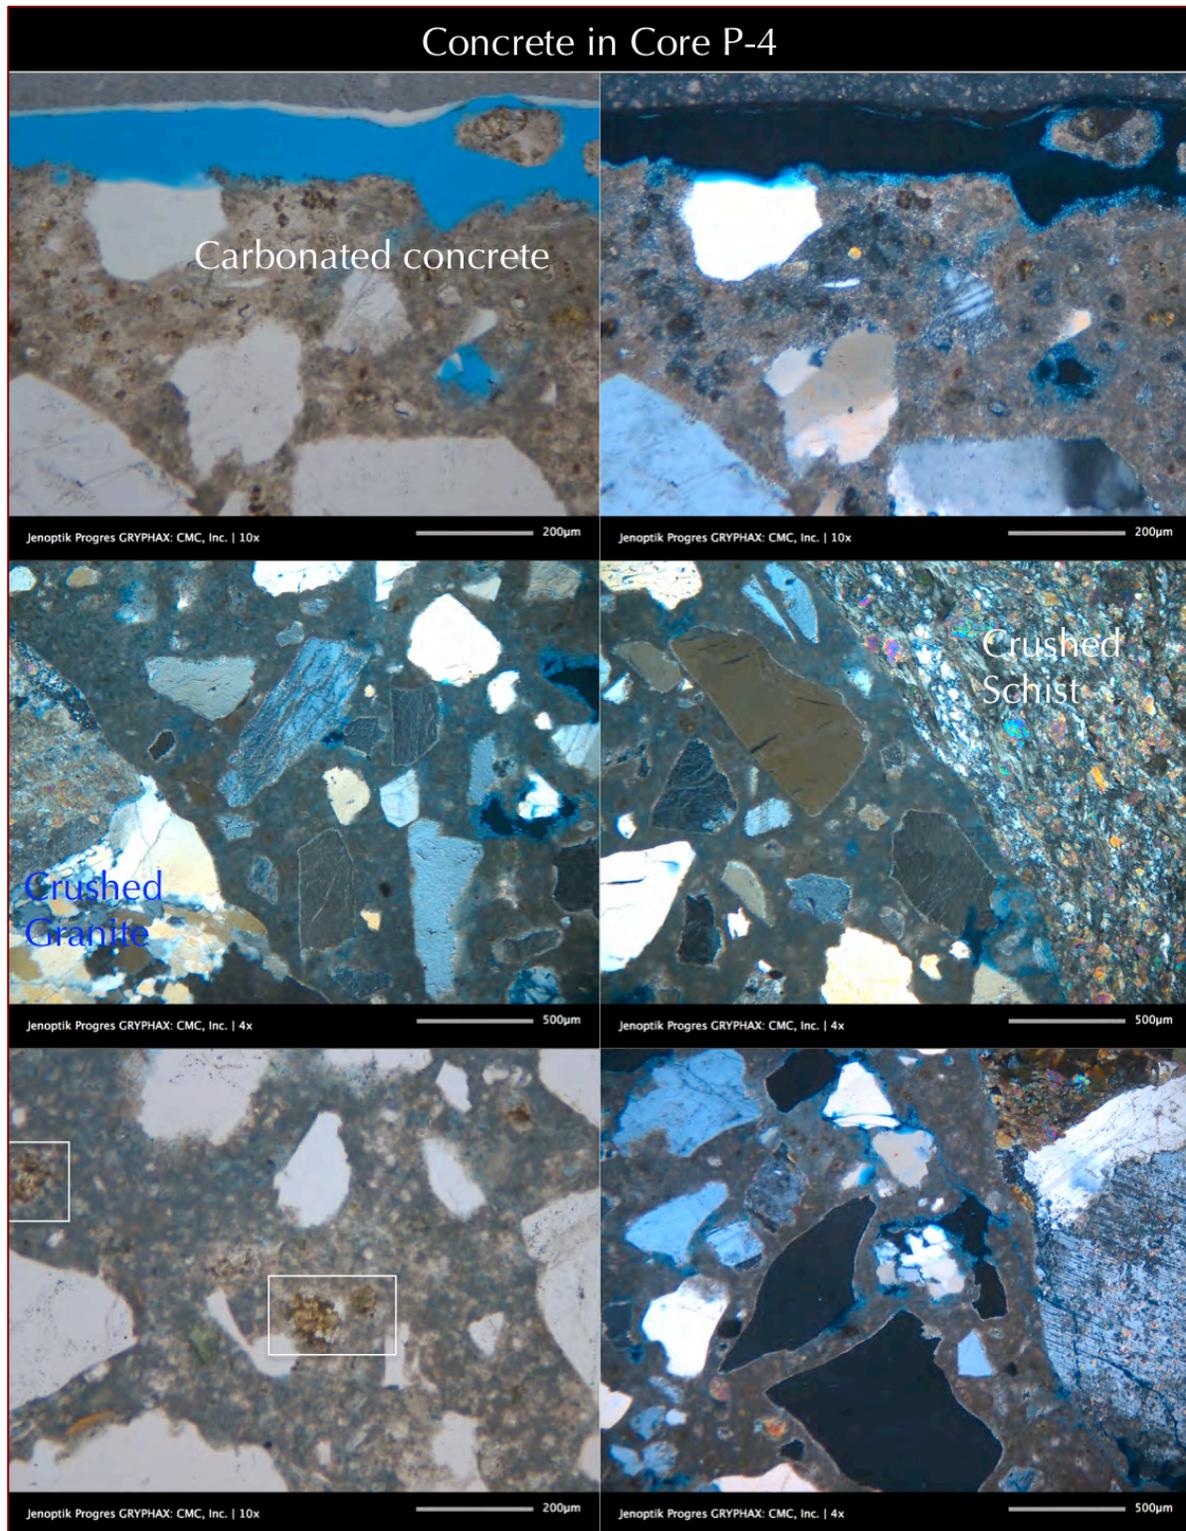
Figure 29: Photomicrographs of blue dye-mixed epoxy-impregnated thin section from the bottom end of Core P-4 showing: (a) carbonated concrete at the top beneath the Coat #2, which is de-bonded from concrete in this portion, (b) crushed granite and schist coarse aggregate and silica (quartz) sand fine aggregate, and (c) Portland cement paste having a few residual cement particles.

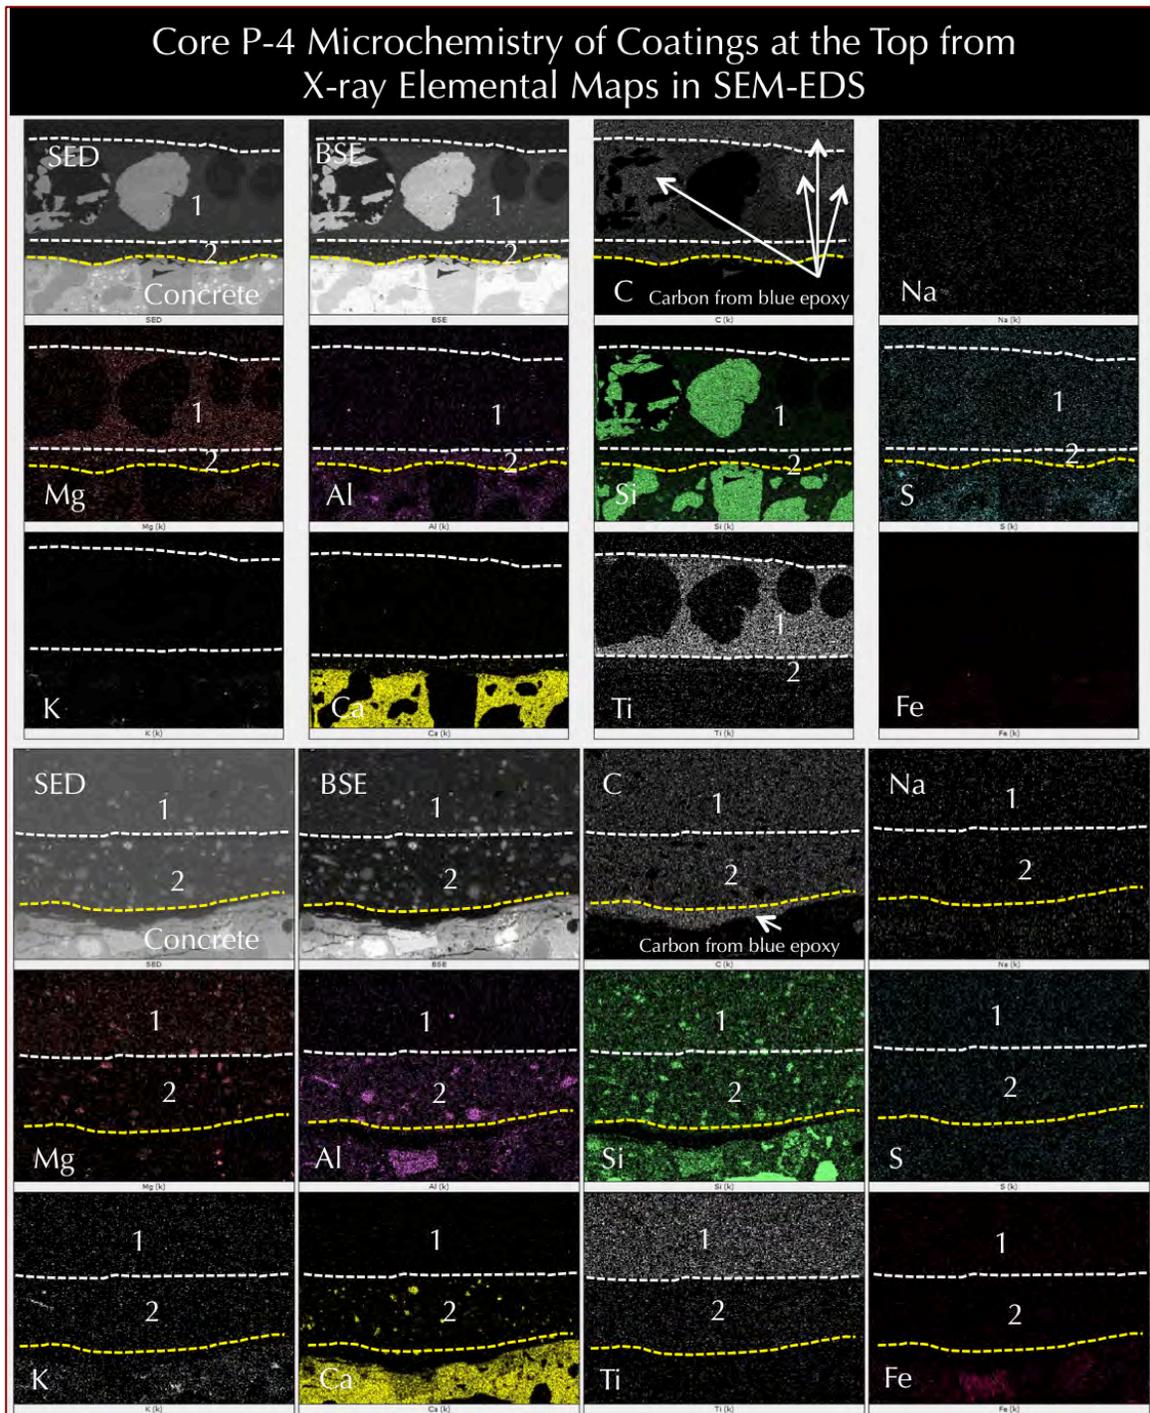
Figure 32: X-ray elemental mapping of top two coatings (#1 and 2) in Core P-4 showing: (a) characteristic titanium enrichment in Coat #1 from incorporation of titanium oxide pigment; (b) presence of silica in both coats from fine silicate fillers and rounded coarse quartz filler in Coat #1; (c) magnesium enrichment in Coat #1 but not in #2; (d) carbon in both coats from carbon-based polymer (separate from carbon footprint from blue epoxy used to impregnate the sample for thin sectioning); (e) calcium enrichment in Portland cement paste in concrete beneath the coatings; (f) some aluminum enrichment in Coat #2 as opposed to Coat #1; and (g) potential slag filler in Coat #2 from Ca, Al, Si highlighted spots in their maps.

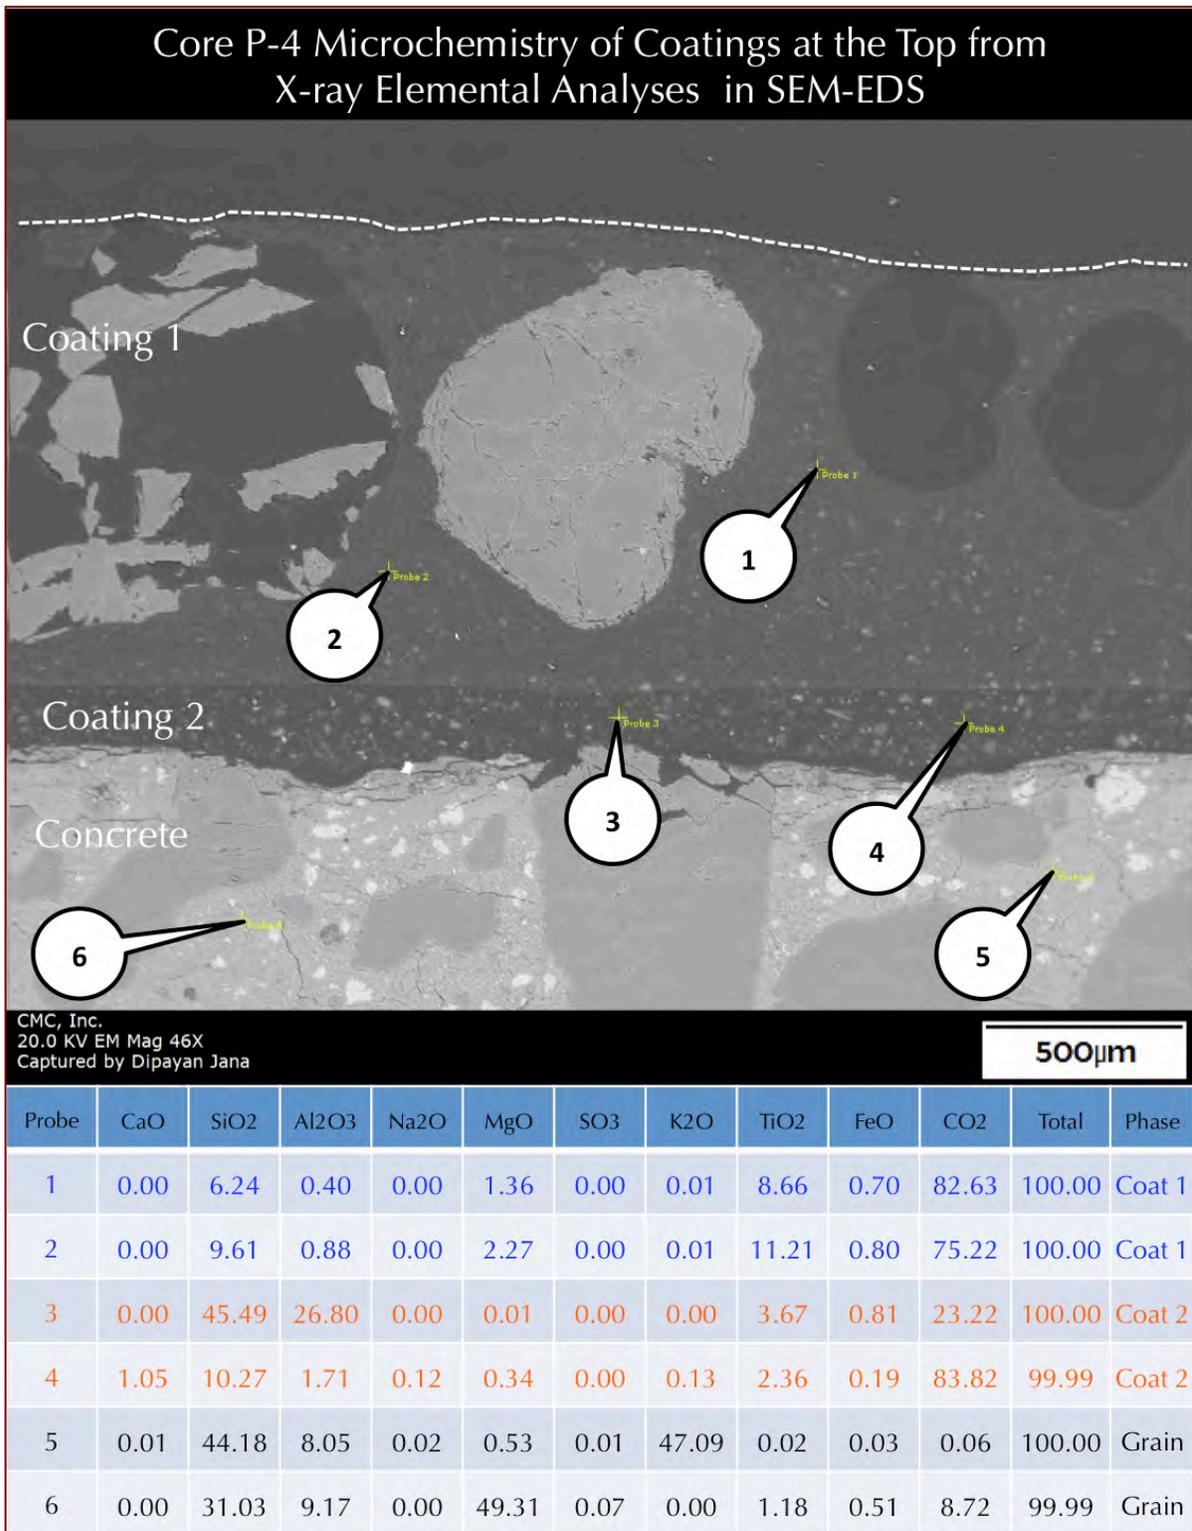
Figure 33: Secondary electron image (top) and X-ray elemental analyses (bottom Table) of selected locations (at the tips of callouts) in the top two protective coatings (#1 and 2 for Probe #1 to 4) in Core P-4 as well as two near-surface locations in Portland cement paste (Probe #5 and 6) showing compositional variations in coats. Coat #2 has low overall titanium but higher aluminum and silica than Coat #1.

Coating# 2 (Top) Type: Epoxy, Non-breathable	Gray to ash color (Figures 20, 21), 0.8 mm nominal thickness (Figures 20, 21, 30), more uniform thickness, Al enrichment, spots of slag filler in Ca, Al, Si-maps (Figure 32); Epoxy binder in FT-IR (Figures 37, 38)	Gray to ash color (Figures 20, 21), 0.5 mm nominal thickness (Figures 20, 21, 30), more uniform thickness, Al enrichment, spots of slag filler in Ca, Al, Si-maps (Figure 32); Epoxy binder in FT-IR (Figures 37, 38)	Gray to ash color (Figures 20, 21), 0.3 mm nominal thickness (Figures 20, 21, 30), more uniform thickness, Al enrichment, spots of slag filler in Ca, Al, Si-maps (Figure 32); Epoxy binder in FT-IR (Figures 37, 38)	Gray to ash color (Figures 20, 21), 0.1 mm nominal thickness (Figures 20, 21, 30), more uniform thickness, Al enrichment, spots of slag filler in Ca, Al, Si-maps (Figure 32); Epoxy binder in FT-IR (Figures 37, 38)
Coating# 3 (Bottom) Type: PVA, Non-breathable	Off-white (Figures 20, 21), 0.5 to 0.8 mm non-uniform thickness (Figures 20, 21, 31), Ti-enrichment from Ti-oxide pigment (Figure 35); also china clay pigment and calcite filler from FT-IR (Figures 39, 40); slag particles as filler too (Figure 28)	Off-white (Figures 20, 21), 0.2 to 0.5 mm non-uniform thickness (Figures 20, 21, 31), Ti-enrichment from Ti-oxide pigment (Figure 35); also china clay pigment and calcite filler from FT-IR (Figures 39, 40); slag particles as filler too (Figure 28)	Off-white (Figures 20, 21), 0.5 to 0.8 mm non-uniform thickness (Figures 20, 21, 31), Ti-enrichment from Ti-oxide pigment (Figure 35); also china clay pigment and calcite filler from FT-IR (Figures 39, 40); slag particles as filler too (Figure 28)	Off-white (Figures 20, 21), 0.4 to 0.6 mm non-uniform thickness (Figures 20, 21, 31), Ti-enrichment from Ti-oxide pigment (Figure 35); also china clay pigment and calcite filler from FT-IR (Figures 39, 40); slag particles as filler too (Figure 28)

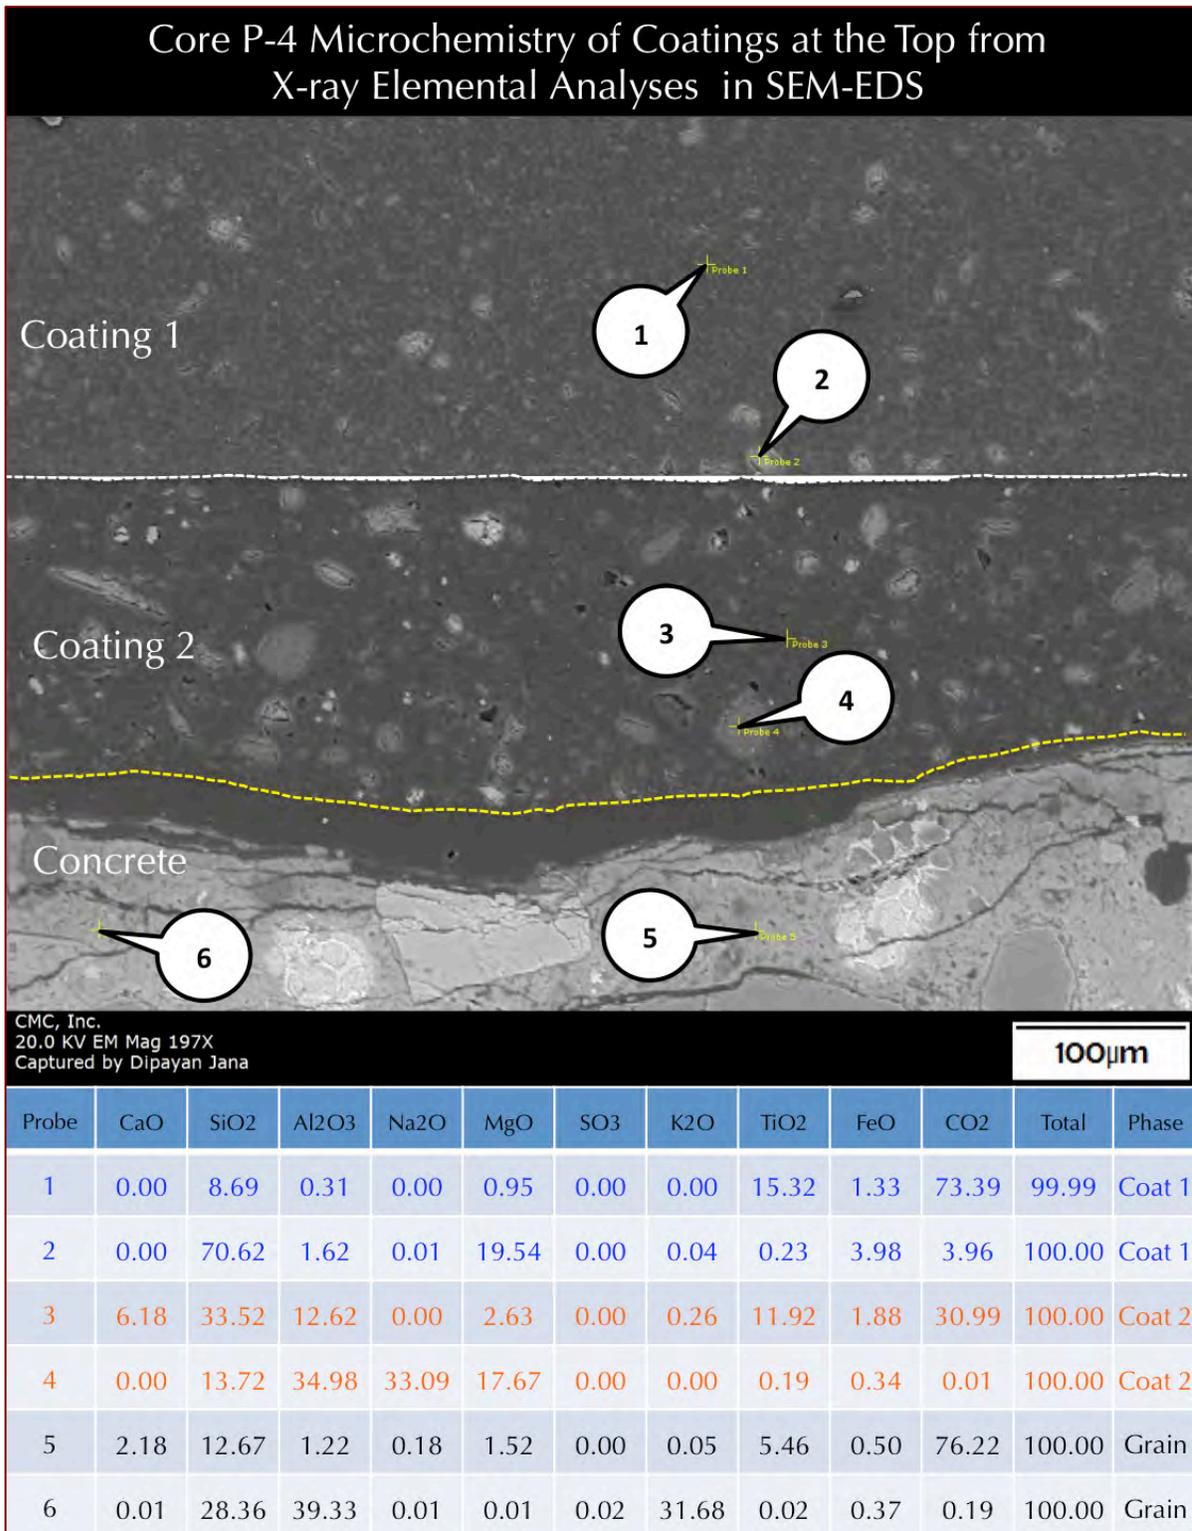
Figure 34: Secondary electron image (top) and X-ray elemental analyses (bottom Table) of selected locations (at the tips of callouts) in the top two protective coatings (#1 and 2 for Probe #1 to 4) in Core P-4 as well as two near-surface locations in Portland cement paste (Probe #5 and 6) showing compositional variations in coats. Coat #2 has low overall titanium but higher aluminum and silica than Coat #1 (except Probe 2 that is on a silica filler in Coat #1).

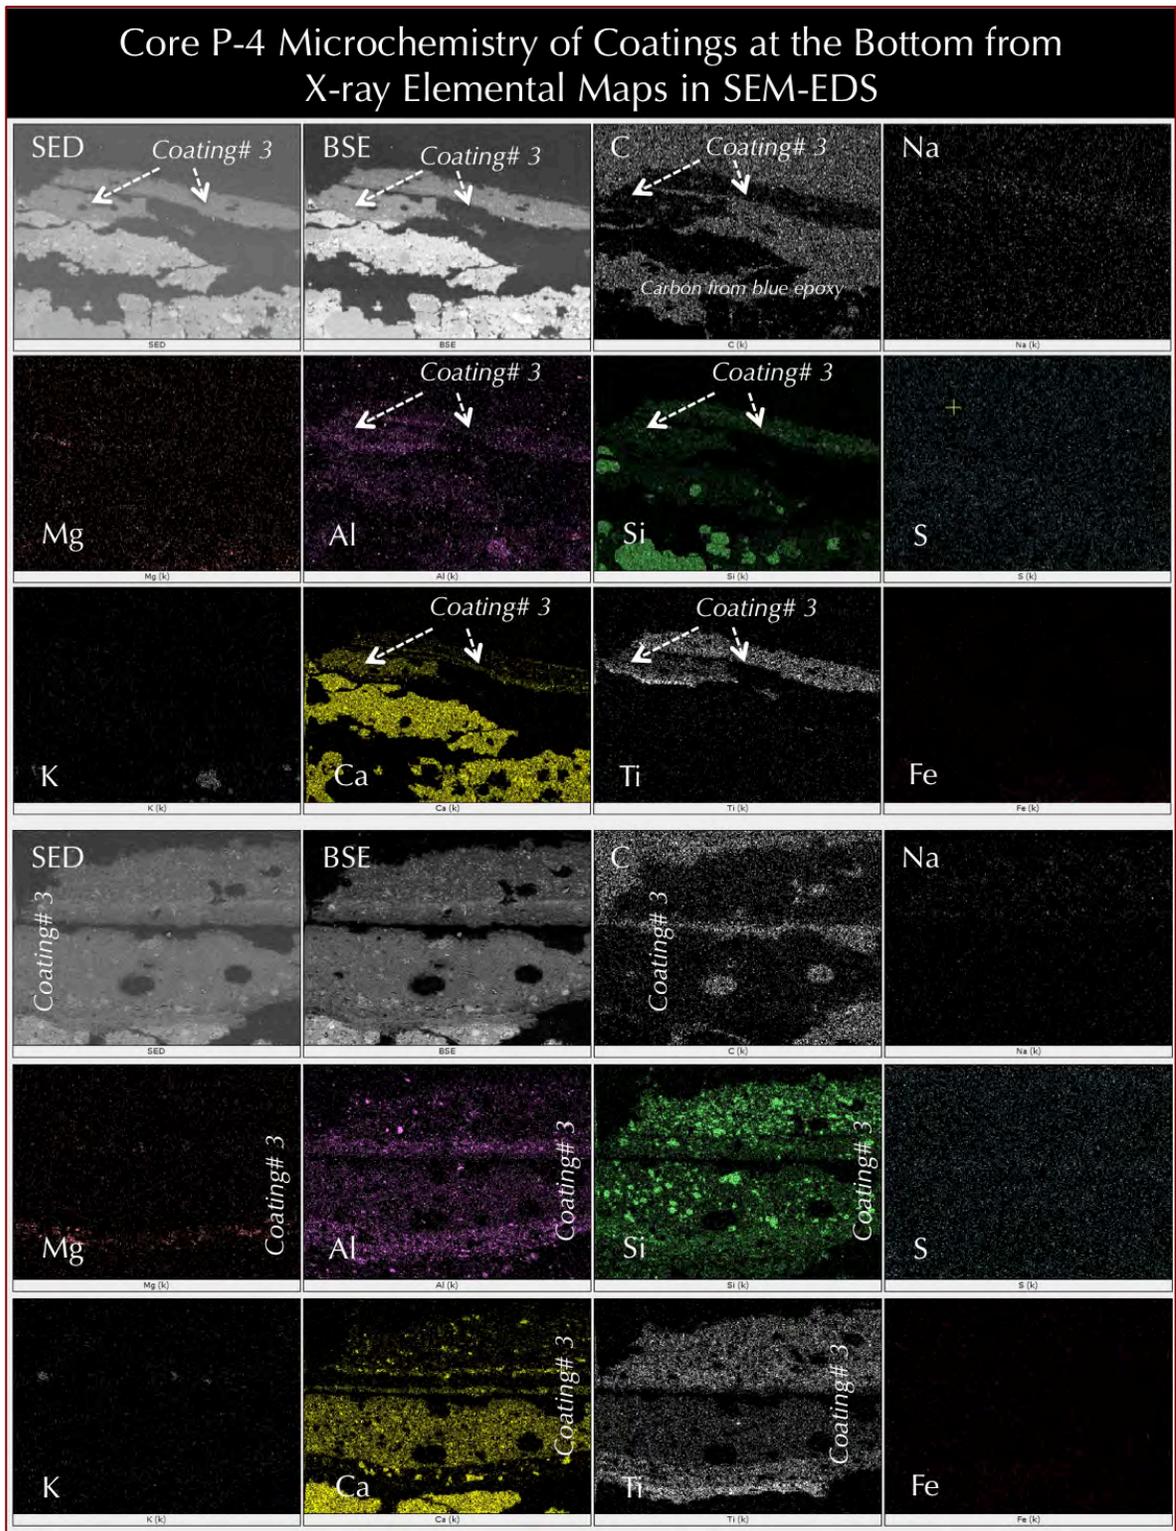
Figure 35: X-ray elemental mapping of bottom coating (#3) in Core P-4 showing: (a) characteristic but variable titanium enrichment in layers or bands in Coat #3 from incorporation of titanium oxide pigment; (b) presence of silica in Coat #3 from fine silicate fillers; (c) magnesium enrichment in some layers within Coat #3; (d) carbon depletion in Coat #3 as opposed to carbon from blue epoxy used to impregnate the sample for thin sectioning; and (e) variable aluminum enrichment in Coat #3.

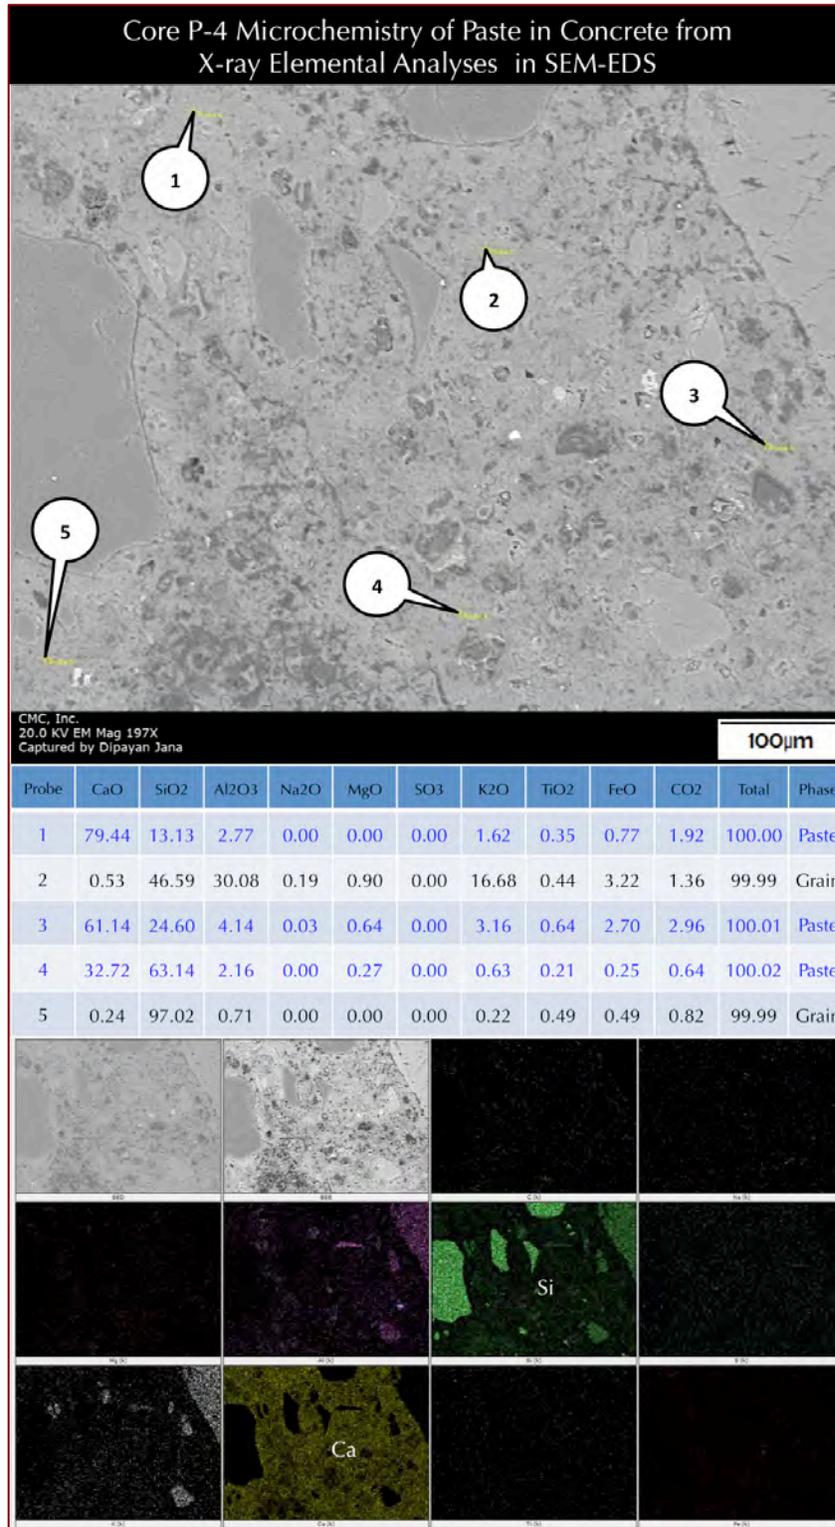
Figure 36: Secondary electron image (top), X-ray elemental analyses (middle Table) of selected locations (at the tips of callouts), and X-ray elemental mapping (bottom) of Portland cement paste in concrete in Core P-4 showing the characteristic calcium silicate hydrate composition of paste as shown in blue rows in the Table.

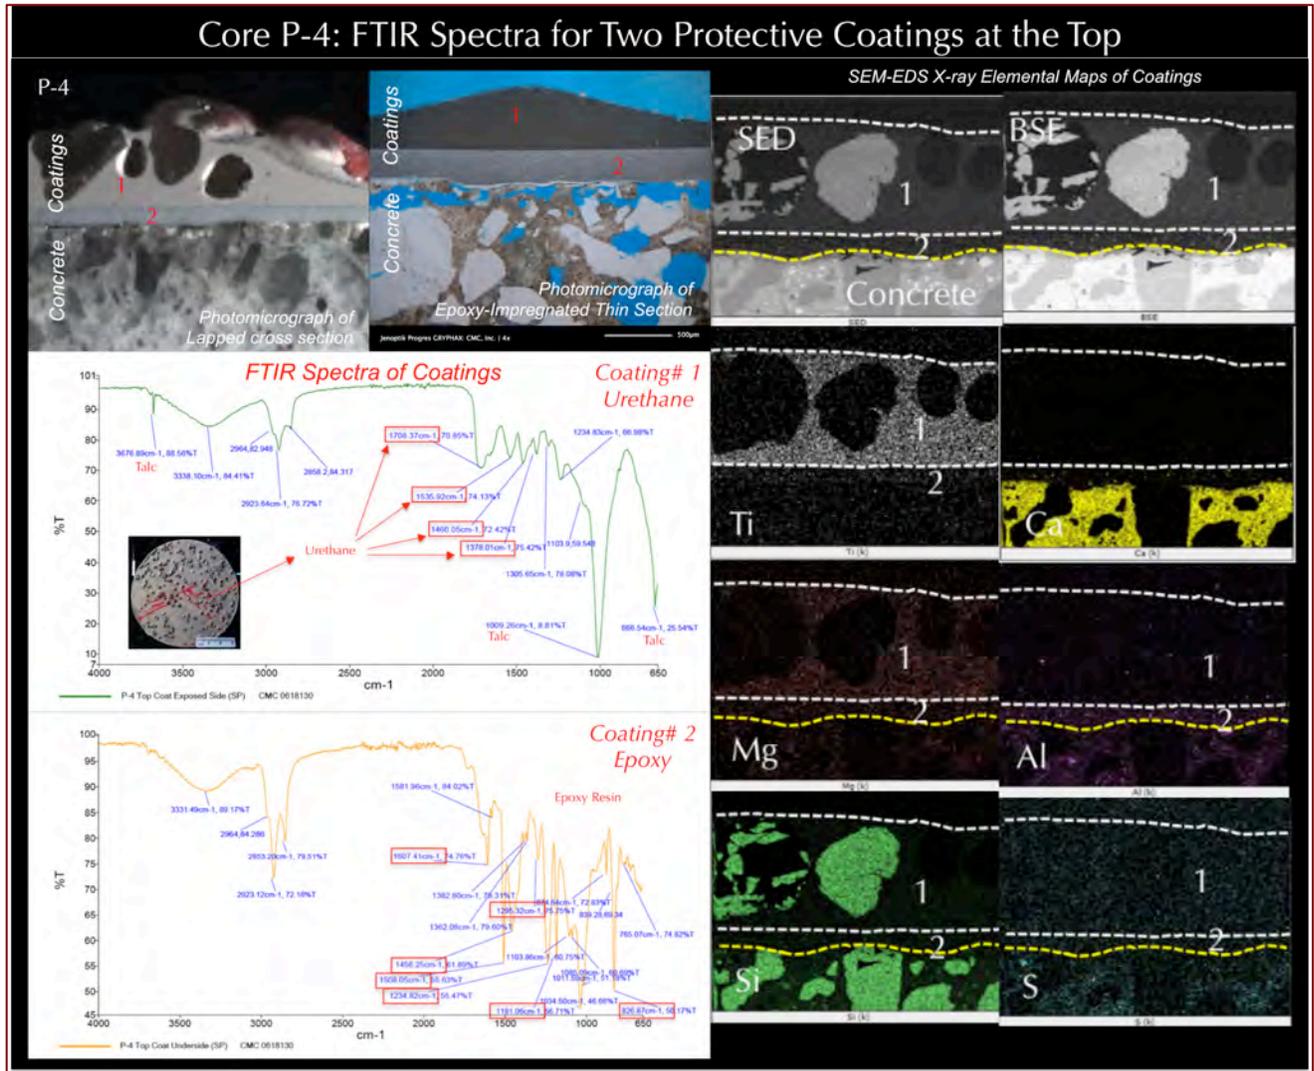
Figure 37: Coating # 1 - The resin is consistent with a urethane as evidenced by the bands near 1710, 1680, 1535, 1460, 1380 cm⁻¹. The large band near 1010 cm⁻¹ with the sharp band near 3700 cm⁻¹ and the band near 670 cm⁻¹ indicated the presence of talc. Coating # 2 - The resin is consistent with an epoxy by bands near 1610, 1510, 1460, 1295, 1230, 1180, and 830 cm⁻¹.

Cores	P-1	P-2	P-3	P-4
Coating# 1 (Top) Type: Urethane, Non-breathable	Gray to Beige (Figures 20, 21), Less than 0.1 to 1.2 mm non-uniform thickness (Figures 20, 21, 30), maximum thick at the quartz filler and minimum where filler is absent; Ti-enrichment from Ti-oxide pigment (Figure 32), Mg and Si from Talc filler (Figure 32), Talc also found in FT-IR (Figures 37, 38)	Gray to Beige (Figures 20, 21), Less than 0.1 to 1.2 mm non-uniform thickness (Figures 20, 21, 30), maximum thick at the quartz filler and minimum where filler is absent; Ti-enrichment from Ti-oxide pigment (Figure 32), Mg and Si from Talc filler (Figure 32), Talc also found in FT-IR (Figures 37, 38)	Gray to Beige (Figures 20, 21), Less than 0.1 to 1.2 mm non-uniform thickness (Figures 20, 21, 30), maximum thick at the quartz filler and minimum where filler is absent; Ti-enrichment from Ti-oxide pigment (Figure 32), Mg and Si from Talc filler (Figure 32), Talc also found in FT-IR (Figures 37, 38)	Gray to Beige (Figures 20, 21), Less than 0.1 to 1.2 mm non-uniform thickness (Figures 20, 21, 30), maximum thick at the quartz filler and minimum where filler is absent; Ti-enrichment from Ti-oxide pigment (Figure 32), Mg and Si from Talc filler (Figure 32), Talc also found in FT-IR (Figures 37, 38)

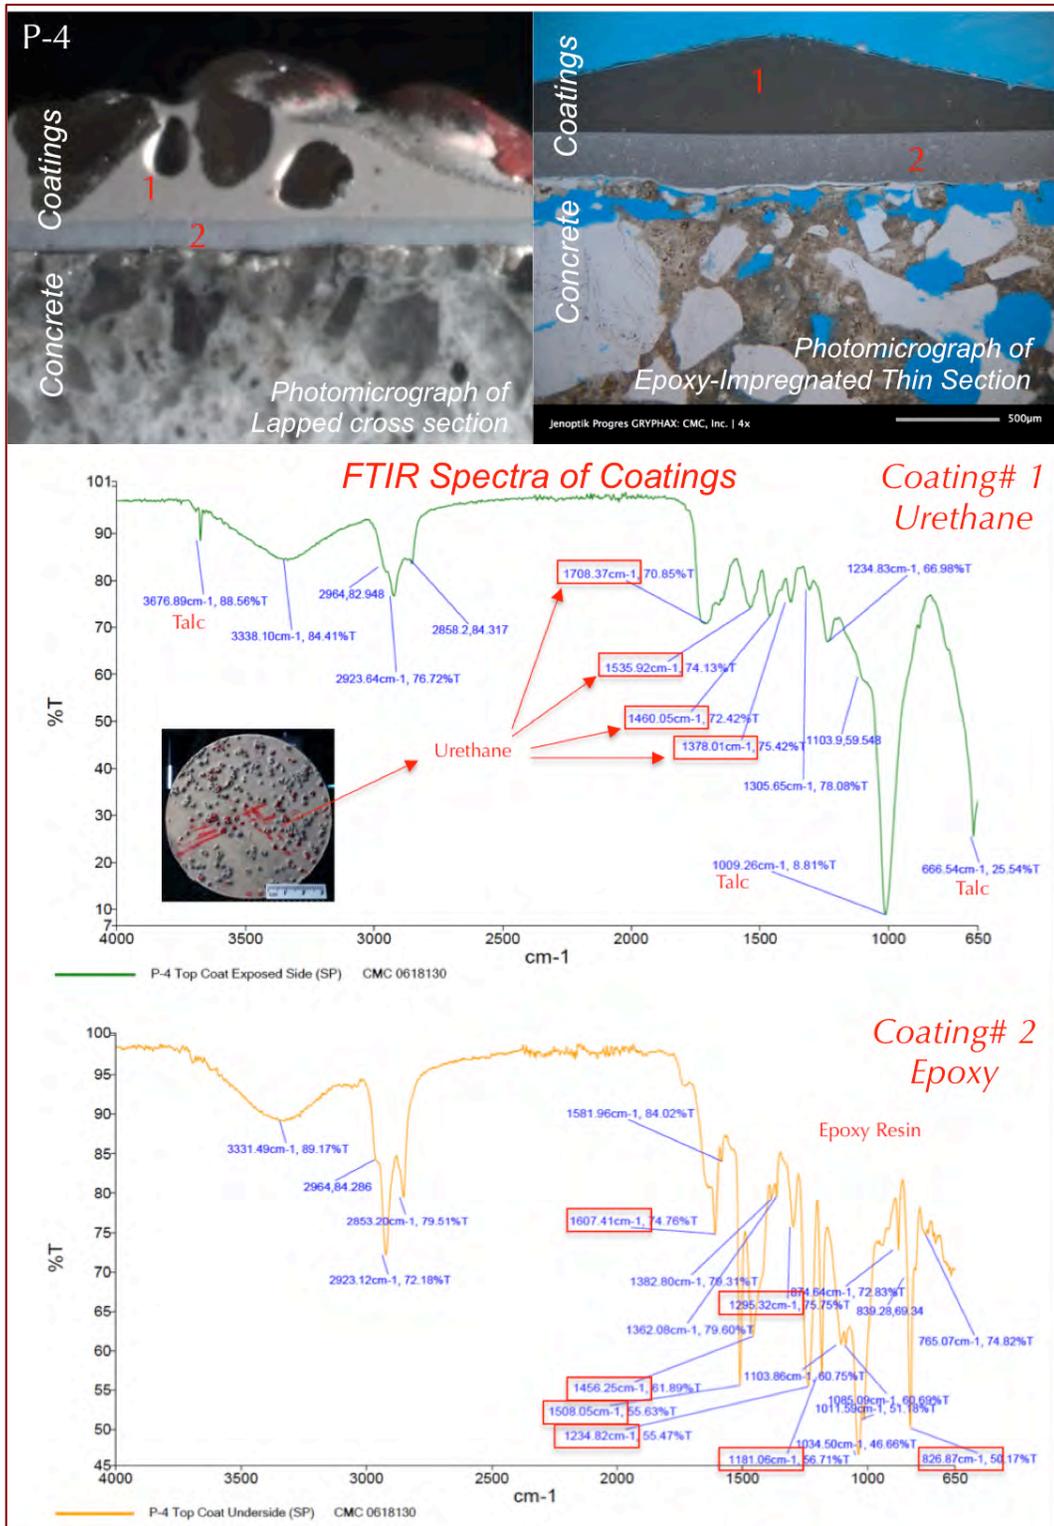
Figure 38: Coating #1 - The resin is consistent with a urethane as evidenced by the bands near 1710, 1680, 1535, 1460, 1380 cm^{-1} . The large band near 1010 cm^{-1} with the sharp band near 3700 cm^{-1} and the band near 670 cm^{-1} indicated the presence of talc. Coating #2 - The resin is consistent with an epoxy by bands near 1610, 1510, 1460, 1295, 1230, 1180, and 830 cm^{-1} .

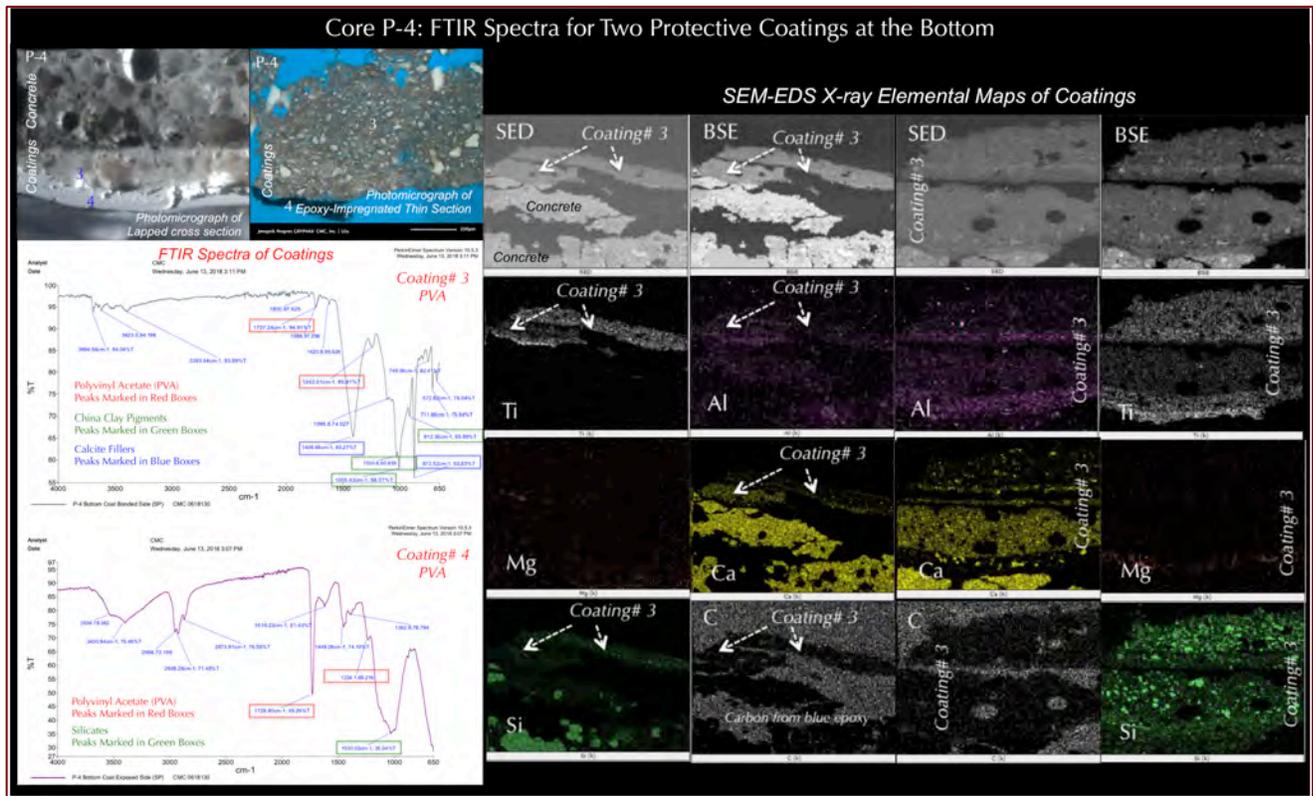
Figure 39: Coating #3 - The resin bands are small. From the bands near 1740 and 1240 cm⁻¹, the resin is most consistent with a vinyl (polyvinyl acetate, PVA). The pigmentation is china clay as indicated by the bands near 1030, 1010, 915 cm⁻¹. The bands near 1410 and 875 cm⁻¹ are a carbonate material (a little low for CaCO₃). Coating #4 - The resin is another layer of vinyl as confirmed from bands near 1728 and 1234 cm⁻¹. The large band between 1100 and 1000 cm⁻¹ is consistent with silicate materials, which, from SEM-EDS studies is judged to be from slag and fine quartz fillers.
