INVESTIGATION OF SUSPENDED WALKWAY DISTRESS BY LABORATORY STUDIES OF FOUR CONCRETE CORES AND A POST-POCKET GROUT SAMPLE

EXECUTIVE SUMMARY

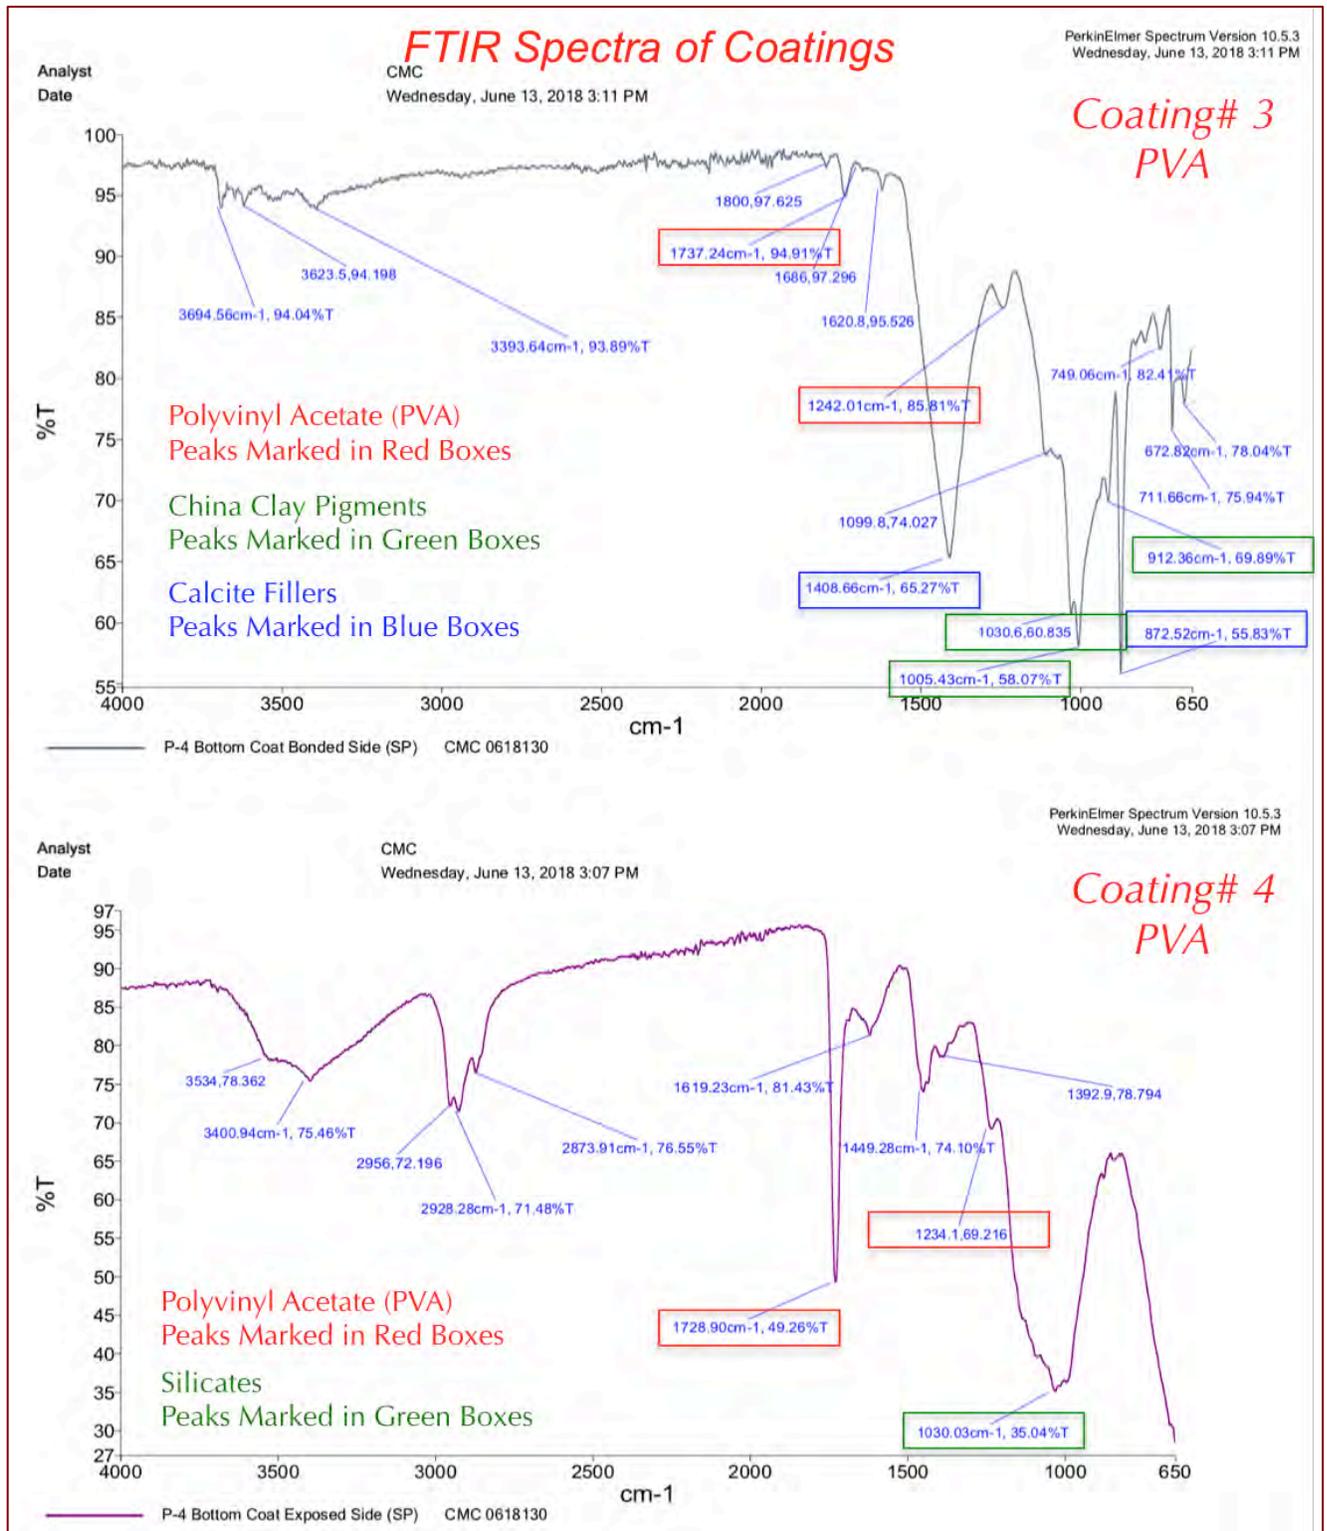
Figure 40: Coating #3 - The resin bands are small. From the bands near 1740 and 1240 cm⁻¹, the resin is most consistent with a vinyl (polyvinyl acetate, PVA). The pigmentation is china clay as indicated by the bands near 1030, 1010, 915 cm⁻¹. The bands near 1410 and 875 cm⁻¹ are a carbonate material (a little low for CaCO₃). Coating #4 - The resin is another layer of vinyl as confirmed from bands near 1728 and 1234 cm⁻¹. The large band between 1100 and 1000 cm⁻¹ is consistent with silicate materials, which, from SEM-EDS studies is judged to be from slag and fine quartz fillers.

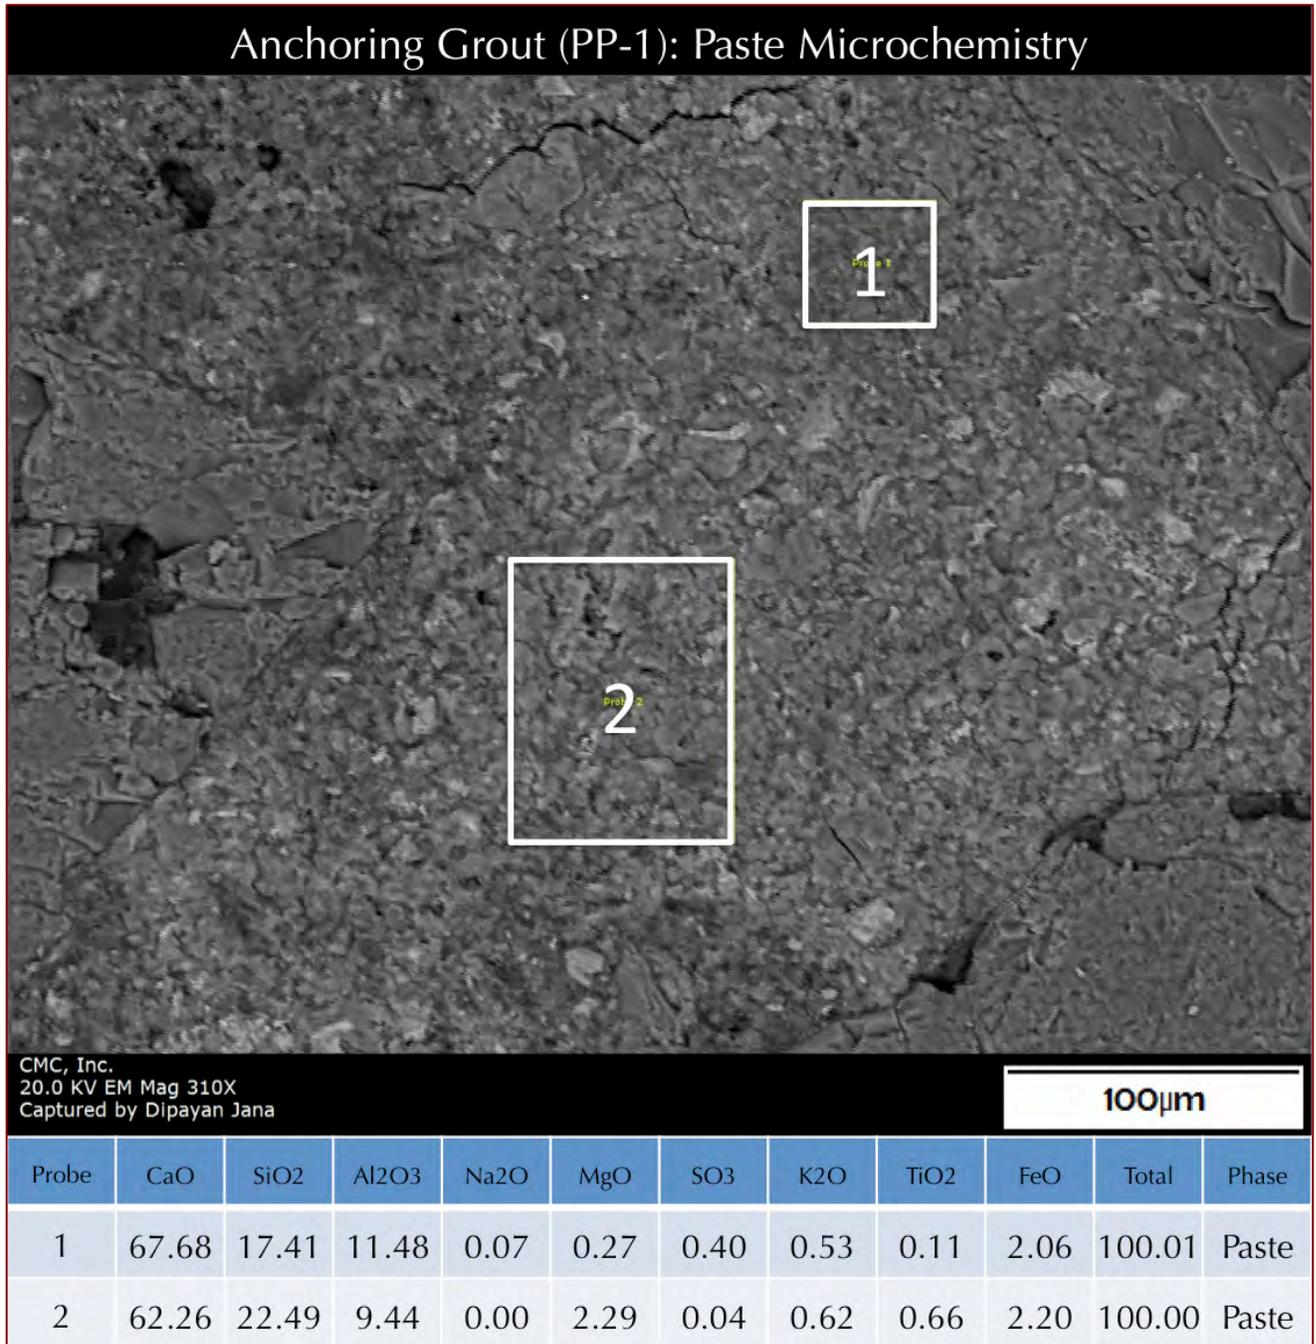
Figure 43: Backscatter electron image (top) and X-ray elemental analyses (bottom Table) of two boxed areas from the paste fraction of grout showing the typical calcium silicate composition of paste as anticipated from incorporation of Portland cement based binder with some sulfate but not high enough as found in many other gypsum-based grouts.

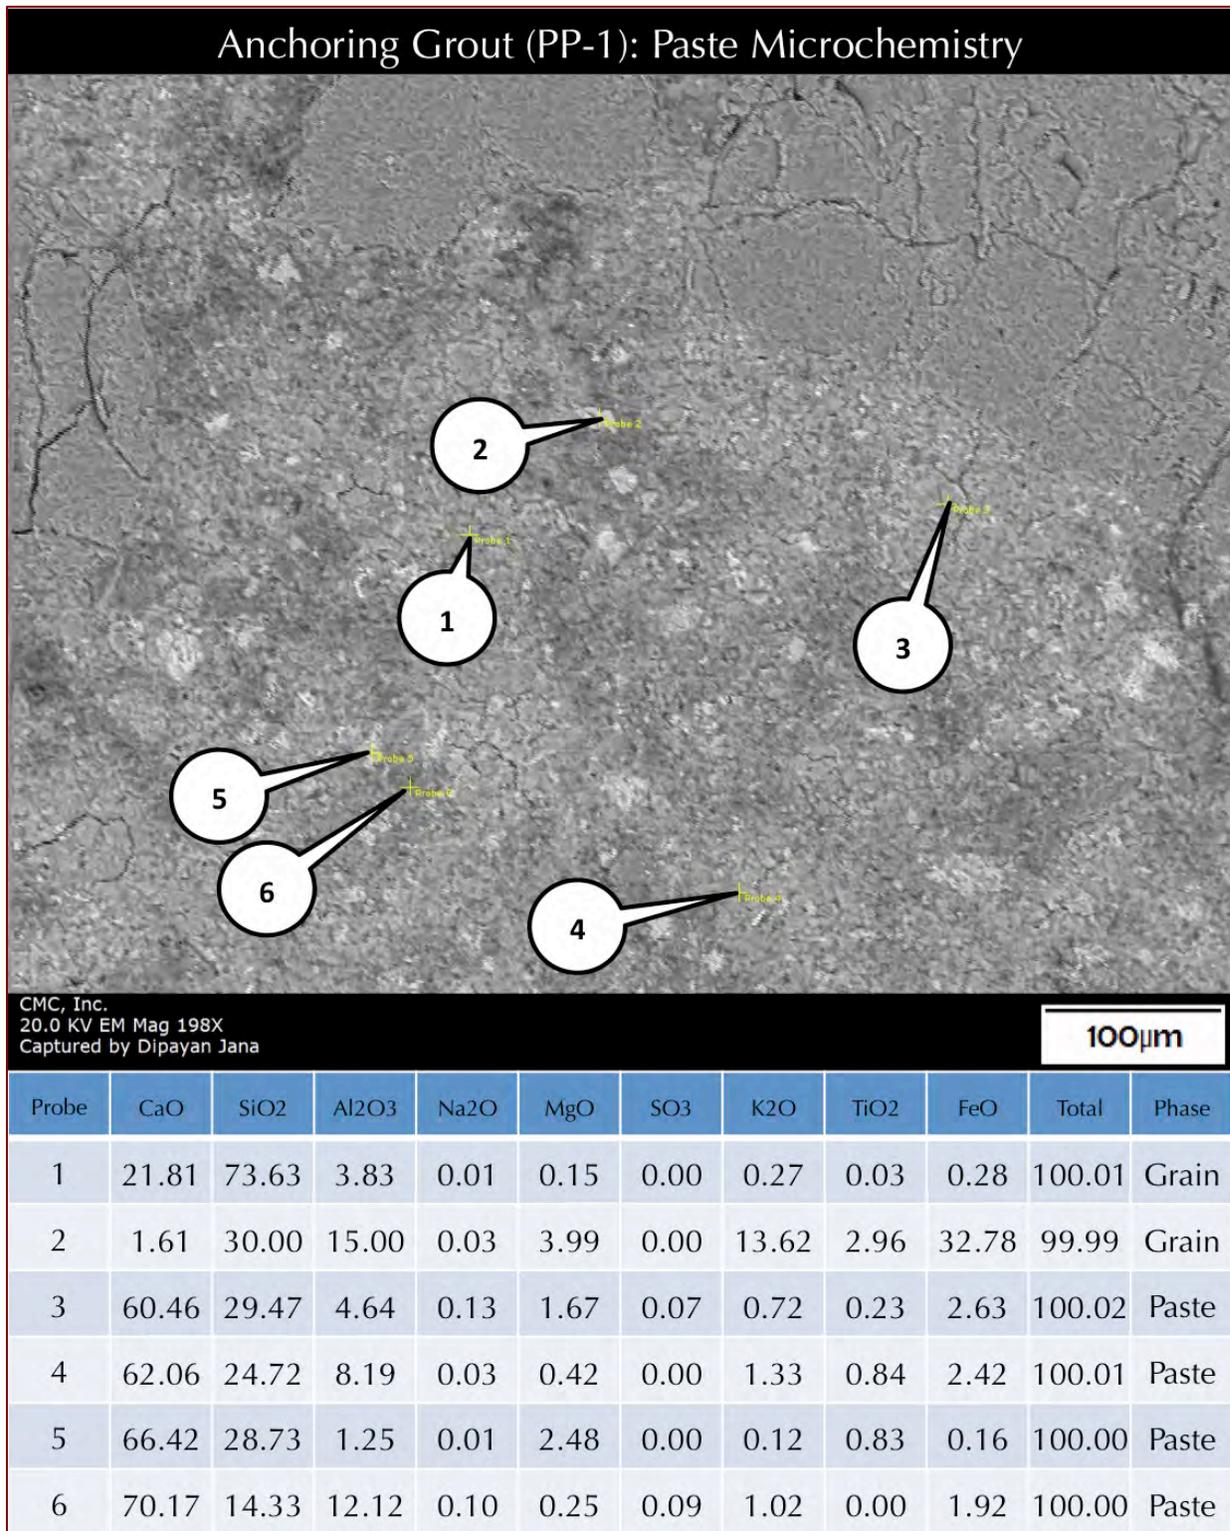
Figure 44: Backscatter electron image (top) and X-ray elemental analyses (bottom Table) of various areas from the paste fraction of grout (at the tips of callouts) showing the typical calcium silicate aluminate composition of paste from incorporation of Portland cement based binder with a calcium aluminate binder typical in many anchoring grouts. Notice the low amount or negligible sulfate in paste indicating absence of gypsum formation in paste (consistent with absence of gypsum peaks in XRD).

The present examined grout belongs to the third category of blended Portland cement and calcium aluminate/sulfoaluminate cement-based cementitious grout, which is determined to contain no gypsum as a major binder component as found in the second category, but Portland cement as the major hydraulic cement along with possible presence of a calcium aluminate and/or sulfoaluminate-based binder. Bulk sulfate (as SO_3) content in the distressed grout is 4.3 percent, which is less than that of a gypsum-based grout but higher than that of a Portland cement-based grout, indicating presence of a sulfate component in the binder, which is not gypsum but a calcium sulfoaluminate cement.

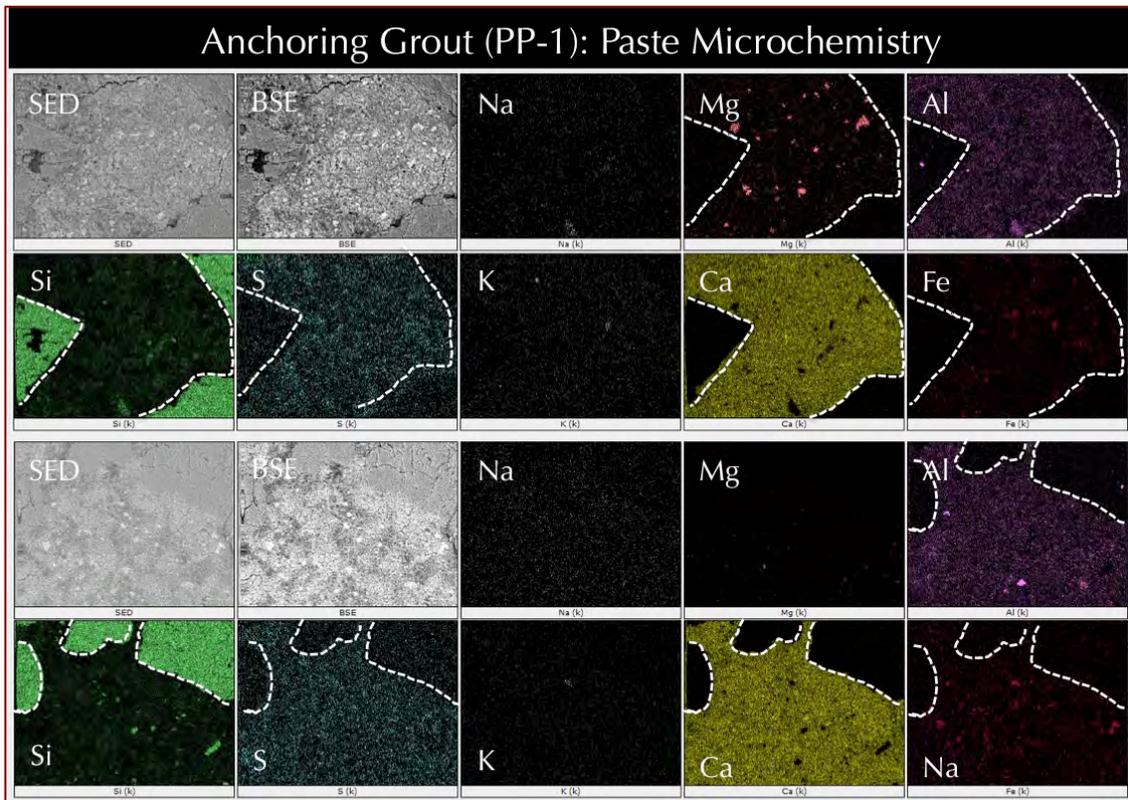
Figure 45: X-ray elemental mapping of paste around silica aggregate particles showing typical calcium, silica enrichment in paste but also some aluminum and sulfur when compared to silica sand particles indicating the presence of a binder that has provided aluminum and sulfur at levels higher than that typically come from Portland cement binder, thus indicating importation of a potential calcium sulfoaluminate component in binder along with Portland cement that is already detected from residual Portland cement particles in paste from optical microscopy (Figure 42).

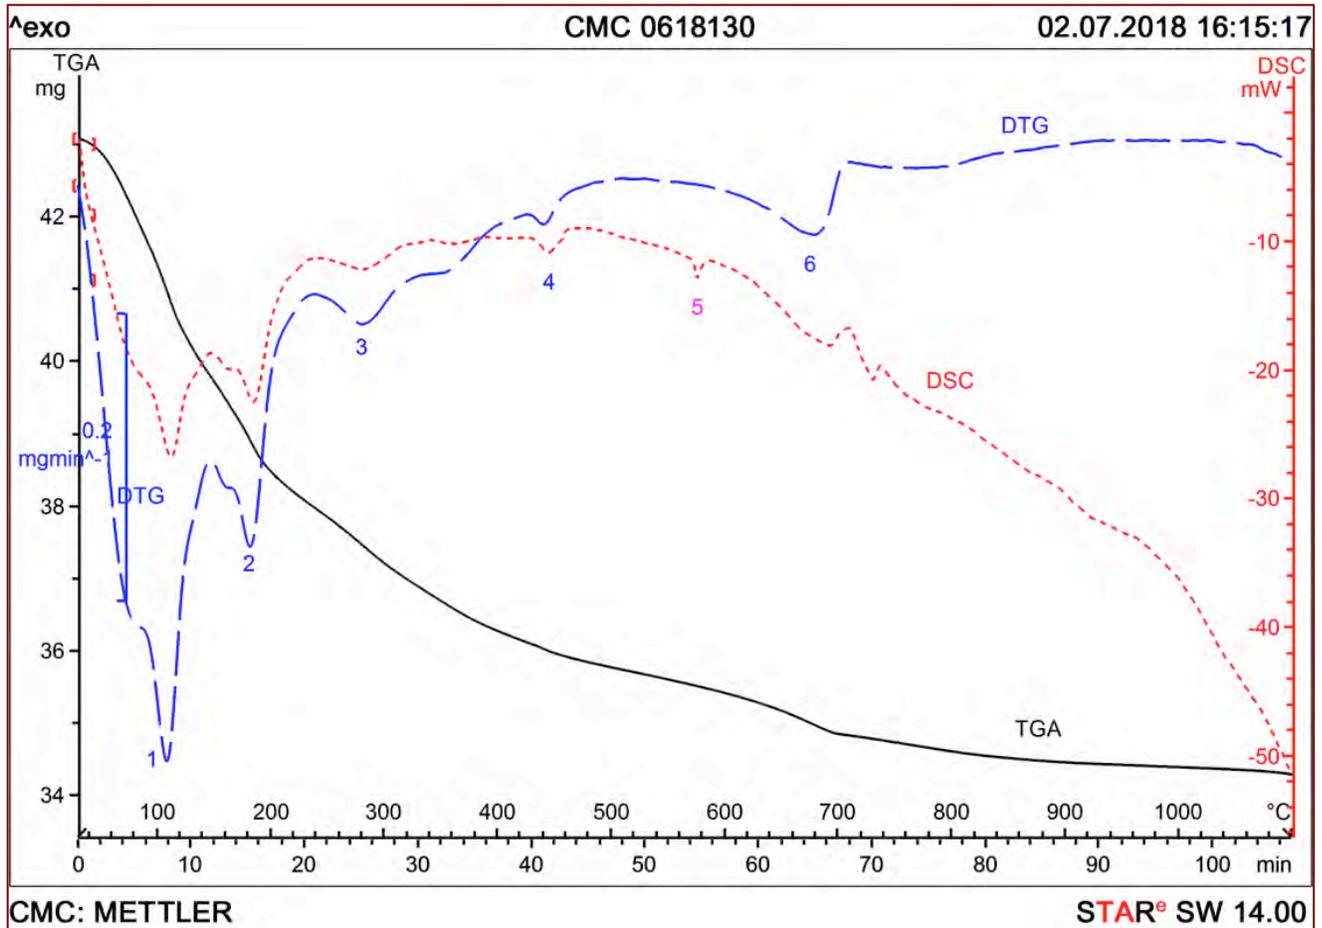
Figure 47: TGA (bold black), DSC (dotted red), and DTG (dashed blue) curves of grout showing weight loss due to thermal decompositions during controlled heating in a Mettler-Toledo’s simultaneous TGA/DSC 1 unit from 30°C to 1000°C in a ceramic crucible (alumina 70µl, no lid) at a heating rate of 10°C/min in a nitrogen purge at a rate of 75 mL/min. Dehydration and decarbonation reactions are marked as endothermic peaks (#1 to 6) in the superposed DSC and DTG curves. Large endothermic peaks at #1, 2, and 3 around 100°C, 180°C, and 280°C, respectively, are from dehydration of CSH and calcium sulfoaluminate hydrate components of paste. Endothermic peak #4 at 440°C is from dehydration of calcium hydroxide (portlandite) component of cement hydration. The alpha-to-beta polymorphic transition of quartz sand occurs around 575°C, where integration of the peak area has indicated about 25 percent quartz in grout. Calcite decarbonation occurred around 680°C and provided a low 1.6 percent calcite (which is consistent with low calcite detected in XRD and low amount of carbonation detected in thin section photomicrograph of paste in Figure 42).
