Laboratory Investigation of An Outdoor Suspended Concrete Slab Of An Underground Vault Adjacent To A Swimming Pool

Algonquin Pool
1614 Cypress Street
Louisville, KY 40210

July 8, 2020
CMC 0620128

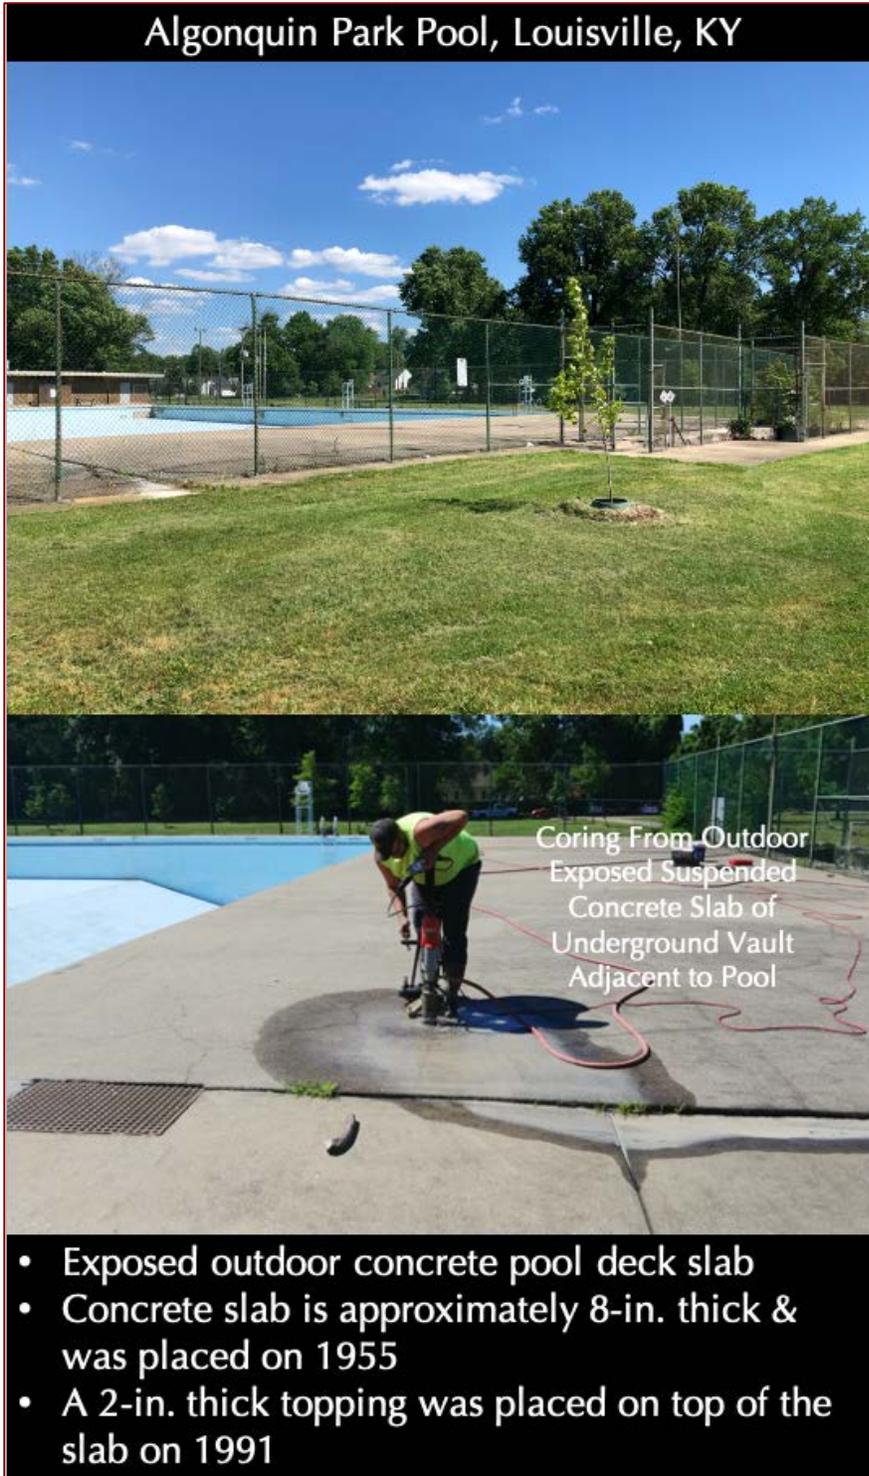
Figure 1: Top Photo - Algonquin Swimming Pool. Bottom Photo – Outdoor exposed concrete Deck around the pool, which also represents the suspended roofing slab for an underground vault that houses various pool equipment and accessories, e.g., pump, filter, and chlorine tanks.

Core samples for this study were collected from this pool-side slab as shown in the bottom photo.

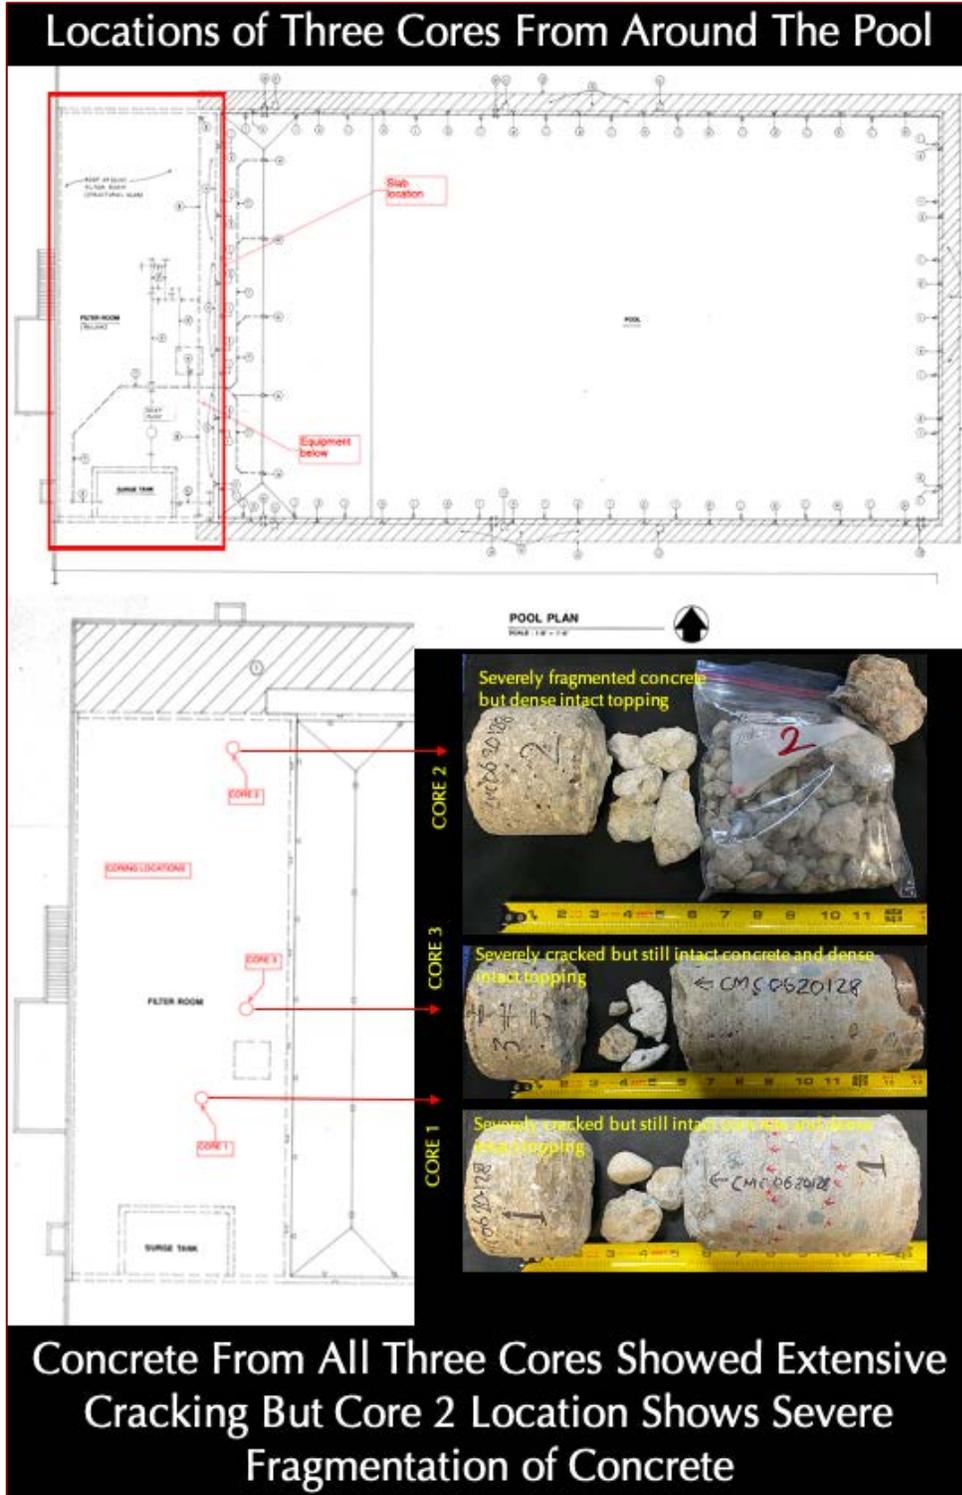
Figure 5: Schematic diagram showing the locations of three cores collected for this study.

Core 1 was received in broken condition where the 2-in. thick topping was entirely separated from the concrete substrate. The concrete showed extensive through-depth cracks oriented parallel to the top surface.

Core 2 was received in mostly fragmented condition for the concrete substrate, where, however, the topping is still dense and intact but entirely separated from rubble concrete substrate.

Core 3 was received in broken condition as well where concrete substrate showed most intact condition (though later found to have extensive through-depth microcracking).

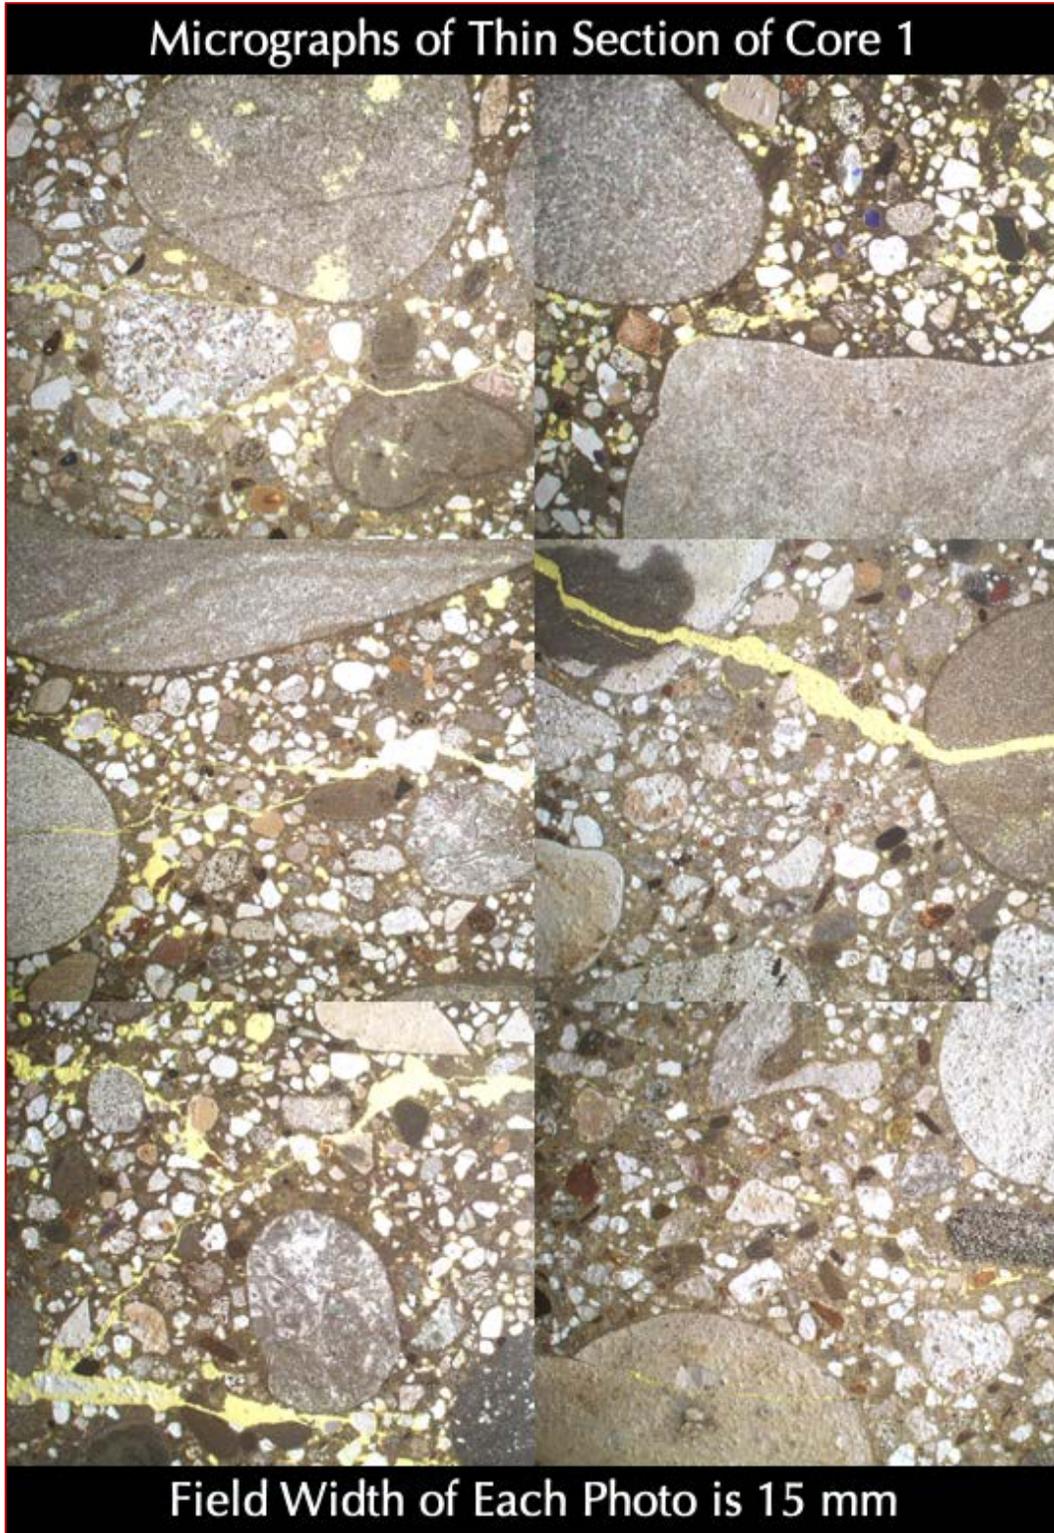
Figure 28: Fluorescent dye-mixed epoxy-impregnated thin section of concrete in Core 1 showing aggregates, paste, air, cracks, and various microstructural features.

The mosaic of six images represent 30 x 45 mm area of thin section where cracks, gravel coarse aggregate particles and interstitial mortar fraction of sand and Portland cement paste are seen.

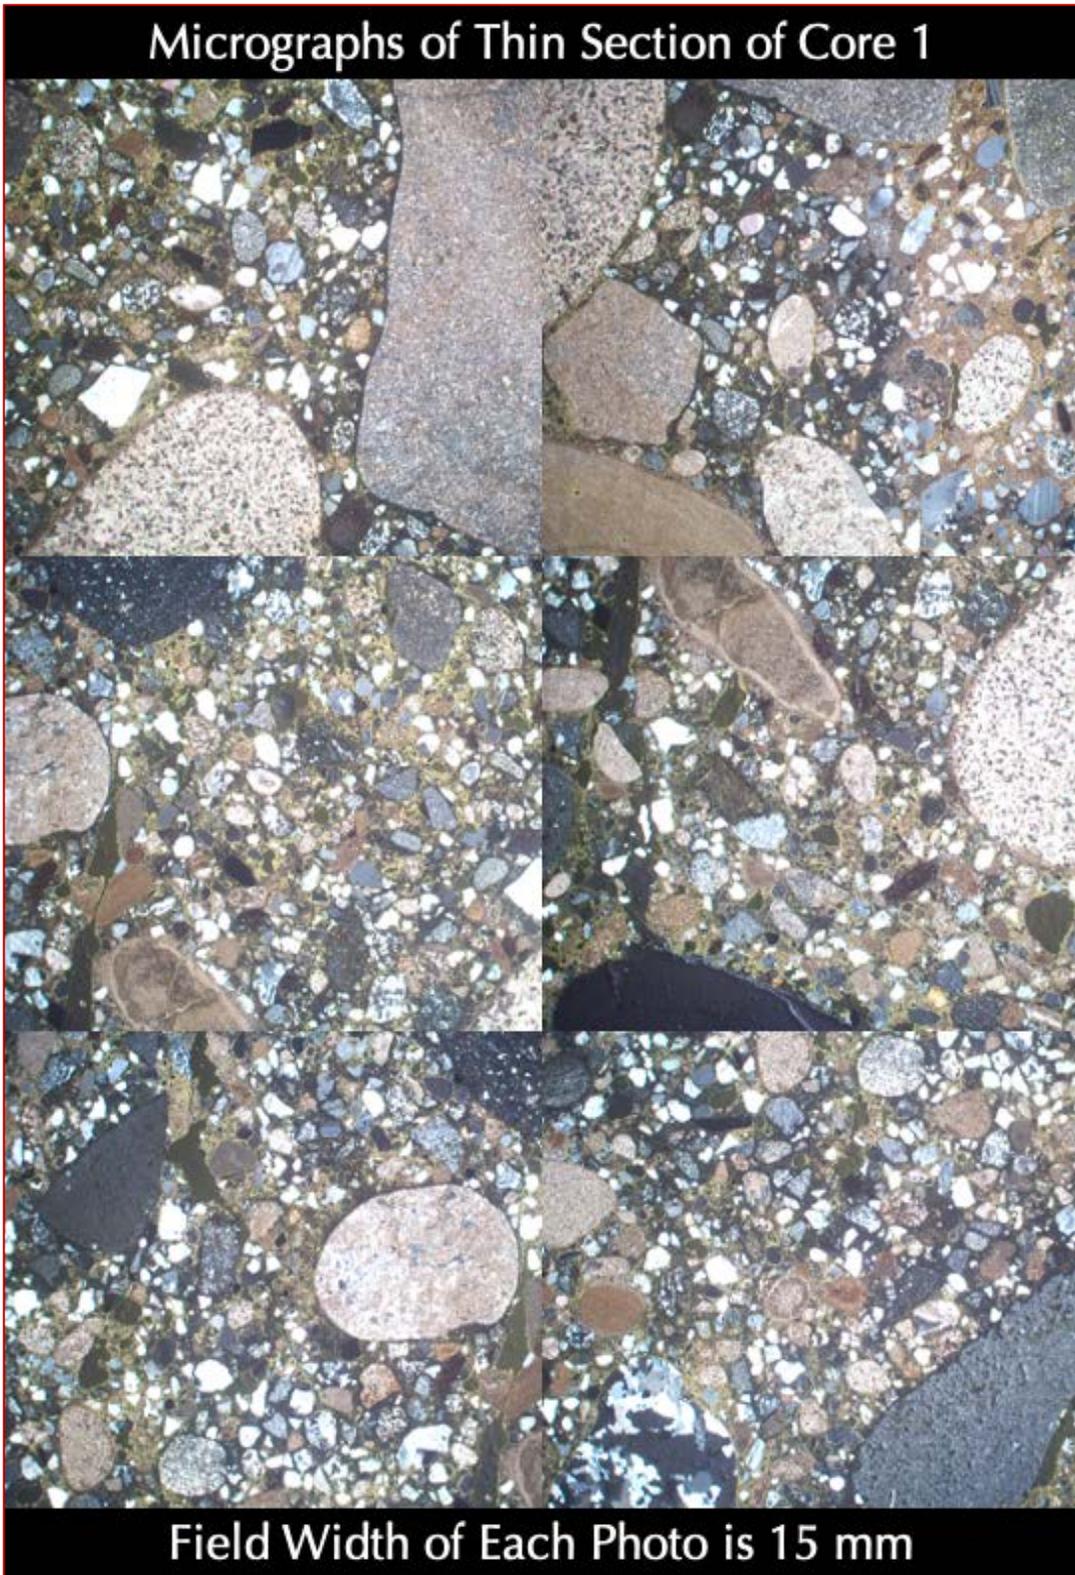
Figure 29: Fluorescent dye-mixed epoxy-impregnated thin section of concrete in Core 1 showing aggregates, paste, air, cracks, and various microstructural features.

The mosaic of six images represent 30 × 45 mm area of thin section where cracks, calcareous gravel coarse aggregate particles and interstitial mortar fraction of siliceous-calcareous sand and variably carbonated Portland cement paste are seen.

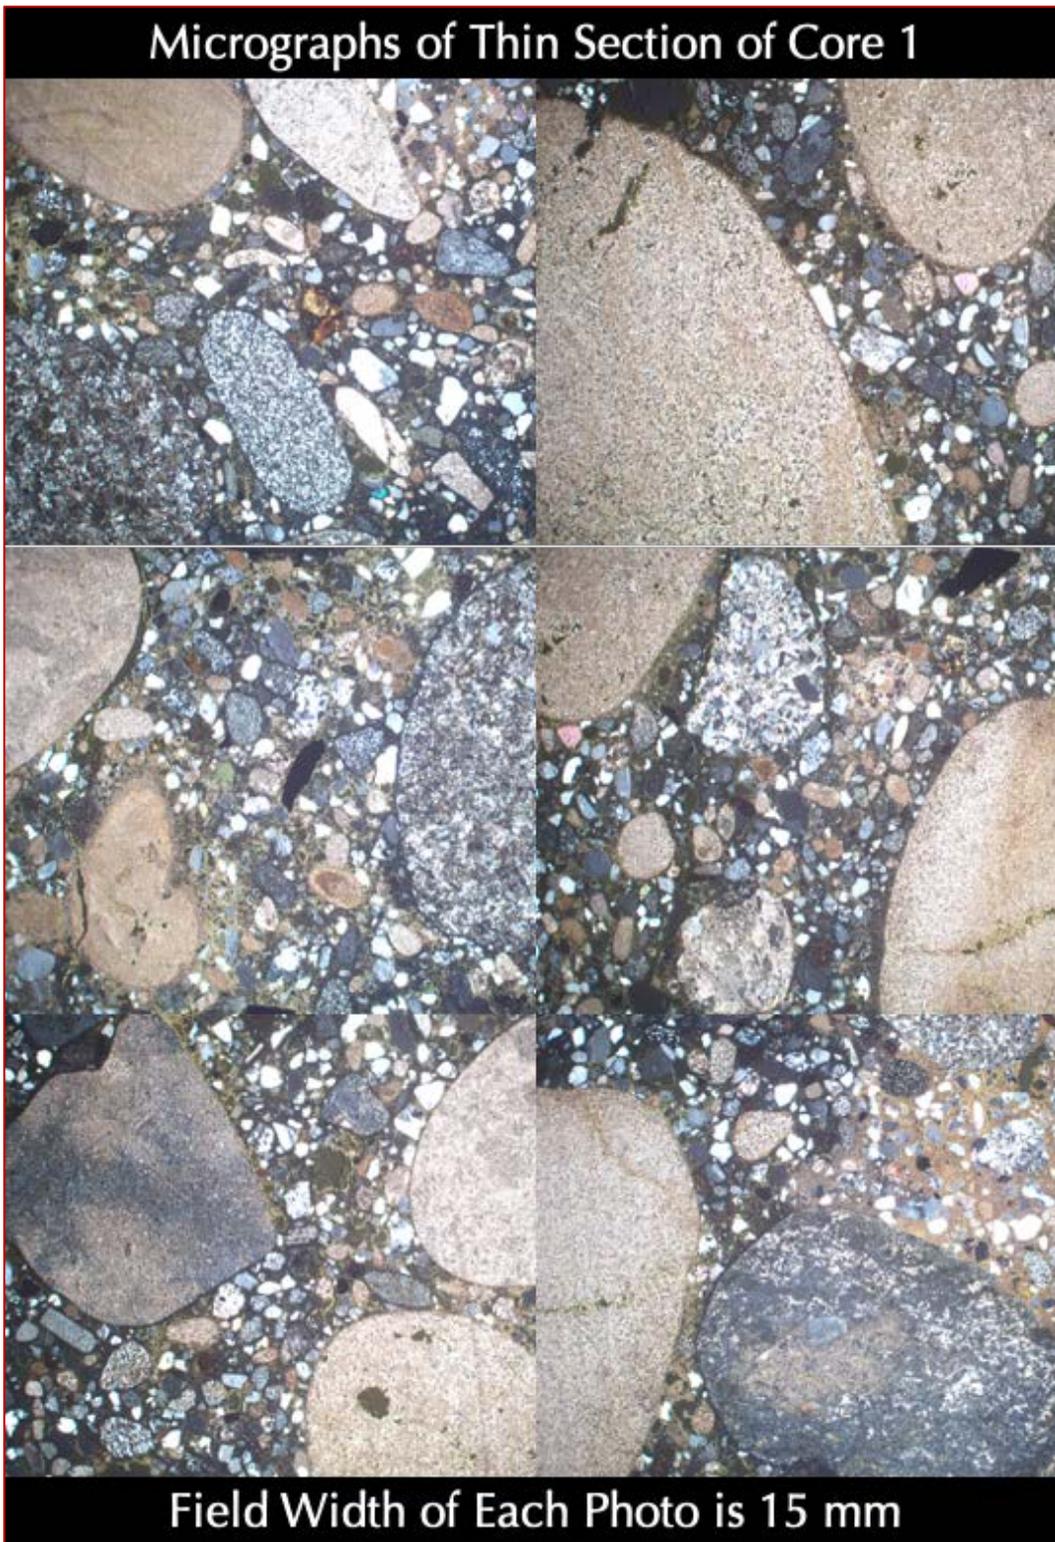
Figure 30: Fluorescent dye-mixed epoxy-impregnated thin section of concrete in Core 1 showing aggregates, paste, air, cracks, and various microstructural features.

The mosaic of six images represent 30 x 45 mm area of thin section where cracks, calcareous gravel coarse aggregate particles and interstitial mortar fraction of siliceous-calcareous sand and variably carbonated Portland cement paste are seen.

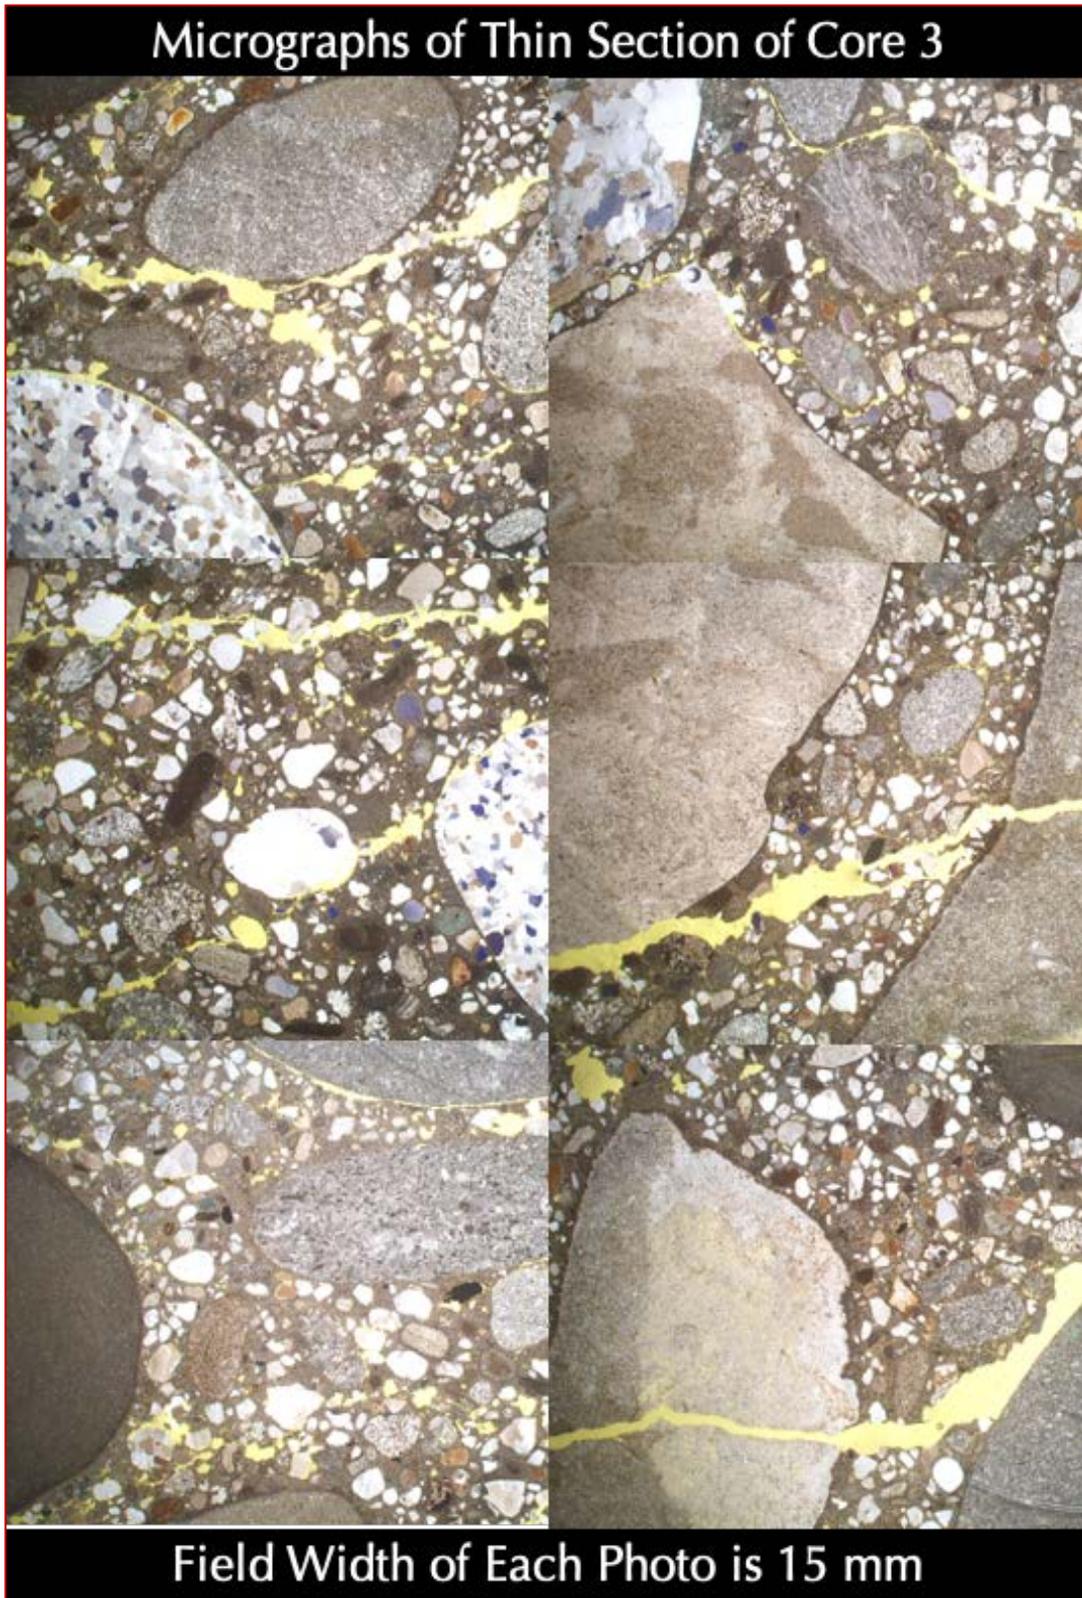
Figure 31: Fluorescent dye-mixed epoxy-impregnated thin section of concrete in Core 3 showing aggregates, paste, air, cracks, and various microstructural features.

The mosaic of six images represent 30 x 45 mm area of thin section where cracks, gravel coarse aggregate particles and interstitial mortar fraction of sand and Portland cement paste are seen.

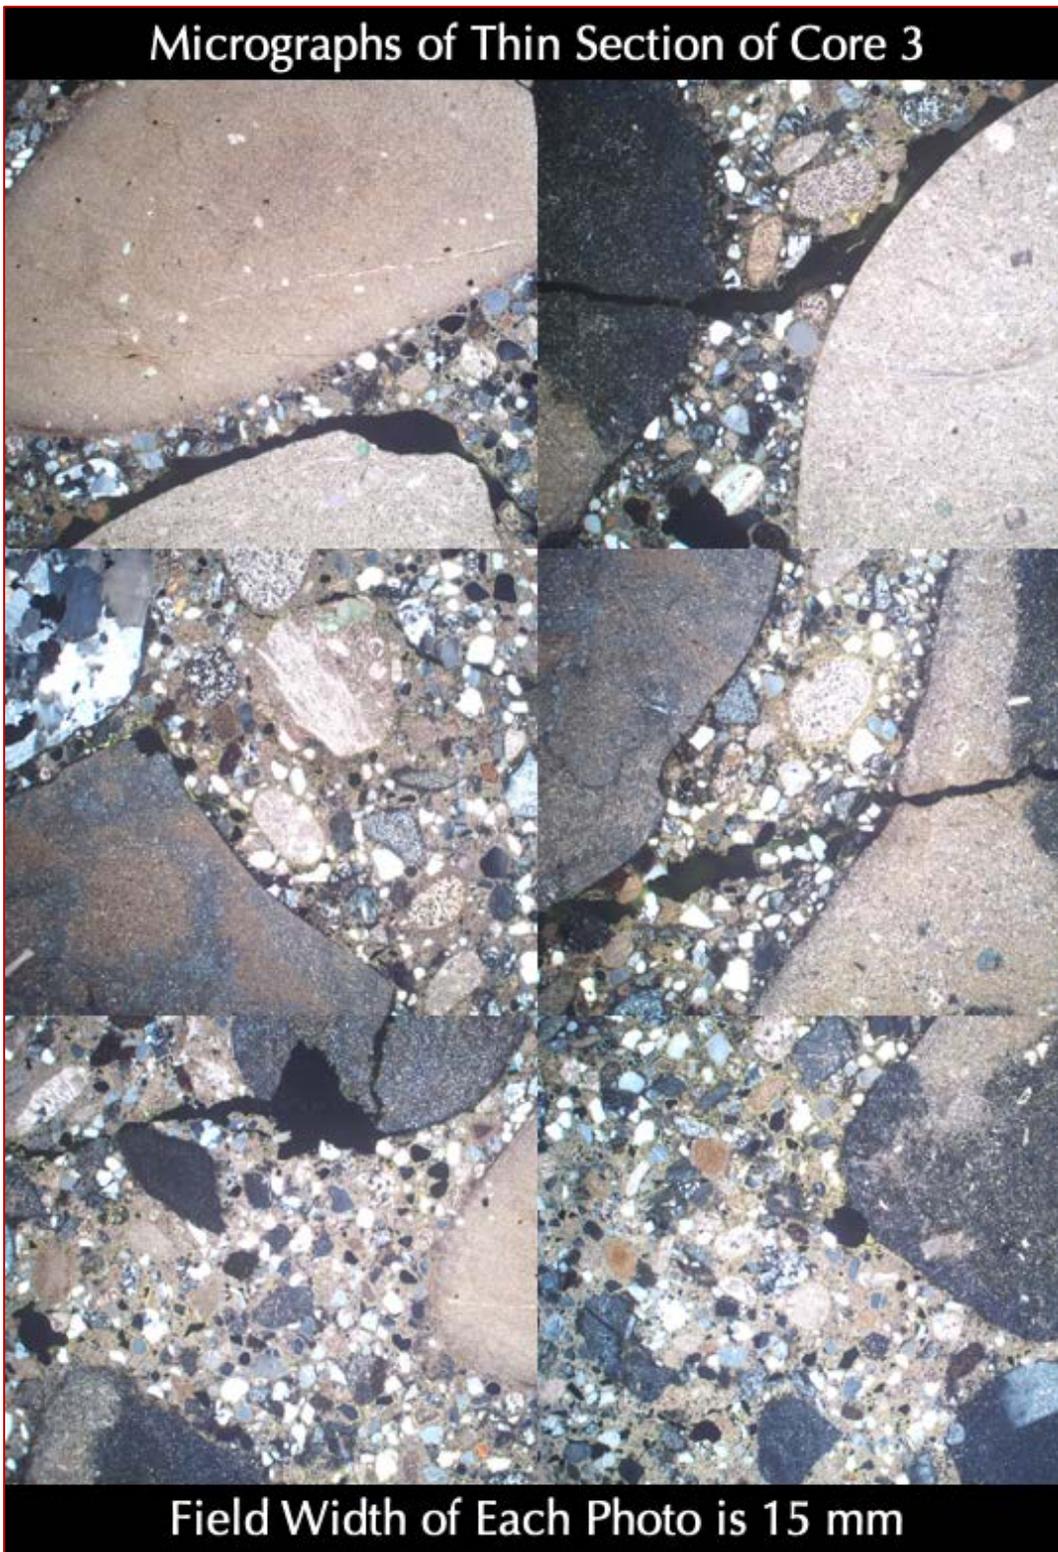
Figure 32: Fluorescent dye-mixed epoxy-impregnated thin section of concrete in Core 3 showing aggregates, paste, air, cracks, and various microstructural features.

The mosaic of six images represent 30 x 45 mm area of thin section where cracks, calcareous gravel coarse aggregate particles and interstitial mortar fraction of siliceous-calcareous sand and variably carbonated Portland cement paste are seen.

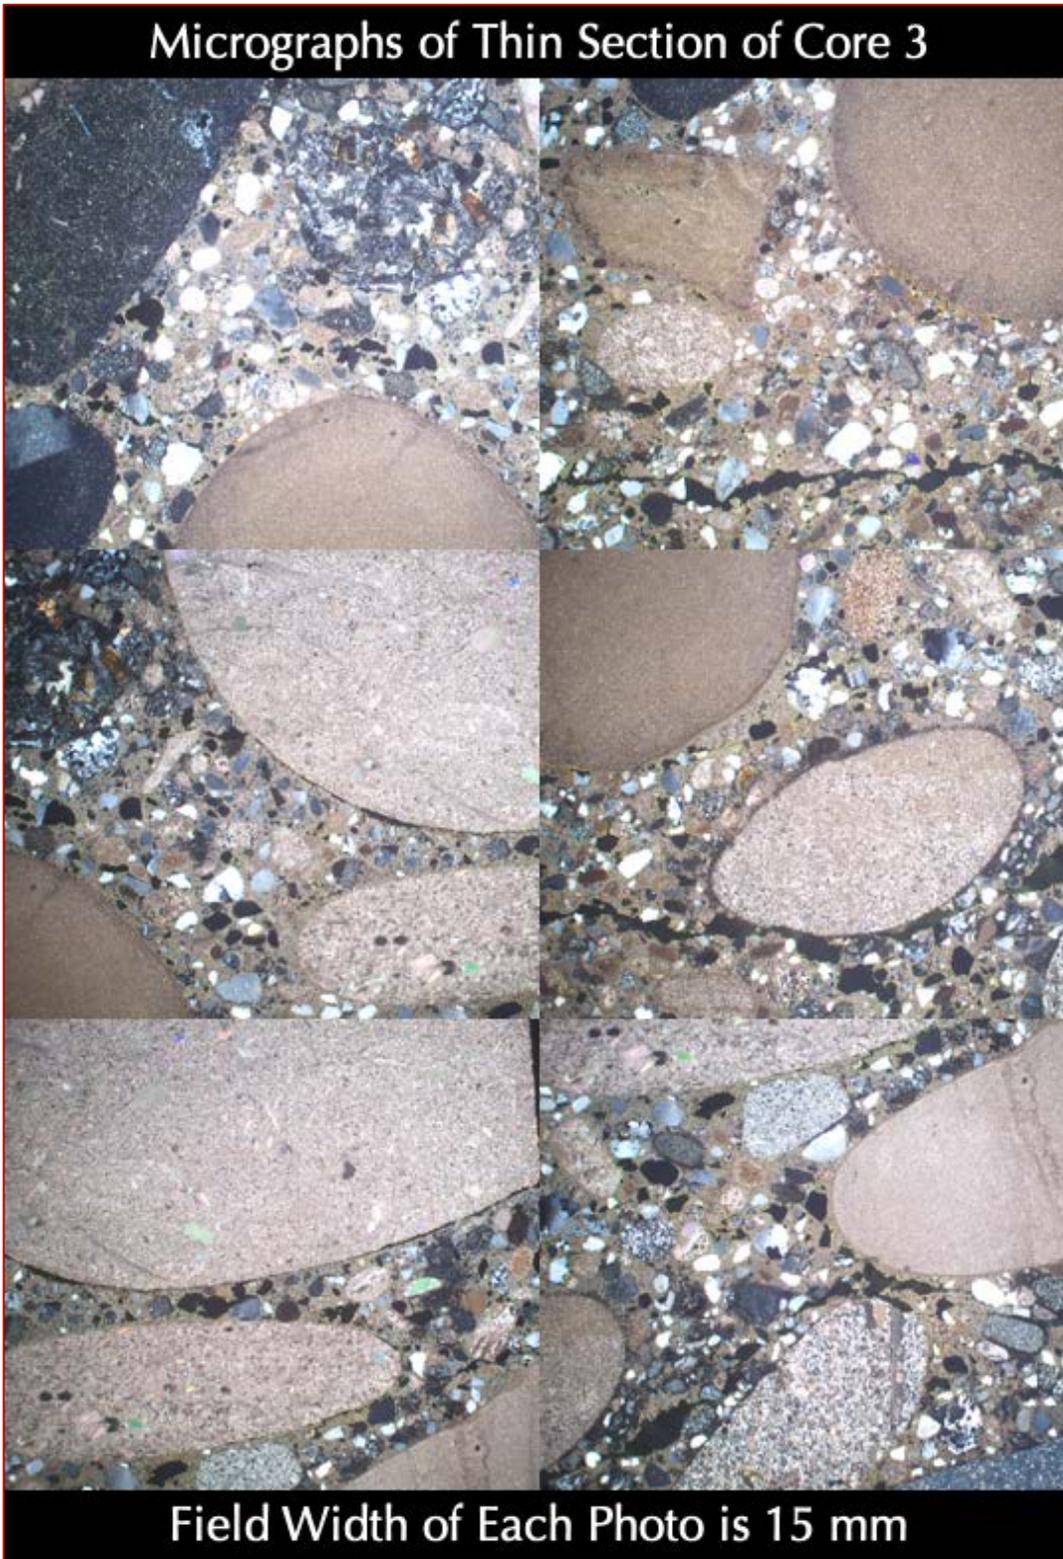
Figure 33: Fluorescent dye-mixed epoxy-impregnated thin section of concrete in Core 3 showing aggregates, paste, air, cracks, and various microstructural features.

The mosaic of six images represent 30 x 45 mm area of thin section where cracks, calcareous gravel coarse aggregate particles and interstitial mortar fraction of siliceous-calcareous sand and variably carbonated Portland cement paste are seen.

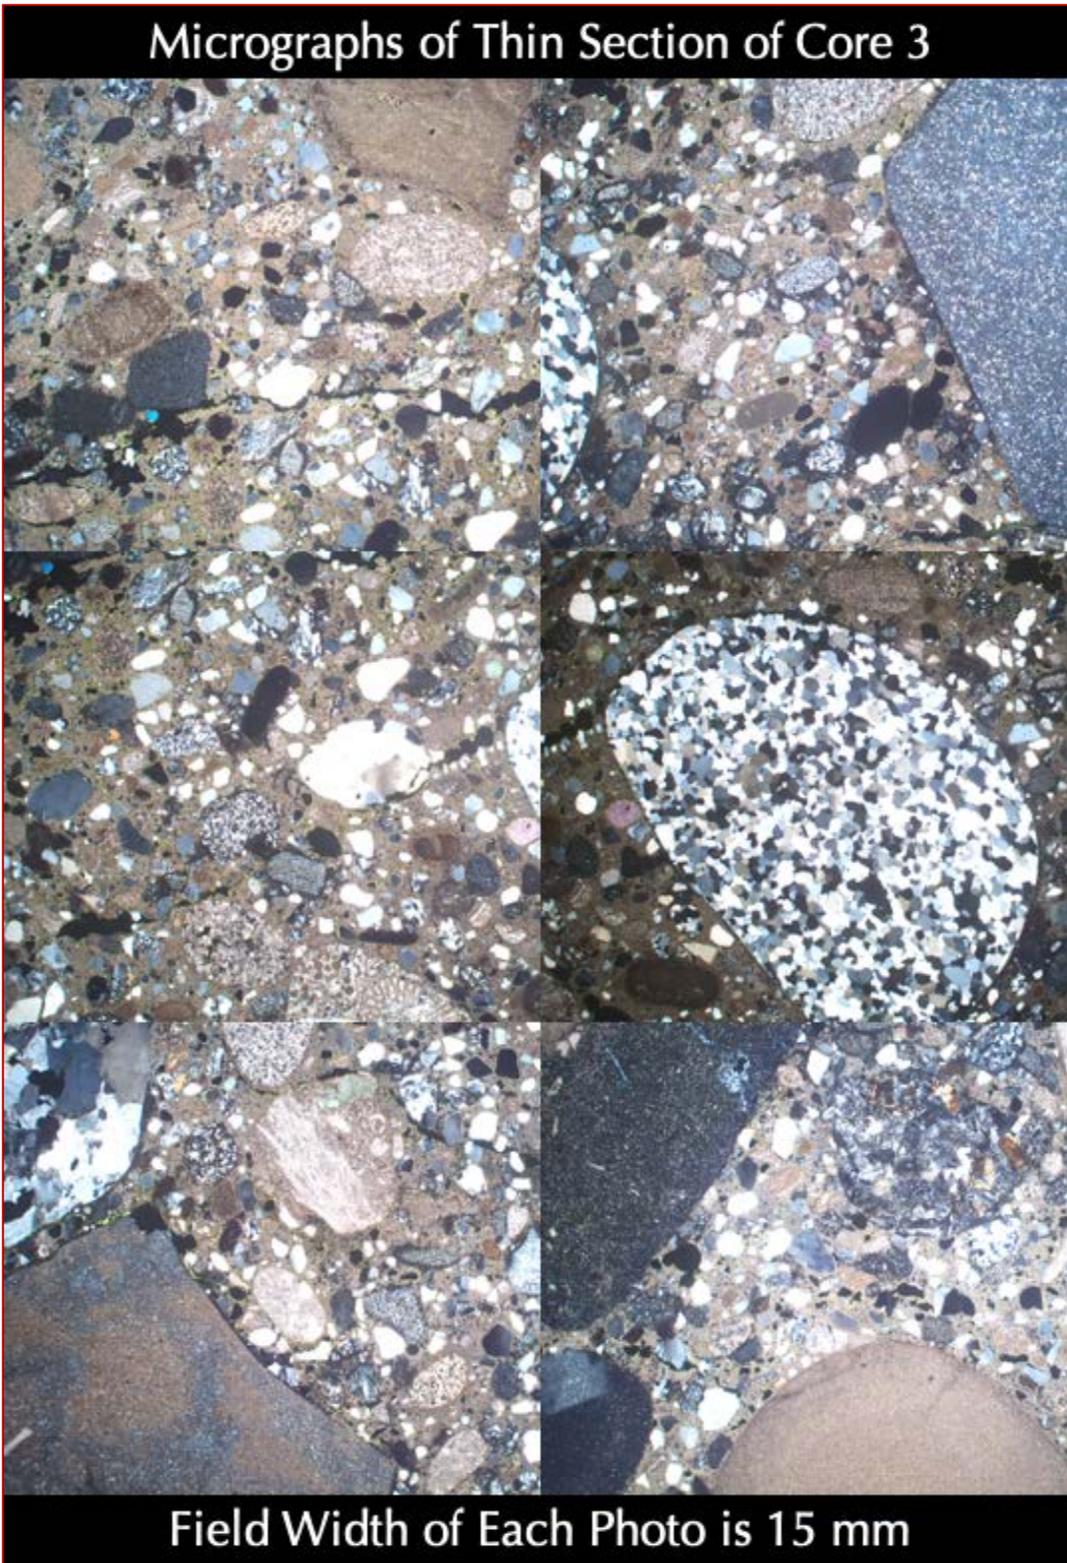
Figure 34: Fluorescent dye-mixed epoxy-impregnated thin section of concrete in Core 3 showing aggregates, paste, air, cracks, and various microstructural features.

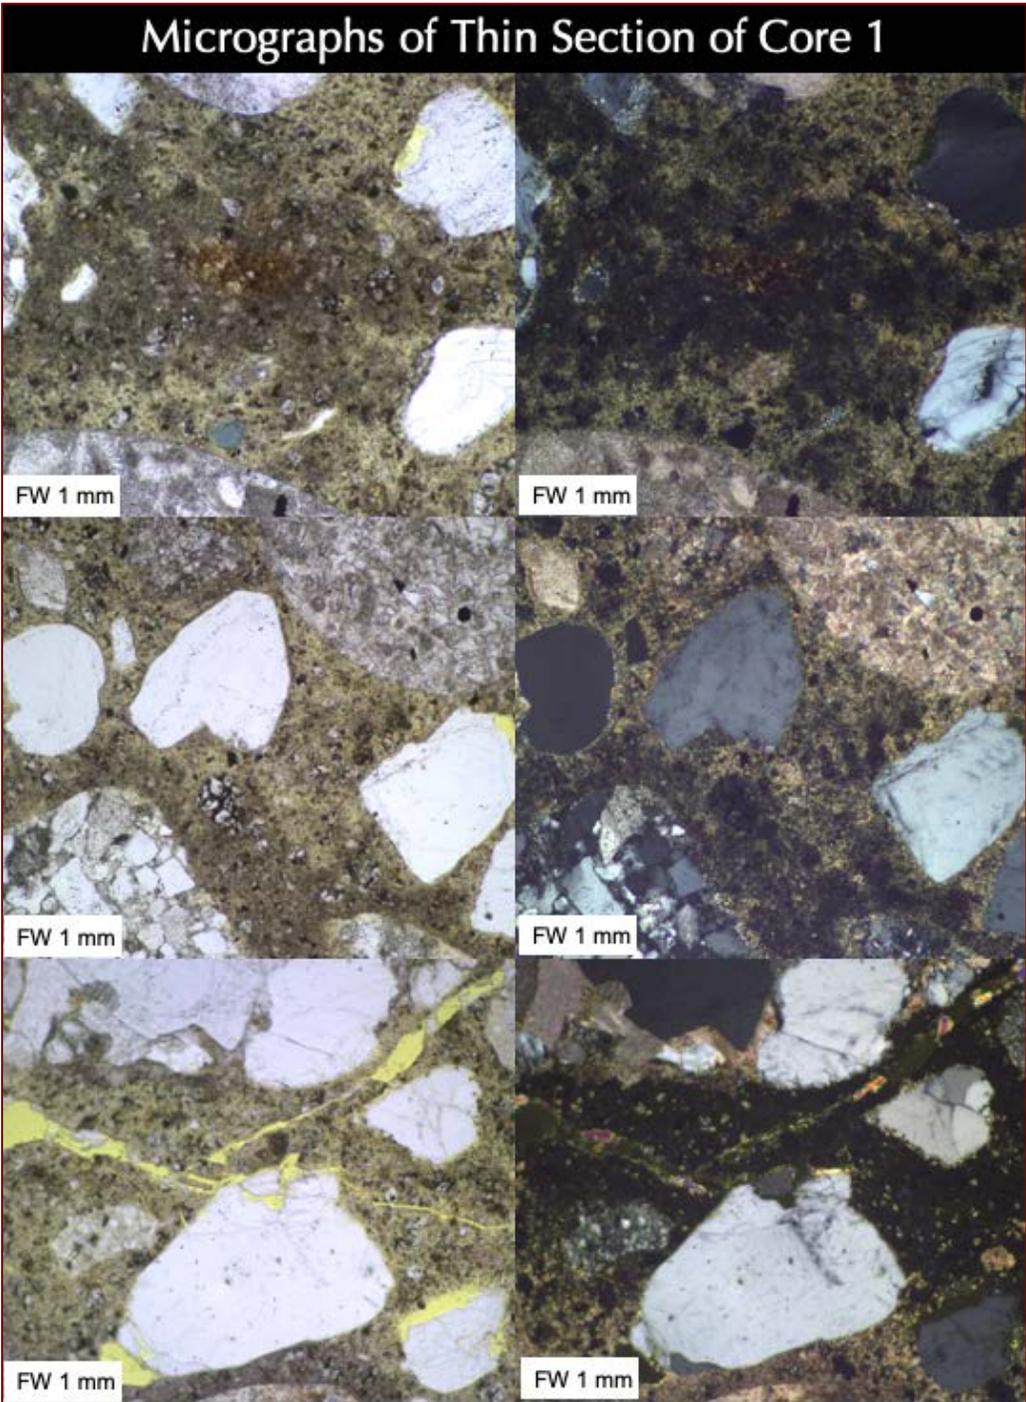
Figure 36: Micrographs of thin section of Core 1 taken in plane and crossed-polarized light modes with a Nikon Eclipse E600 fluorescent-light microscope with an attached Basler camera showing:

(a) Portland cement paste that is variably carbonated, contains many residual cement particles and cement hydration products;

(c) Cracks that are highlighted by fluorescent epoxy.

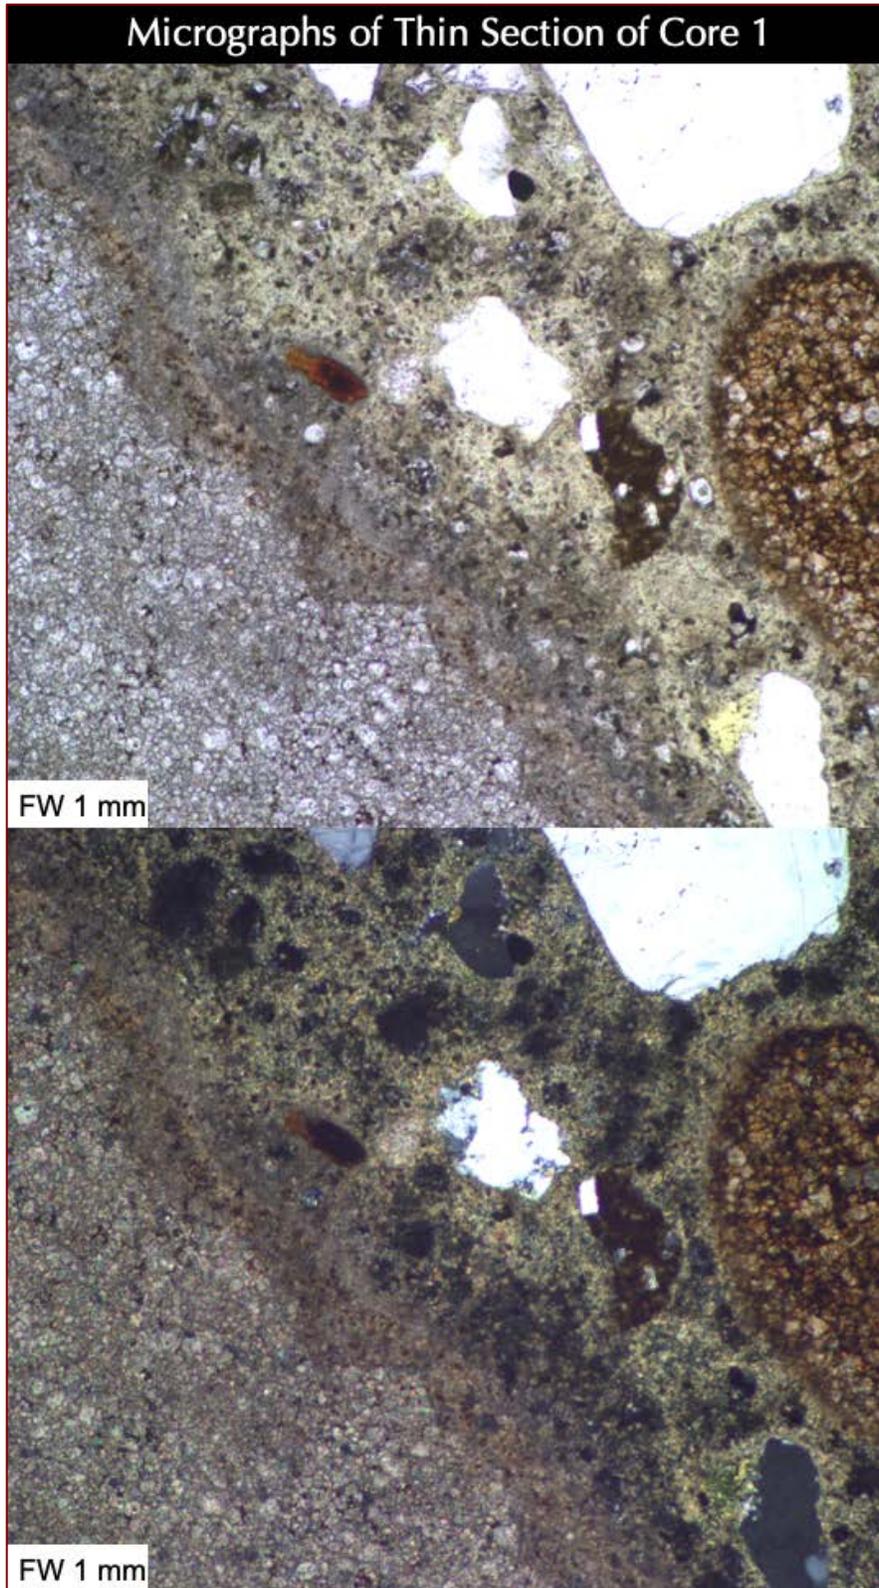
Figure 37: Micrographs of thin section of Core 1 taken in plane and crossed-polarized light modes with a Nikon Eclipse E600 fluorescent-light microscope with an attached Basler camera showing:

(a) Portland cement paste that is variably carbonated, contains many residual cement particles and cement hydration products;

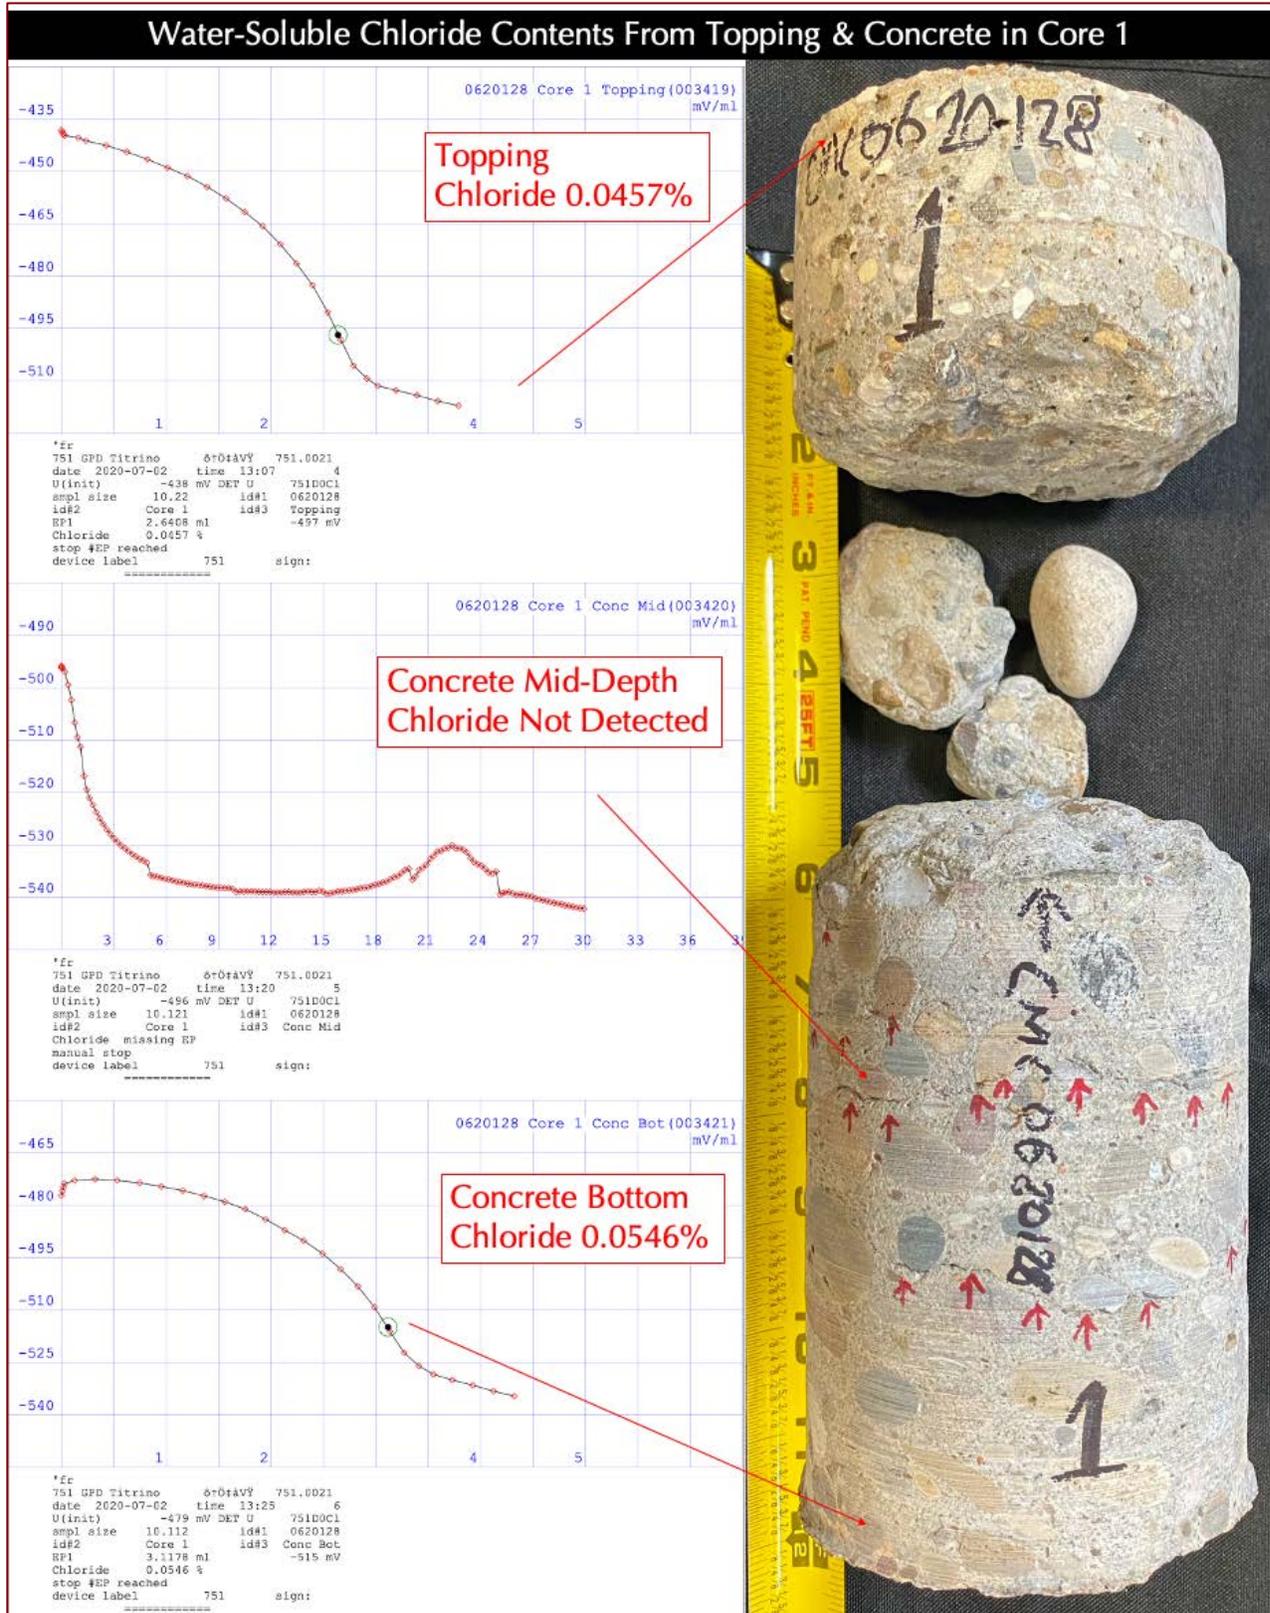
Figure 48: The potentiometric titration curves of chloride analyses where the equivalent points of titration, marked as EP1, represent the steepest points in the curves. Chloride contents are determined from equivalent points times 0.177 divided by sample weight (which is approximately 10.00 grams).

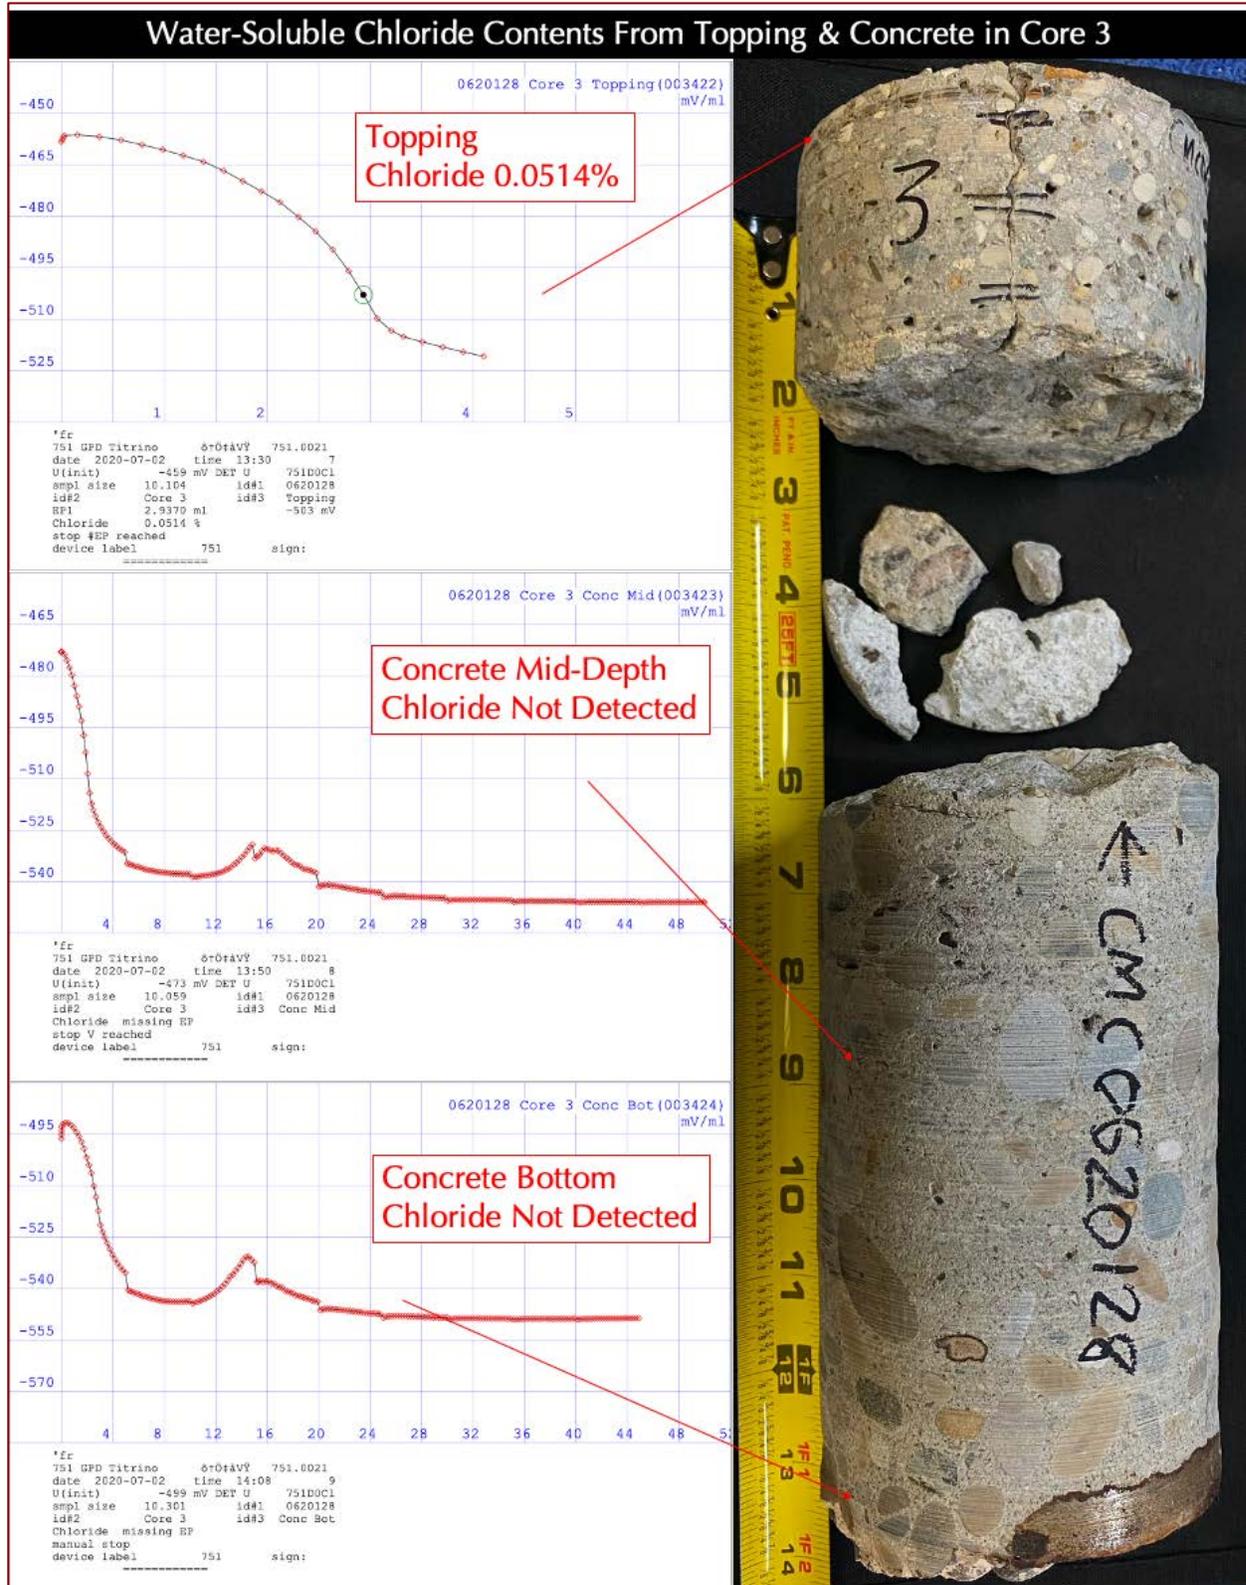
Figure 49: The potentiometric titration curves of chloride analyses where the equivalent points of titration, marked as EP1, represent the steepest points in the curves. Chloride contents are determined from equivalent points times 0.177 divided by sample weight (which is approximately 10.00 grams).
