## Chloride and Carbonation-Induced Corrosion of Reinforcing Steel In A Concrete Column – A Case Study

North Carolina State University  
Mann Hall Column Testing

**Background** - Exposed perimeter reinforced concrete columns at 4-story Mann Hall (constructed in 1963) in North Carolina State University has experienced corrosion of reinforcing steel in columns resulting in various levels of distress from vertical and horizontal cracking, delamination and spalls. Previous tests have determined the presence of elevated chlorides in some columns and deep carbonation, hence potential chloride-induced and/or carbonation-induced corrosion of steel in concrete to cause the distress. A repair attempt in 1993 was taken to reduce chloride and carbonation ingress by patching many deteriorated concrete covers over corroded rebars with adequate concrete cover of 1 to 4 in. thicknesses. However, continued deterioration over the past couple of decades has led to other engineering firms evaluate these columns in 2017. Recently, field evaluation of these columns were done in August of 2019 from visual surveying to audible sounding, excavations, chloride powder sampling, and removal of cores for pre

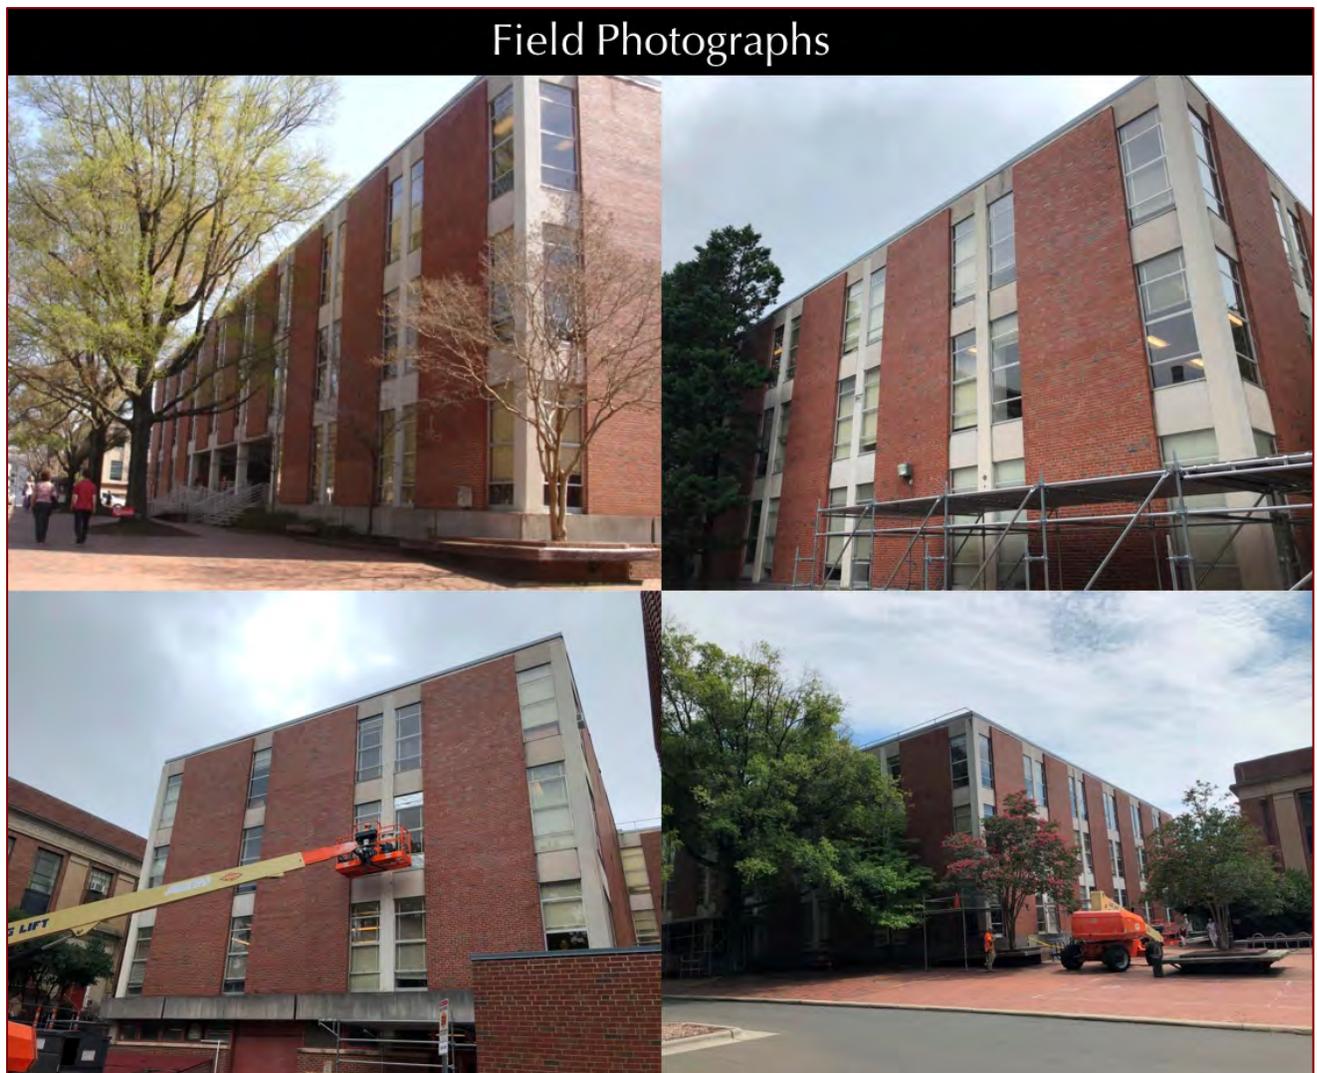
Figure 1: Field photos showing an overview of Mann Hall.

Figure 1 shows overall views of Mann Hall at North Carolina State University. Figure 2 shows locations of cores extracted for present laboratory testing. The column at the location of Core PC-3 shows severe delamination and exposure of corroded rebar.

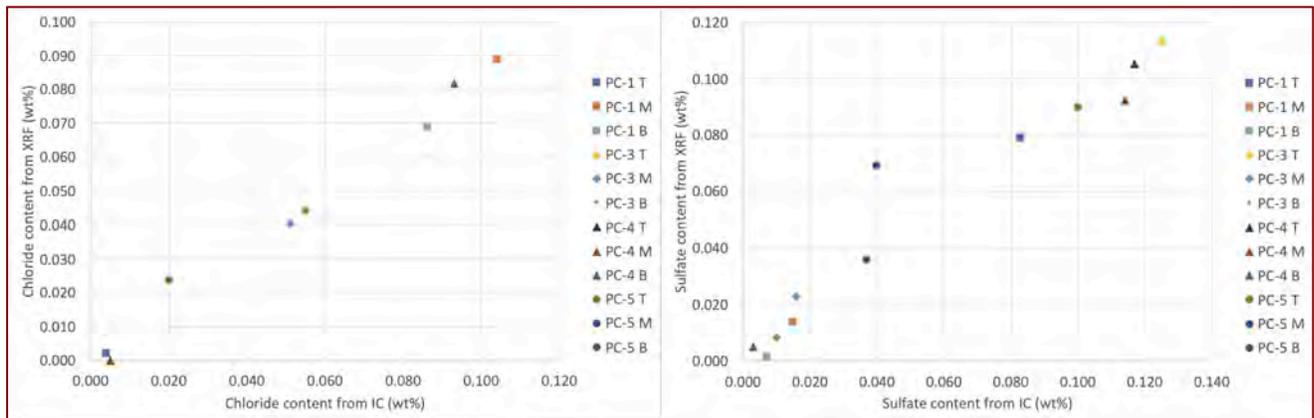
Figure 41: Correlations of chloride and sulfate contents of concrete from ion chromatography and X-ray fluorescence techniques. Both techniques show very good correlation of chloride and sulfate contents.

Chloride contents shown in red are higher than the common industry-recommended threshold chloride content of 0.2 percent by mass of cement for chloride-induced corrosion of reinforcing steel to occur in concrete in the presence of oxygen and moisture. Column concretes in Cores PC-1, PC-3, and PC-4 are thus susceptible to chloride-induced corrosion of steel in the presence of oxygen and moisture. Deep carbonation of concrete in the column at the locations of these cores measured to be 30 mm in PC-1 and PC-3 and 15 to 25 mm in PC-4 can further reduce the threshold chloride needed for steel corrosion (along with depassivation of gamma-lepidocrocite protective oxide film over the steel situated within the carbonated zone to cause carbonation-induced corrosion of steel).
