First International Conference on Iron Sulfide Reactions in Concrete May 2024

## Cracking and crumbling of concrete blocks in County Donegal, Ireland: A holistic approach from case studies on deleterious effects of open microstructure of blocks, phyllite aggregate, pyrrhotite Oxidation, paste carbonation, lime leaching, and internal sulfate attacks

### Dipayan Jana<sup>1</sup>

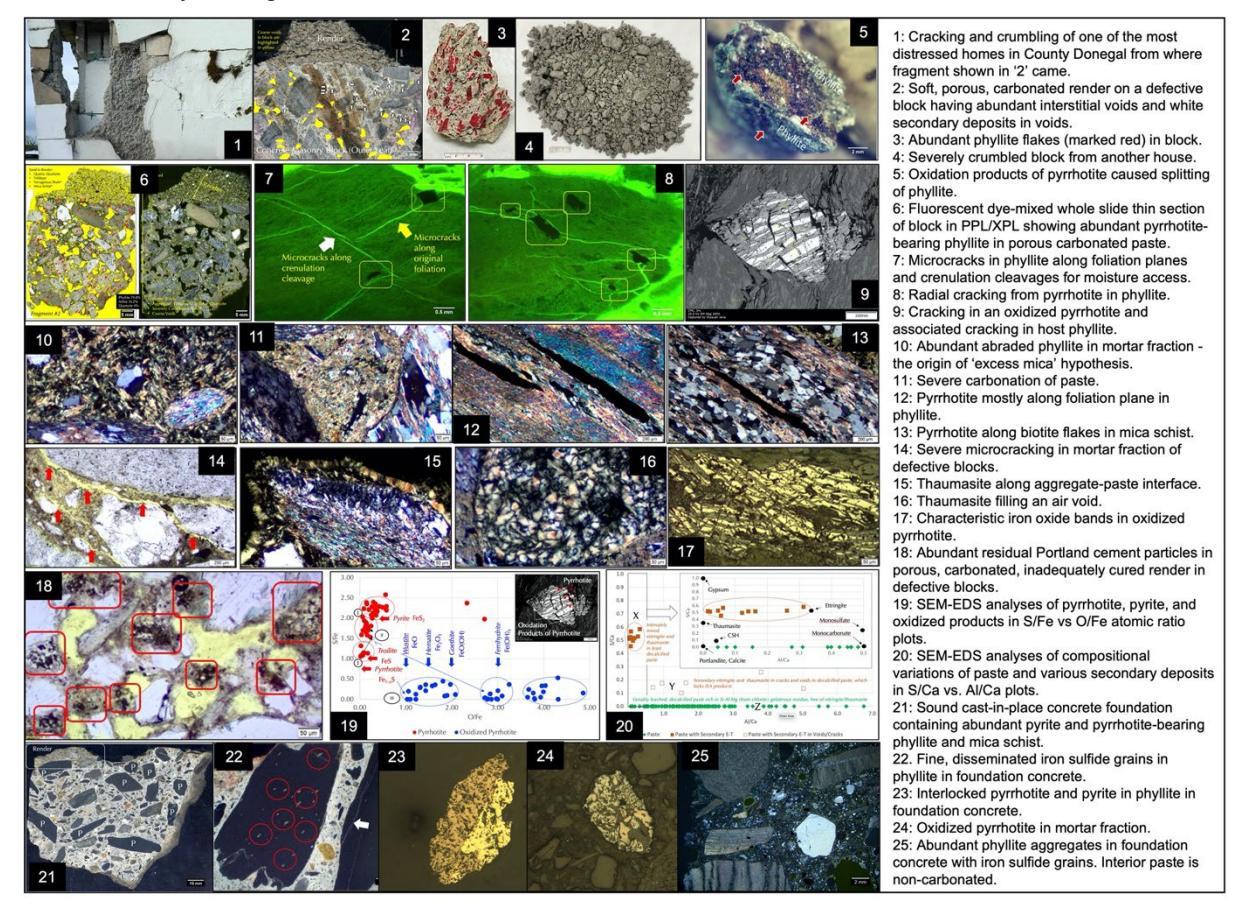
Figure 1.1: A microstructural collage of defective concrete blocks (Photos 1 to 20) and sound cast-inplace foundation (Photos 21 to 25) from County Donegal, Ireland.

Crumbling in one of the most distressed homes in County Donegal (Fig. 1.1 Photo 1) examined by author was the result of multiple episodes that started with the use of defective concrete blocks having: (1) abundant easily splitable phyllite aggregates (as high as 80% by volume of coarse aggregate, Fig.

1.1 Photos 2, 6), along with (2) overall porous, high water-cement ratio (w/c), and low cement content (4% [3]) nature of blocks leaving a lot of interstitial spaces for migration of moisture, oxygen and CO<sub>2</sub> through the renders to the blocks especially at the outer leaf to cause pyrrhotite oxidation, paste carbonation, ISA, and leaching/re-precipitation.

Abundant pyrrhotite grains in phyllite (sizes from < 1 mm at long to <0.5 mm at short directions, Fig. 1.1 Photos 6-9) have acted as the effective sites for expansion from oxidation during service especially at the moist and alkaline (pH >10, less to non-carbonated) conditions of blocks. Some prior oxidations, however, may have occurred in geologic formation and during storage in the aggregate stockpile. Pyrrhotite grains are detected mostly in phyllite as opposed to mica schist or metaguartzite as (a) finegrained isolated disseminated irregular-shaped to subhedral equant grains (Fig. 1.1 Photo 7) to (b) mostly elongated grains aligned along the dominant foliation planes (Fig. 1.1 Photo 12), which shows extensive reddish-brown oxidation products (e.g., goethite, ferrihydrite, Fig. 1.1 Photo 5) causing further cracking, splitting, and disintegration of phyllite. In situ oxidation of pyrrhotite has caused further splitting and crumbling of phyllite (Fig. 1.1 Photos 8,9) especially since most pyrrhotite grains have crystallized along the prevailing foliation planes where the inherent phyllitic texture of foliation and deformed (crenulation) cleavage planes provided pathways for ready migration of moisture to facilitate oxidation. Additionally, spectacular radial cracks are often seen from oxidized pyrrhotite grains in phyllite (Fig. 1.1 Photos 8, 9) as a testament of in situ expansion from pyrrhotite oxidation. Reddish-brown oxidized pyrrhotite products are preferentially noticed between the greenish sheened (from chlorite) foliated sheets where expansive oxidation reactions have further disintegrated the phyllite. Pyrrhotite contents in phyllite aggregates varied from 0.75 to 1.5 percent, by volume. Pyrrhotite is associated with pyrite though no evidence of oxidation of pyrite, or its subsequent sulfate attack (as found in the neighboring County Mayo from framboidal pyrite) was found in the present study.

Fig. 1.1 Photos 19 and 20 show SEM-EDS analysis of compositional variations of pyrrhotite with oxidation products, and paste with secondary deposits, respectively. XRD studies showed both pyrite and pyrrhotite in blocks and foundation but higher amounts of pyrrhotite in blocks leading to higher risk along with indication of potential variations in pyrrhotite contents across the quarry.

Along with aggregate disintegration, mortar fractions of blocks (Fig. 1.1 Photos 10, 11, 14) became the junkyard of (1) abundant abraded fractions of phyllite, (2) oxidized pyrrhotite grains, (3) products of carbonation, (4) lime-poor silica-alumina-magnesia gel from carbonation to decalcification (magnesia was from chlorite decomposition), (5) scattered products of E/T/G-forms of ISA either in least leached/carbonated paste, or as (6) innocuous secondary deposits lining air voids and pores from dissolution and reprecipitation in the decalcified regions of paste. All these products are initially characterized from optical microscopy but best diagnosed during subsequent SEM-EDS studies.

For the sample from cast-in-place foundation, nonreactive pyrite is more abundant than pyrrhotite, where the former contributed to the lion's share of  $S_T$  and the latter mostly occurred as nonreactive fine disseminated grains in phyllite (Fig. 1.1 Photo 22) instead of along foliations, and lesser in the mortar fractions where it shows some oxidation (Fig. 1.1 Photo 24), which is consistent with lesser amount of abraded phyllite in the mortar fraction (Fig. 1.1 Photo 25) than found in defective blocks. Characteristic 'striated' appearance of oxidized pyrrhotite grains having iron oxide bands in iron sulfide body so common in the blocks (Fig. 1.1 Photos 9, 17) are virtually absent in the foundation (Fig. 1.1 Photo 23). Carbonation was restricted to the top 15 mm mostly in a porous cementitious coating on concrete, where secondary ettringite is found in voids. Evidence of E-ISA, T-ISA, or G-ISA are not found in the interior concrete, nor any cracking, which are due to the inherent denser microstructure of concrete along with the absence of moisture during service. Cases from Canada and US, however, showed that denser microstructure alone cannot prevent the distress if foundation were exposed to moisture during service.

Distresses from E/T-ISA, however, are less evident in the severely carbonated, porous, silica-aluminarich gelatinous regions of paste where products of ISA are mostly found as secondary deposits in coarse voids (as interlayered secondary ettringite and thaumasite fibers, Fig. 1.1 Photo 16) from dissolution and re-participation, whereas in the least de-calcified regions E/T-ISA products are often found mixed within the paste to implant seeds for potential expansions. Distresses from E/T-ISA, however, are inherently restricted for the low (<10%) paste volumes of blocks and even more so only in the moderately carbonated and less decalcified paste regions. The outcome, however, is severe crumbling of blocks.
